V2500-A5/D5 SERIES PROPULSION SYSTEM SERVICE BULLETIN

V2500-ENG-72-0486

ENGINE - HP COMPRESSOR VARIABLE VANES - INTRODUCTION OF A REVISED VIGV WITH AN OPTIMISED SPINDLE - MOD 72-0486

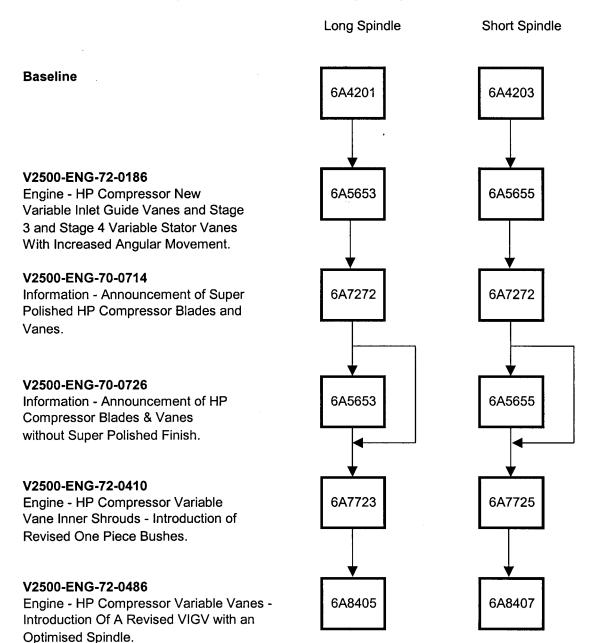
HP Compressor VIGV Vane Assembly Family Tree

- (1) This modification introduces revised arrangement for attaching the lever arms to the top of the VIGV spindles from the existing stud and nut to a bolt and helicoil configuration. The changes introduced are:
 - (a) Revised HP Compressor VIGV long and short spindle assemblies are introduced, similar to the existing items except for:
 - (b) The stud in the top of the vane outer spindle is deleted and replaced by a helicoil insert.
 - (i) The existing thread size is reduced from 0.3125 UNJF to 0.2964 UNJF.
 - (ii) The depth of the outer spindle hole has been increased.
 - (iii) The counter bore diameter has been reduced from 8,68mm. to 7,80mm.
 - (iv) The weight relief areas on the long spindle are removed.
 - (c) The nut which was previously used to attach the lever arms to the top of the vane spindles is deleted and replaced by a standard type bolt.
