V2500-A1 SERIES PROPULSION SYSTEMS SERVICE BULLETIN

V2500-ENG-72-0542

ENGINE – NEW FIRST STAGE DUCT SEGMENTS AND HPT VANE SUPPORT**1. Planning Information****A. Effectivity**

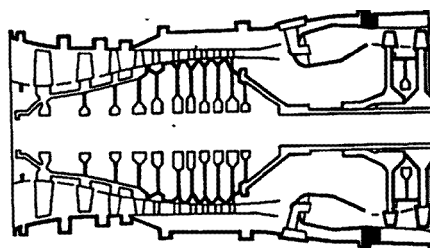
LOCATION OF THE STAGE 1 HIGH PRESSURE TURBINE SUPPORT ASSEMBLY
Figure 1

INSTALL THE 2A4027 STAGE 1
HPT SUPPORT ASSEMBLY (1OFF)

USE THE 2A3328 STAGE 1
HPT SEAL (1OFF)
