**International Aero Engines
NON-MODIFICATION
SERVICE BULLETIN**

ENGINE – HP COMPRESSOR, STAGE 3 ROTOR – REPEAT INSPECTION OF CLAPPERS – NON-MODIFICATION SERVICE BULLETIN

V2500-D5 SERIES PROPULSION SYSTEMS NON-MODIFICATION SERVICE BULLETIN

V2500-ENG-72-0545

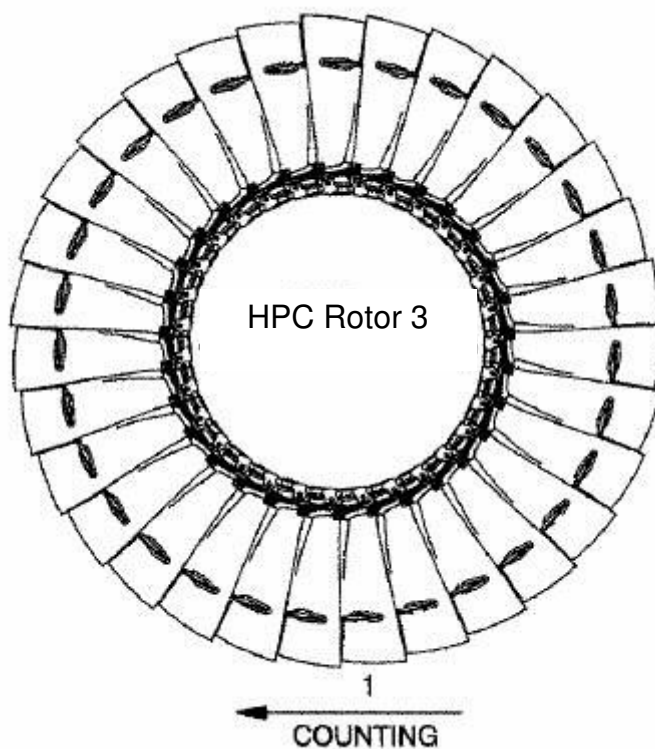
NOTE: Count the blades as the rotor is rotated in the anti-clockwise direction (viewed from the front). The first blade to be inspected should be designated number 1.
