V2500-A1 SERIES PROPULSION SYSTEMS SERVICE BULLETIN

V2500-ENG-72-0548
Transmittal - Page 1 of 2

ENGINE - PROVIDE NEW SECOND STAGE TURBINE AIR SEAL

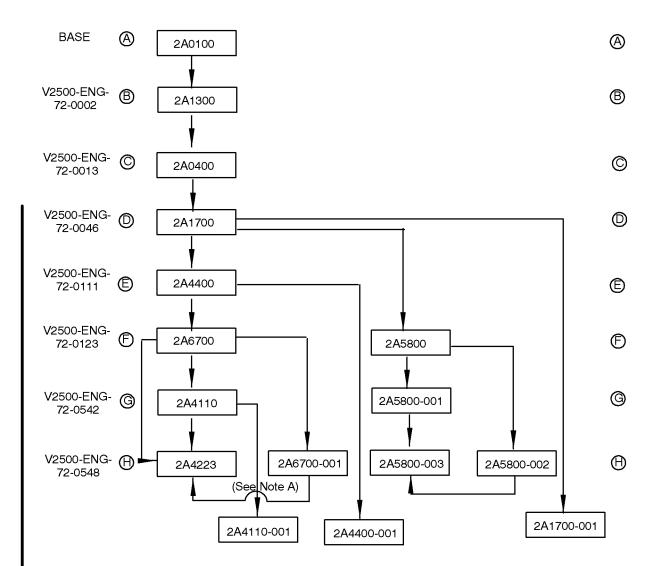
FAMILY TREE - ROTOR AND STATOR ASSEMBLY REF. CATALOG SEQUENCE NO. 72-45-00 FIGURE 01 ITEM 001 CHART A (Sheet 1 of 3)

NOTE A: Engines which have incorporated SB 72-0542 (1st OAS) may replace 2A6700-001 with 2A4223.

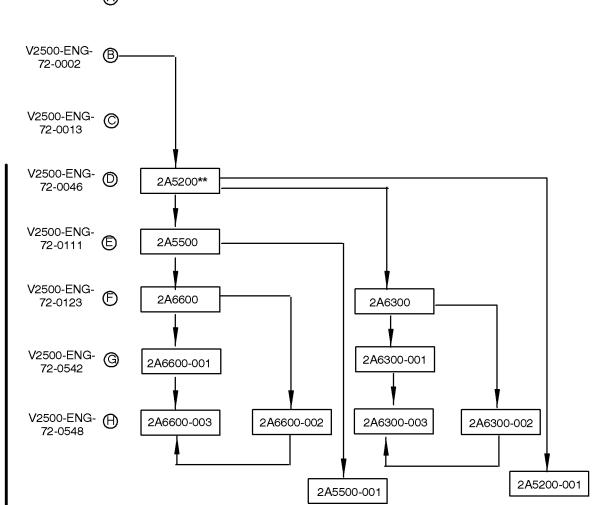
FAMILY TREE - ROTOR AND STATOR ASSEMBLY
REF. CATALOG SEQUENCE NO. 72-45-00 FIGURE 01 ITEM 001
CHART A (Sheet 3 of 3)

- No procedure for advancement.
- ** Engines not incorporating 72-0111
- *** Engines incorporating 72-0111
