V2500-A1/A5/D5 SERIES PROPULSION SYSTEM NON-MODIFICATION SERVICE BULLETIN

V2500-ENG-72-0580

NON-MODIFICATION SERVICE BULLETIN – BORESCOPE INSPECTION OF HIGH PRESSURE TURBINE
(HPT) STAGE 1 DUCT SEGMENTS

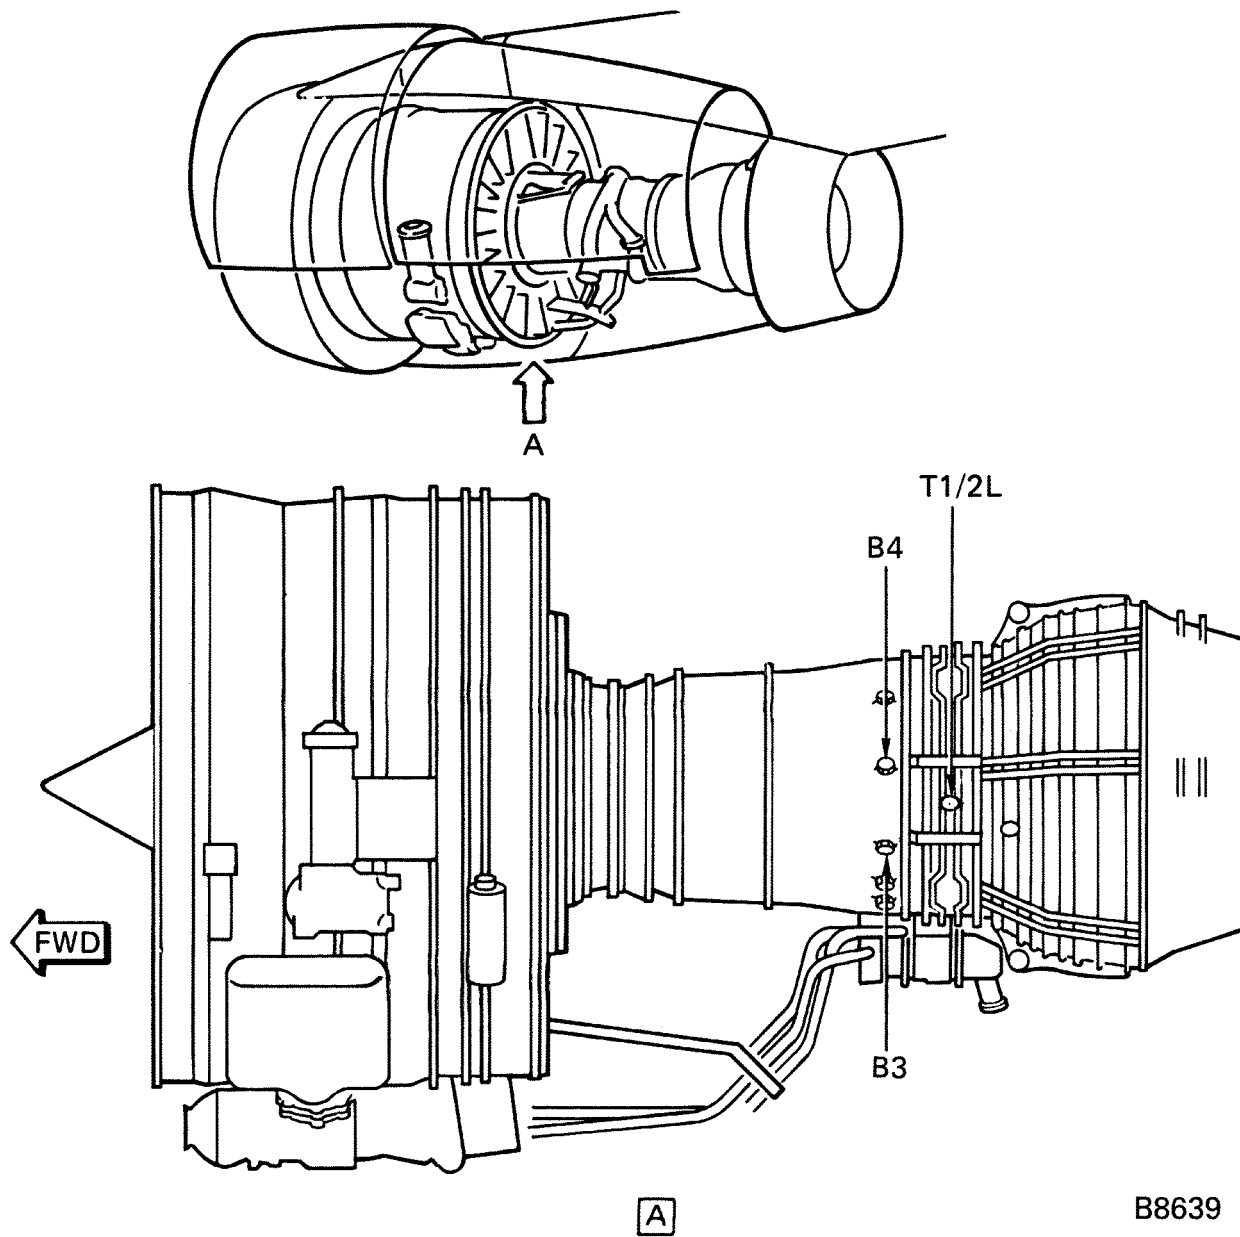
Appendix A (Sheet 1 of 2)

HP TURBINE BORESCOPE LOCATION FOR INSPECTION OF THE STAGE 1 HPT DUCT SEGMENTS
(LEFT SIDE)

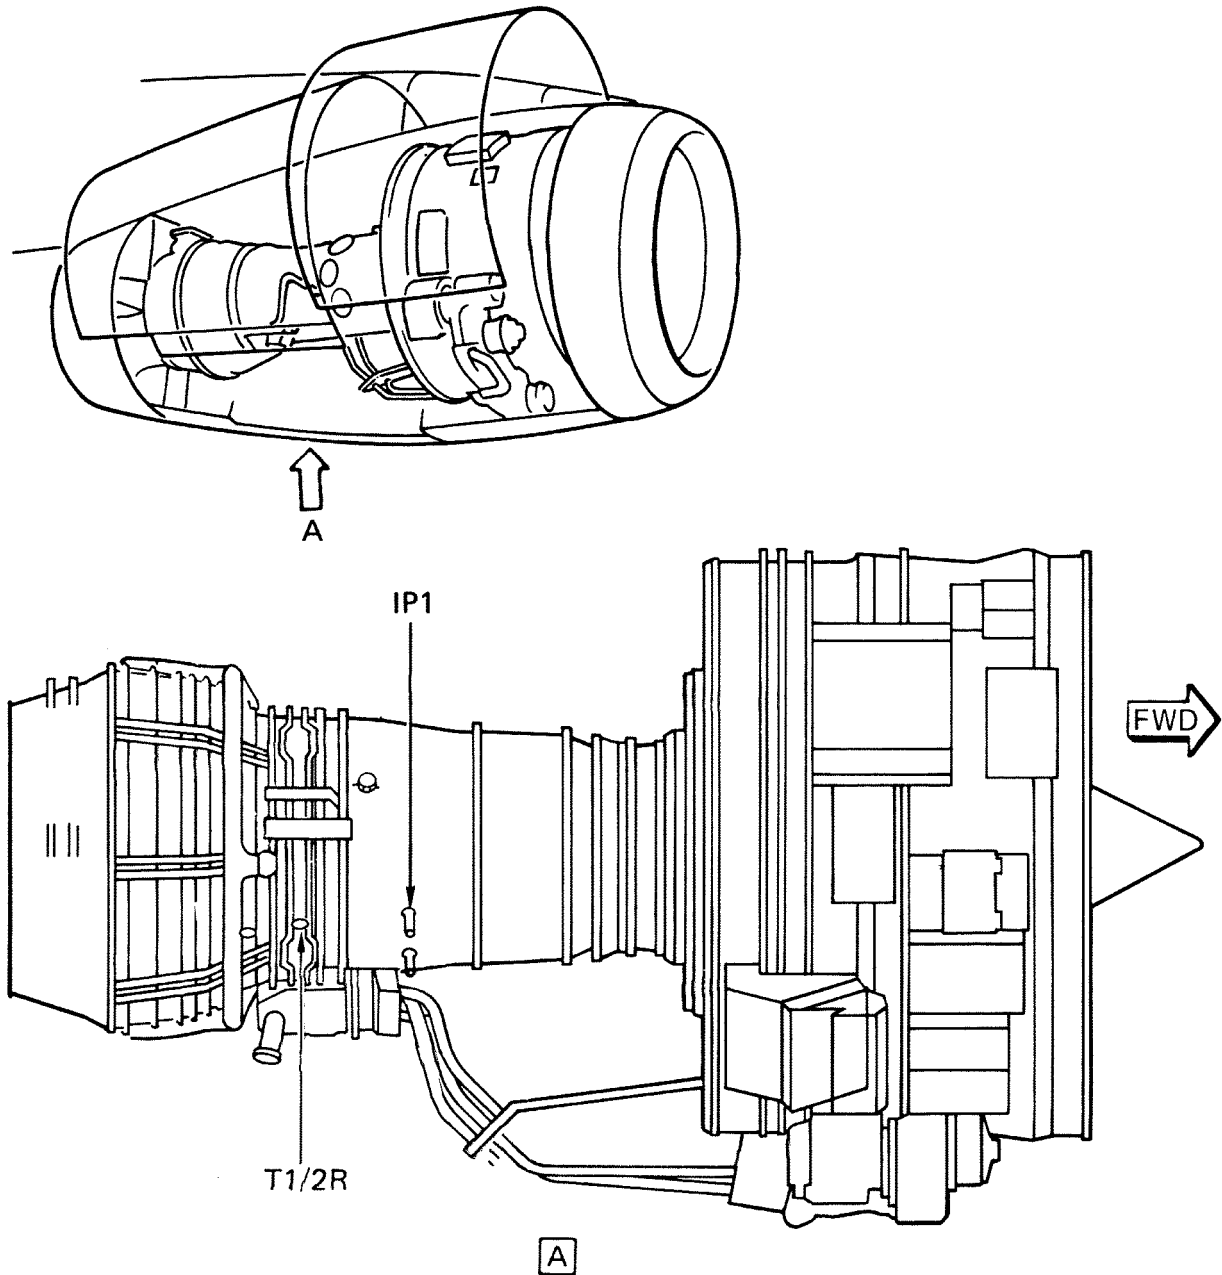
HP TURBINE BORESCOPE LOCATION FOR INSPECTION OF THE STAGE 1 HPT DUCT SEGMENTS
(RIGHT SIDE)

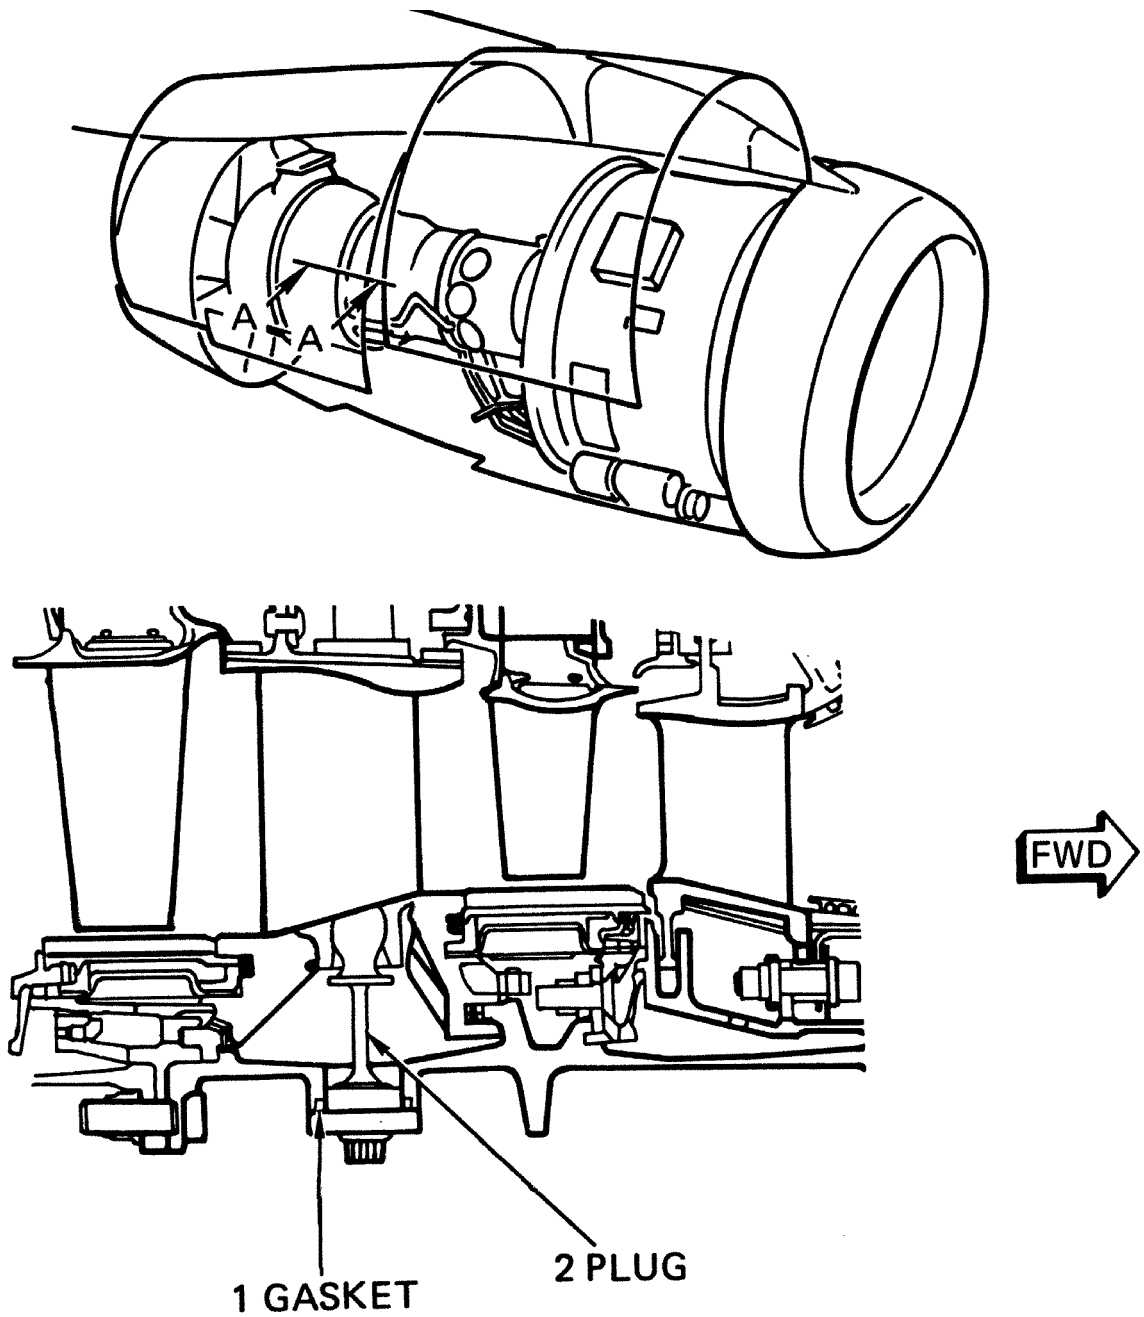
2. Appendix B – HP Turbine Ports for Inspection of the Stage 1 HPT Duct Segments

**SECTION A-A
(T1/2L and T1/2R)
2 LOCATIONS**

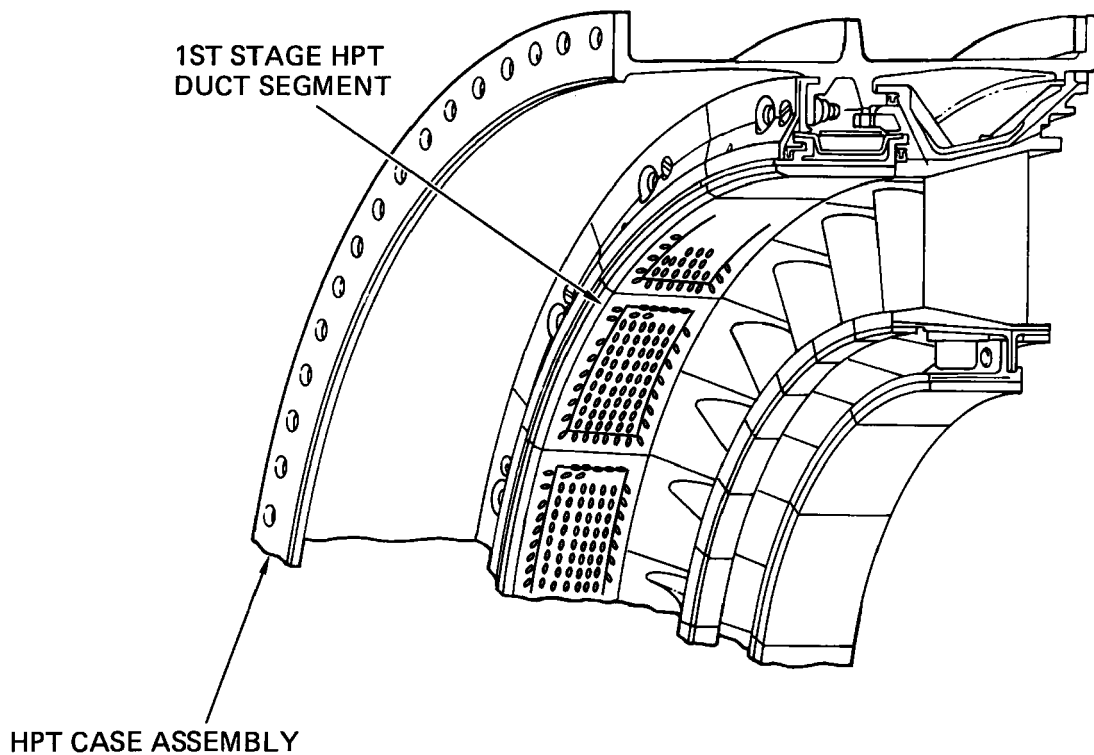
3. Appendix C – Stage 1 HPT Duct Segment Inspection Locations

Condition	300-hr inspection	125-hr inspection	Pull in 10 cycles
Axial Cracks	Any crack longer than 0.250 in. (6,35 mm) and shorter than 0.500 in. (12,70 mm)	Any crack longer than or equal to 0.500 in. (12,70 mm) but shorter than 1.20 in. (30,48 mm)	Any crack longer than or equal to 1.20 in. (30,48 mm)
Circumferential Cracks	Any crack longer than 0.375 in. (9,53 mm) and shorter than 0.500 in. (12,70 mm)	Any crack longer than or equal to 0.500 in. (12,70 mm) but shorter than 1.50 in. (38,1 mm)	Any crack longer than or equal to 1.50 in. (38,1 mm)
Intersecting Cracks * See Sheets 4, 5 and 6	Any combined crack longer than 0.250 in. (6,35 mm) and shorter than 0.500 in. (12,70 mm) axially or longer than 0.375 in. (9,53 mm) and shorter than 0.500 in. (12,70 mm) circumferentially	Any combined crack longer than or equal to 0.500 in. (12,70 mm) and shorter than 1.200 in. (30,48 mm) axially or longer than or equal to 0.500 in. (12,70 mm) and shorter than 1.500 in. (38,10 mm) circumferentially	Any combined crack longer than or equal to 1.200 in. (30,48 mm) axially or 1.500 in. (38,10 mm) circumferentially

Closed loop of cracks * See Sheet 9	Does Not Apply	Maximum length in X or Y direction less than 0.500 in. (12,70 mm)	Maximum length in X or Y direction more than or equal to 0.500 in. (12,70 mm)
Burning/ Erosion of base metal Area 1 (No Burn Through)	Any amount greater than two connecting cooling holes	Does Not Apply	Does Not Apply
Burning/ Erosion of base metal Area 2 (No Burn Through)	Shiplap burning greater than the 1st row of cooling holes and up to 2nd row of cooling holes	Shiplap burning beyond 2nd row of cooling holes	Does Not Apply
Burn Through Area 1 and 2	Does Not Apply	Less than 0.500 in. (12,70 mm) of continuous burn-through in Area 1, Area 2 or Areas 1 and 2 together	0.500 in. (12,70 mm) or more of continuous burn-through in Area 1, Area 2, or Areas 1 and 2 together
Burn through with adjoining cracks in the axial direction * See Sheet 7	Does Not Apply	Combined length of X1+X2+Z less than 1.200 in. (30,48 mm) and Z less than 0.500 in. (12,70 mm) in Area 1, Area 2 or Areas 1 and 2 together	Combined length of X1+X2+Z more than or equal to 1.200 in. (30,48 mm) or Z more than or equal to 0.500 in. (12,70 mm) in Area 1, Area 2 or Areas 1 and 2 together

Burn through with adjoining cracks in the circumferential direction *See Sheet 8	Does Not Apply	Combined length of Y1+Y2+Z less than 1.500 in. (38,10 mm) and Z less than 0.500 in. (12,70 mm) in Area 1, Area 2 or Areas 1 and 2 together	Combined length of Y1+Y2+Z more than or equal to 1.500 in. (38,10 mm) or Z more than or equal to 0.500 in. (12,70 mm) in Area 1, Area 2 or Areas 1 and 2 together
Burn Through Impingement Plate	Does Not Apply	Does Not Apply	Any Amount
Lifting of LE Material	Does Not Apply	Does Not Apply	Lifting of Seal Edge
Loss of LE Material	Less than 0.300 in. (7,62 mm)	0.300 in. (7,62 mm) or more, but less than 0.500 in. (12,70 mm)	0.500 in. (12,70 mm) or more

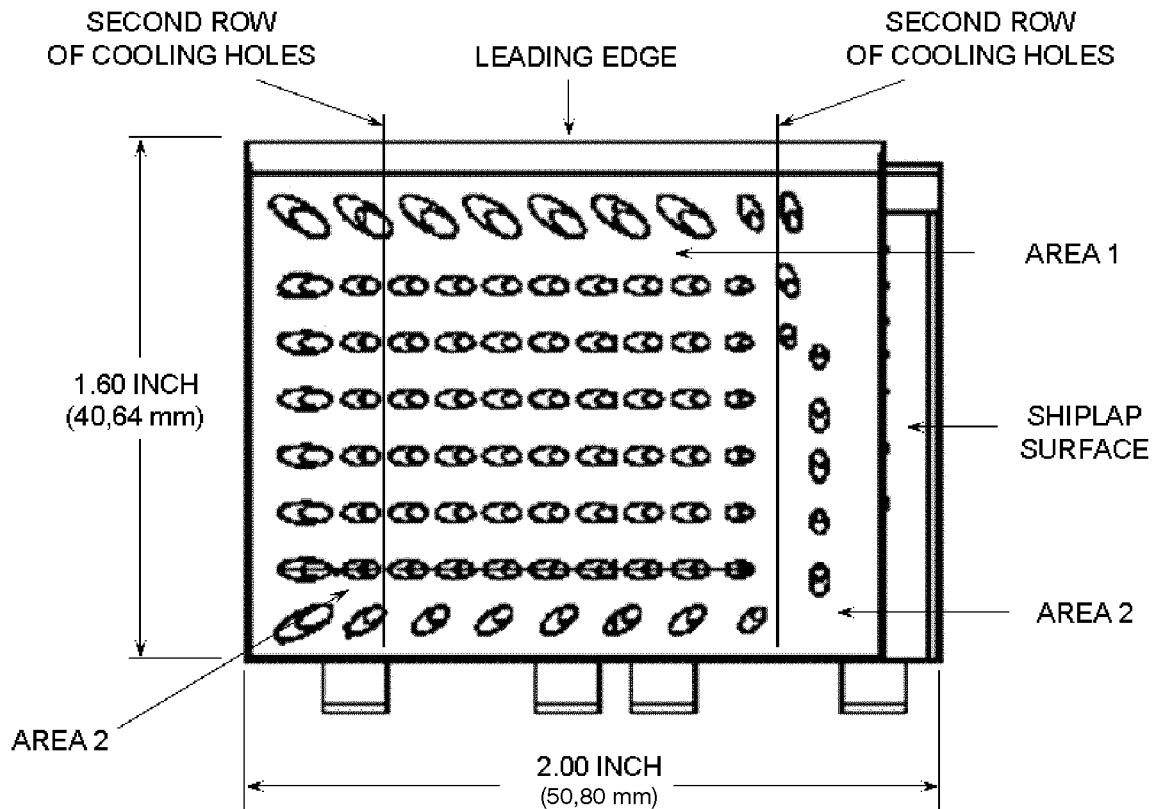
Location where adjoining duct segments overlap. See Sheets 2 and 3.

STAGE 1 BOAS PLATFORM OVERVIEW – PRE SERVICE BULLETIN
V2500-ENG-72-0542 (A1 SERIES ENGINES)
Appendix D (Sheet 2 of 9)

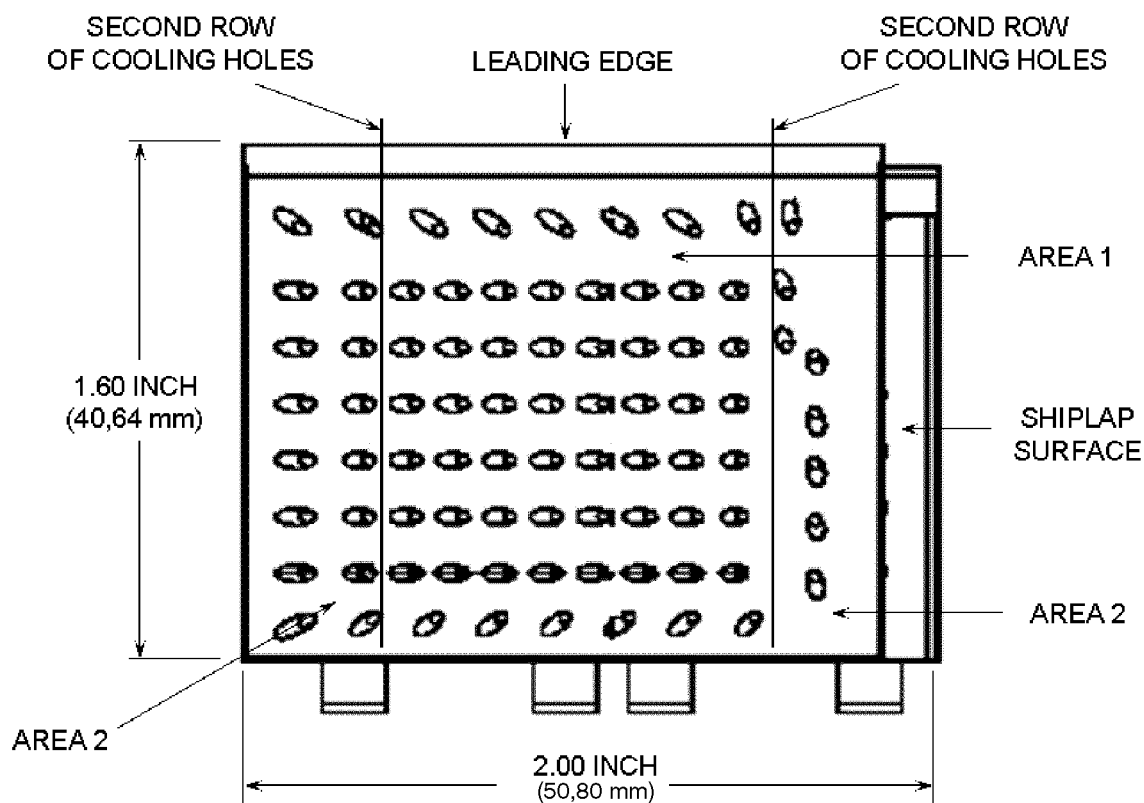
STAGE 1 BOAS PLATFORM OVERVIEW – PRE SERVICE BULLETIN
V2500-ENG-72-0483 (A5/D5 SERIES ENGINES)
Appendix D (Sheet 3 of 9)
