NON-MODIFICATION SERVICE BULLETIN — ENGINE — TURBINE EXHAUST CASE (TEC) — EDDY CURRENT INSPECTION (ECI)

Turbojet Engine Service Bulletin No. 72-0694 Revision No. 2 dated July 2, 2018.

V2500 Series 72-0694

ATA NUMBER 72-50-00

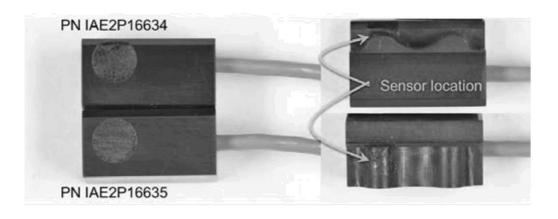
FIGURE 3

EDDY CURRENT PROBES, PN IAE2P16634 AND IAE2P16635. ACTIVE SENSOR POSITION TO COVER FULL EXTENT OF FORWARD AND AFT RAIL. SENSOR IS LOCATED BELOW OUTER MOST FOOT OF THE PROBE (AWAY FROM CABLE ENTRY POSITION).

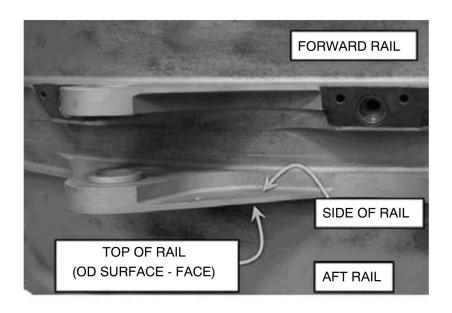
GEOMETRY DEFINITION SHOWING SIDE RAIL FACE AND TOP OF RAIL. THE OD SURFACE OR "TOP OF THE RAIL" IS THE REQUIRED INSPECTION SURFACE FOR THIS INSPECTION. FIGURE 5

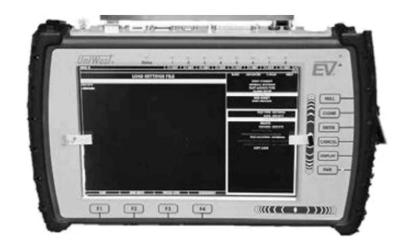
UNIWEST EVI EDDY CURRENT INSTRUMENT FIGURE 13

- A. The EVi instrument as shown in Figure 13 is approved for use for this inspection. Install Cable #72306 and #94032 to the instrument. Connect the probe, PN IAE2P16634 to the instrument. Turn on the EVi using the power button at the lower right edge of the instrument.

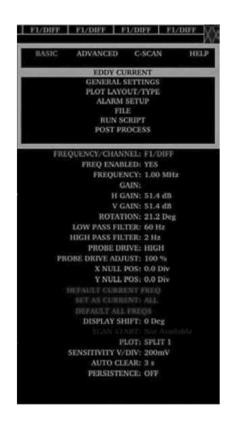
F1/DIFF INITIAL SETTINGS FIGURE 14

- C. After loading, verify that F1/DIFF on the EVi instrument is set to the following initial settings. To access the settings, go to the "BASIC" menu, use the vertical slider to select "EDDY CURRENT" and press ENTER. The FREQUENCY/CHANNEL should be at F1/DIFF. Use the ENTER function as necessary to set to F1/DIFF. If any of the values are different than listed below, modify to the correct setting, see Figure 14:

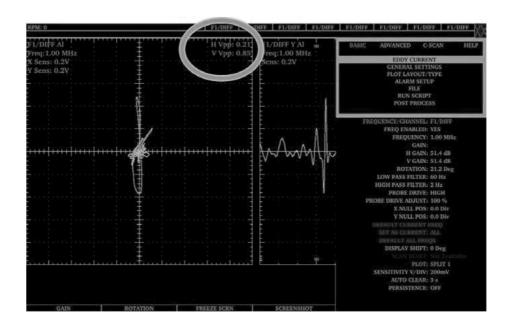
TYPICAL CALIBRATION RESPONSE FOR IAE2P16634 PROBE FIGURE 15

- Set the rotation such that the notch response is vertical. Adjust the gain such that the response is 4 div or V Vpp = 0.8 V then adjust the gain as specified on the calibration card for the standard. The Vpp reading is shown in the upper right corner of the impedance plane display, as shown in the oval in Figure 15. The response from the calibration notch is shown for typical gain and rotation settings for this probe.

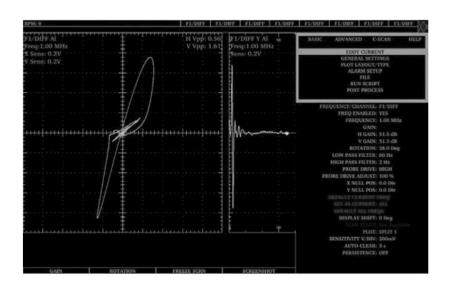
TYPICAL RESPONSE FOR NOTCH INDICATION IN THE V2500 TEC FIGURE 16

- C. An indication will appear as a figure eight on the impedance plane (MAIN PLOT). similar to the notch response during calibration. The response will also show up as an amplitude spike in the vertical response vs. time trace as shown in Figure 16.

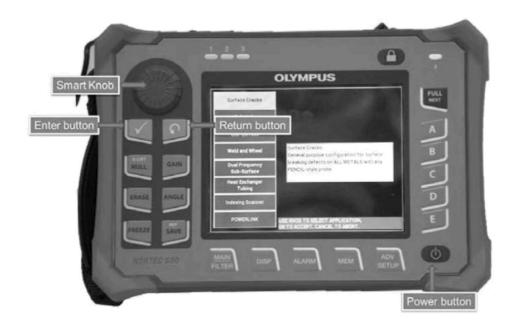
NORTEC 600 INSTRUMENT FIGURE 17

- A. The Nortec 600 shown in Figure 17 is approved for use for this inspection. Install Cable #94186 to the instrument. Connect the probe, PN IAE2P16634 to the instrument. Turn on the Nortec 600 using the power button at the lower right edge of the instrument. When the display has activated, select the "Surface Cracks" menu option using the "Enter" button ($\sqrt{}$) at the upper left. When the display has activated, if the Application screen is present, select the return button. If the settings are in the Memory, load the settings from the appropriate file for NDIP1167. If the settings are not in the memory, proceed to set up the instrument per paragraph 12.C.

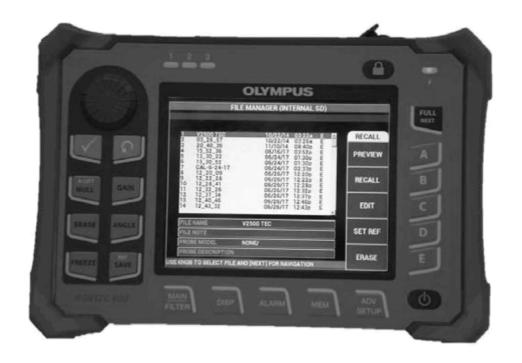
- B. Load the settings file, "V2500 TEC". Enter the "MEM" menu key at the bottom right side of the instrument, use the smart knob (upper left) to highlight the "V2500 TEC" file as shown in Figure 18. Use function Key "B" (upper right) to activate the RECALL function and load the V25000 TEC setup file.

FILE MANAGER SCREEN USED TO LOAD THE INITIAL SETTINGS FILE FOR THE V2500 TEC SETUP. USE FUNCTION KEY B TO ACTIVATE RECALL AND LOAD THE CORRECT SETTINGS. FIGURE 18

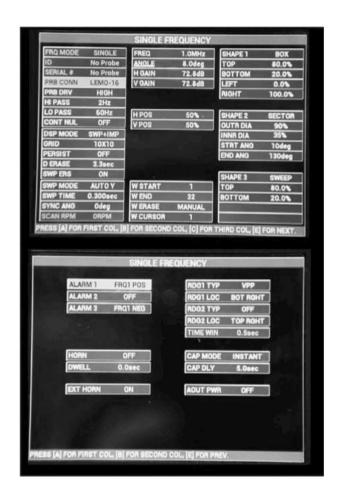
INITIAL SETTINGS FIGURE 19

- C. Verify that instrument is set to the following initial settings. To access the settings, go to the "ADV SETUP" menu, using the button in the lower right. Select "ALL SETTINGS" by pressing function key, B, on the right side. The FREQUENCY should be set to Single (upper display) as shown below. Use the function keys (A for col 1; B for col 2; C for Col 3) and the "FULL Next" button (upper right) as necessary to step thru set-up parameters. Use the Smart Knob as necessary to change the settings to the values listed below. See Figure 19.

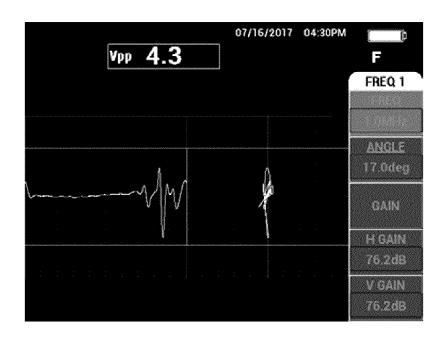
TYPICAL CALIBRATION RESPONSE FIGURE 20

- E. Set the rotation such that the notch response is vertical. Adjust the gain such that the response is 4 div or Vpp = 4.0 +/- 0.3V then adjust the gain as specified on the calibration card for the standard. The Vpp reading is shown on the instrument display. The response from the calibration notch is shown for typical gain and rotation settings for this probe in Figure 20.

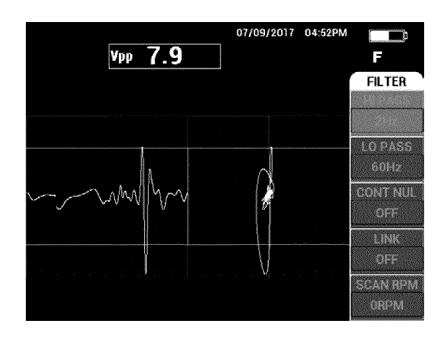
- C. An indication will appear as a figure eight on the impedance plane (MAIN PLOT), similar to the notch response during calibration. The response will also show up as an amplitude spike in the vertical response vs. time trace as shown in Figure 21. Figure 22 provides additional impedance place examples. Note that for larger indications, there will be phase rotation to the upper right quadrant.

EXAMPLE OF NOTCH RESPONSE FOR REJECTABLE INDICATION (TOP) FIGURE 21
