## SERVICE BULLETIN

ENGINE - FUEL AND CONTROL - TO PROVIDE A NEW ELECTRONIC ENGINE CONTROL (EEC) WITH THE  
SCN12B SOFTWARE CONFIGURATION - CATEGORY CODE 4 - MOD.ENG-73-0044

# V2500-ENG-73-0044

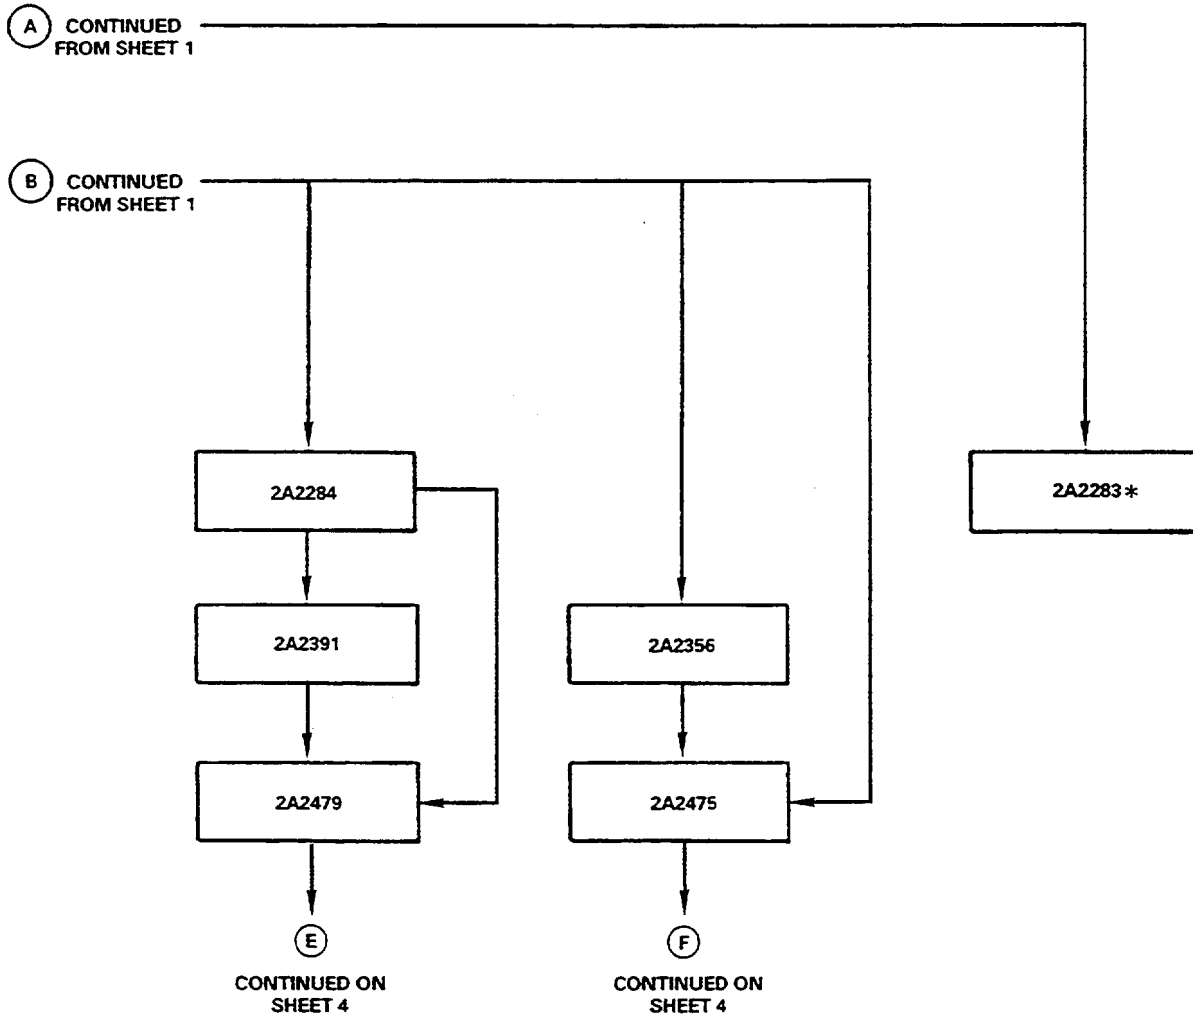
Family Tree - Electronic Engine Control (EEC) Catalog Sequence No. 73-22-34, Fig 01,  
Item 280  
Fig.3 (Sheet 2)

\*THERE IS NO PROCEDURE TO  
ADVANCE THIS CONFIGURATION
