ENGINE - FUEL AND CONTROL - NEW FUEL DIVERTER AND RETURN VALVE ASSEMBLY WITH NEW CAP SEAL AND ENLARGED SOLENOID ORIFICE - CATEGORY CODE 5 - MOD.ENG-73-0054

No. 13298-73-003

ENGINE - FUEL AND CONTROL - NEW FUEL DIVERTER AND RETURN VALVE ASSEMBLY WITH NEW CAP SEAL AND ENLARGED SOLENOID ORIFICE

No. 17300-73-003

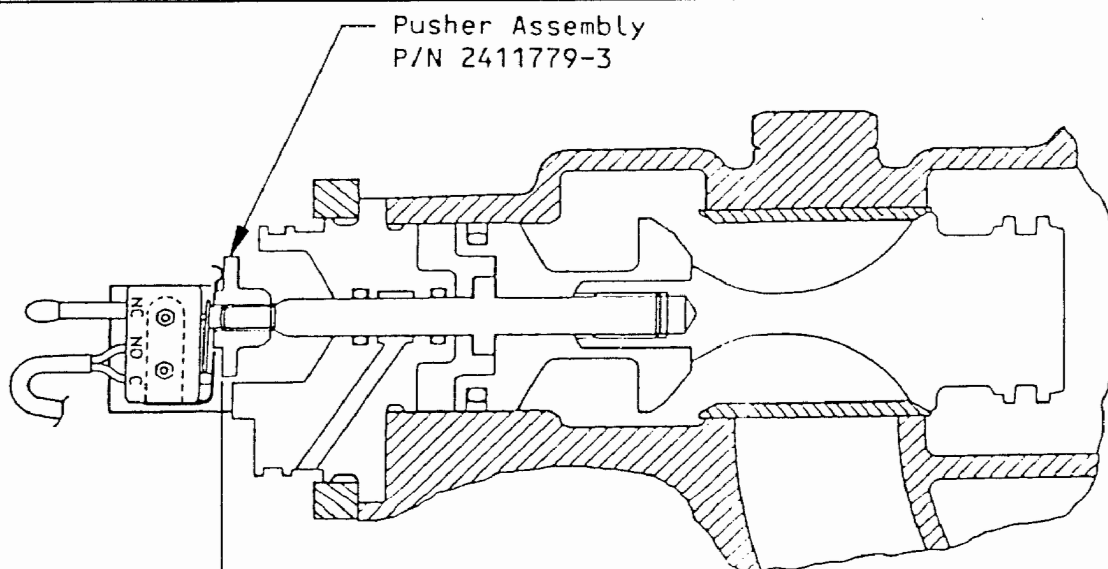
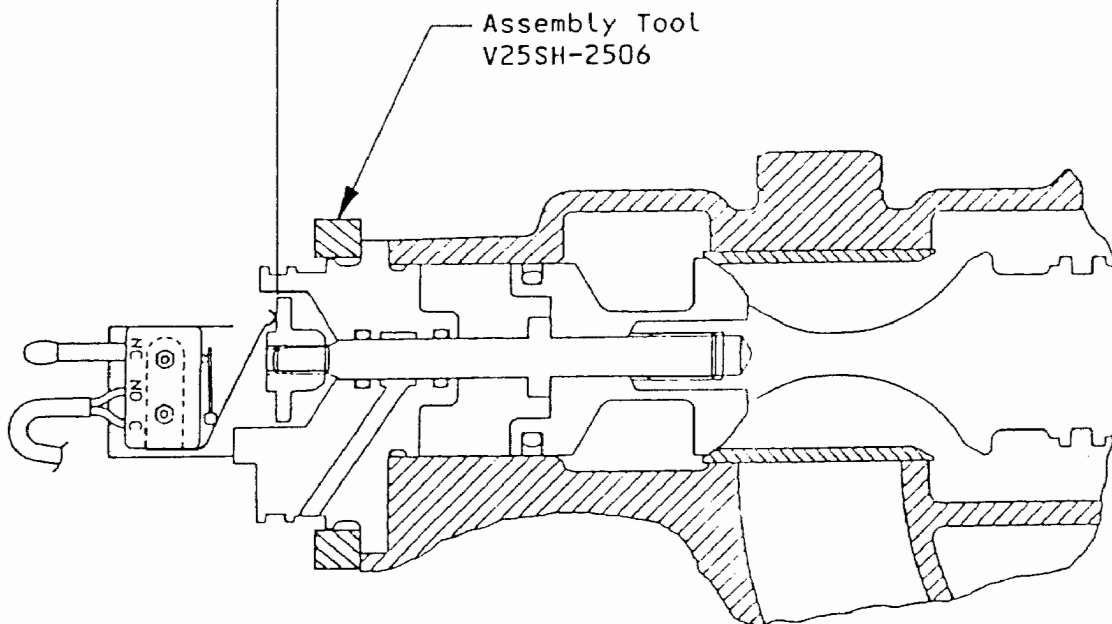
Measurement of FDV Full Stroke
Figure 6

Condition : 1. Solenoid de-energized.

Condition : 1. Supply fuel pressure (550 psig) to port 9.
2. Solenoid energized.

- (1) Measure the FDV full stroke (dimension A, in figure 6) using slide calipers with solenoid de-energized condition and solenoid energized/supplying the applicable pressure in to the HP (port 9) side (550 psig) condition. Note the FDV full stroke.
