ENGINE - FUEL AND CONTROL - INTRODUCTION OF A NEW FUEL DIVERTER AND RETURN VALVE WITH
NEW MICROSWITCH ASSEMBLIES - CATEGORY CODE 6 - MOD.ENG-73-0081

V2500-ENG-73-0081

No: 13298-73-006

**ENGINE - FUEL AND CONTROL - NEW FUEL DIVERTER AND RETURN VALVE
WITH NEW MICROSWITCH ASSEMBLIES****1. Planning Information****A. Effectivity****(a) Engine**

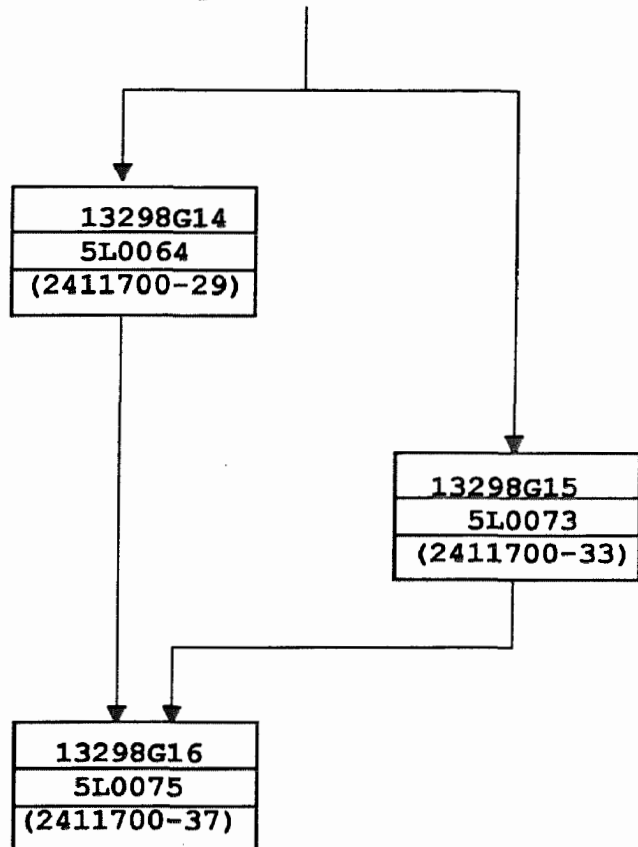
Family Tree - Fuel Diverter and Return Valve
Ref. Catalog Sequence No. 73-13-42
Figure 4 (Sheet 2)

13298-73-006 - PART 1
MICROSWITCH CHANGE

13298-73-006 - PART 2
MICROSWITCH CHANGE
13298-73-005 - PART 2
SEAL MATERIAL CHANGE

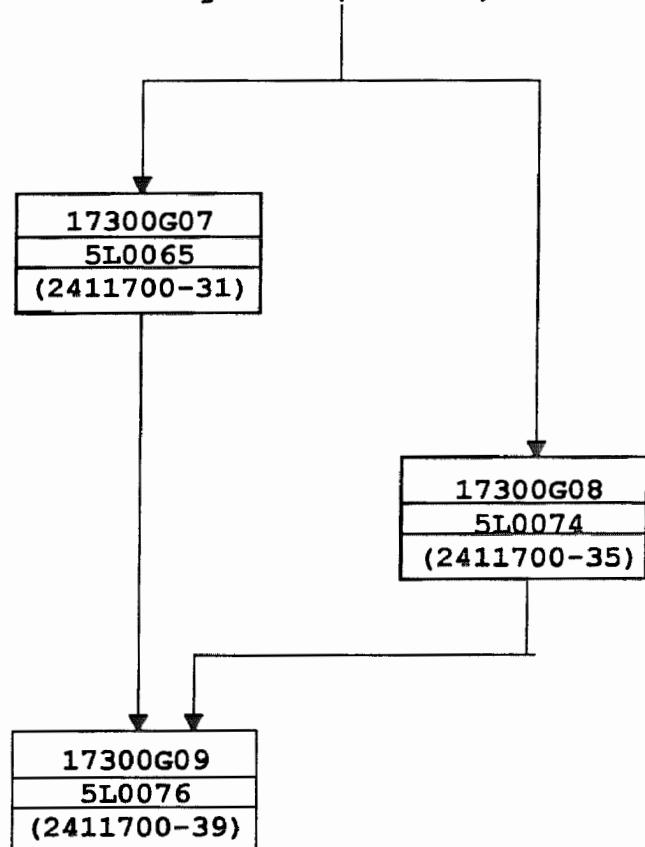
Family Tree - Fuel Diverter and Return Valve
Ref. Catalog Sequence No. 73-18-52
Figure 4 (Sheet 2)

17300-73-006 - PART 1
MICROSWITCH CHANGE

17300-73-006 - PART 2
MICROSWITCH CHANGE
17300-73-005 - PART 2
SEALING MATERIAL CHANGE
