SERVICE BULLETIN

ENGINE - FUEL AND CONTROL - ENGINE - ELECTRONIC ENGINE CONTROL - PROVIDE A NEW ELECTRONIC ENGINE CONTROL (EEC) WITH THE SCN12D SOFTWARE CONFIGURATION - CATEGORY CODE 4 - MOD.ENG-73-0082

V2500-ENG-73-0082

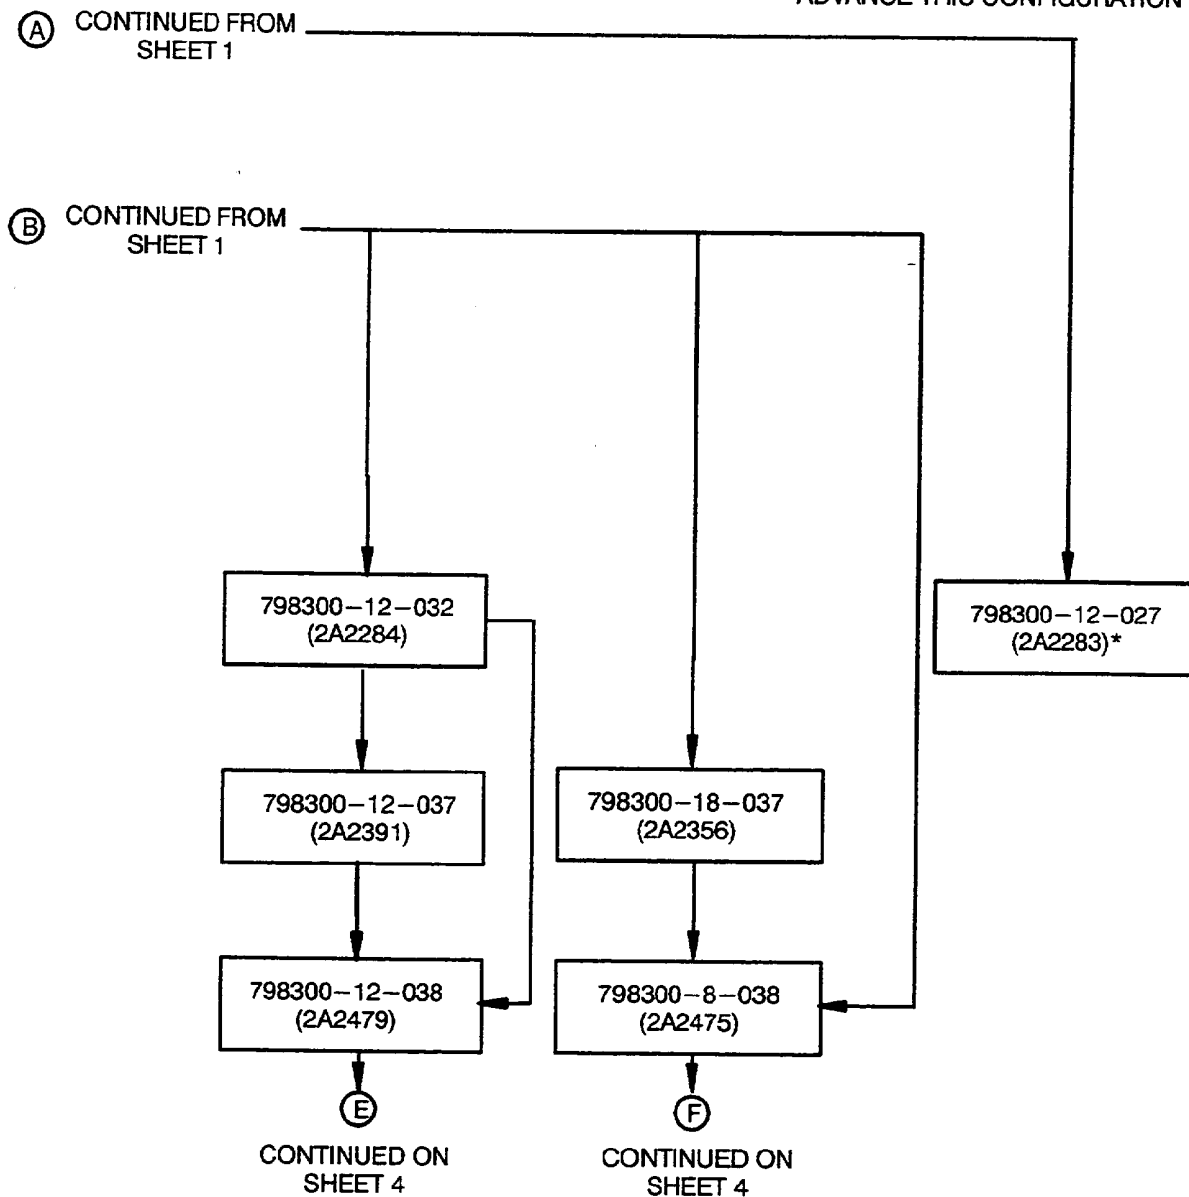
Family Tree - Electronic Engine Control (EEC) Ref. Catalog Sequence No. 73-22-34. Fig. 01 Item 280
Fig.3 (Sheet 2)

*THERE IS NO PROCEDURE TO
ADVANCE THIS CONFIGURATION

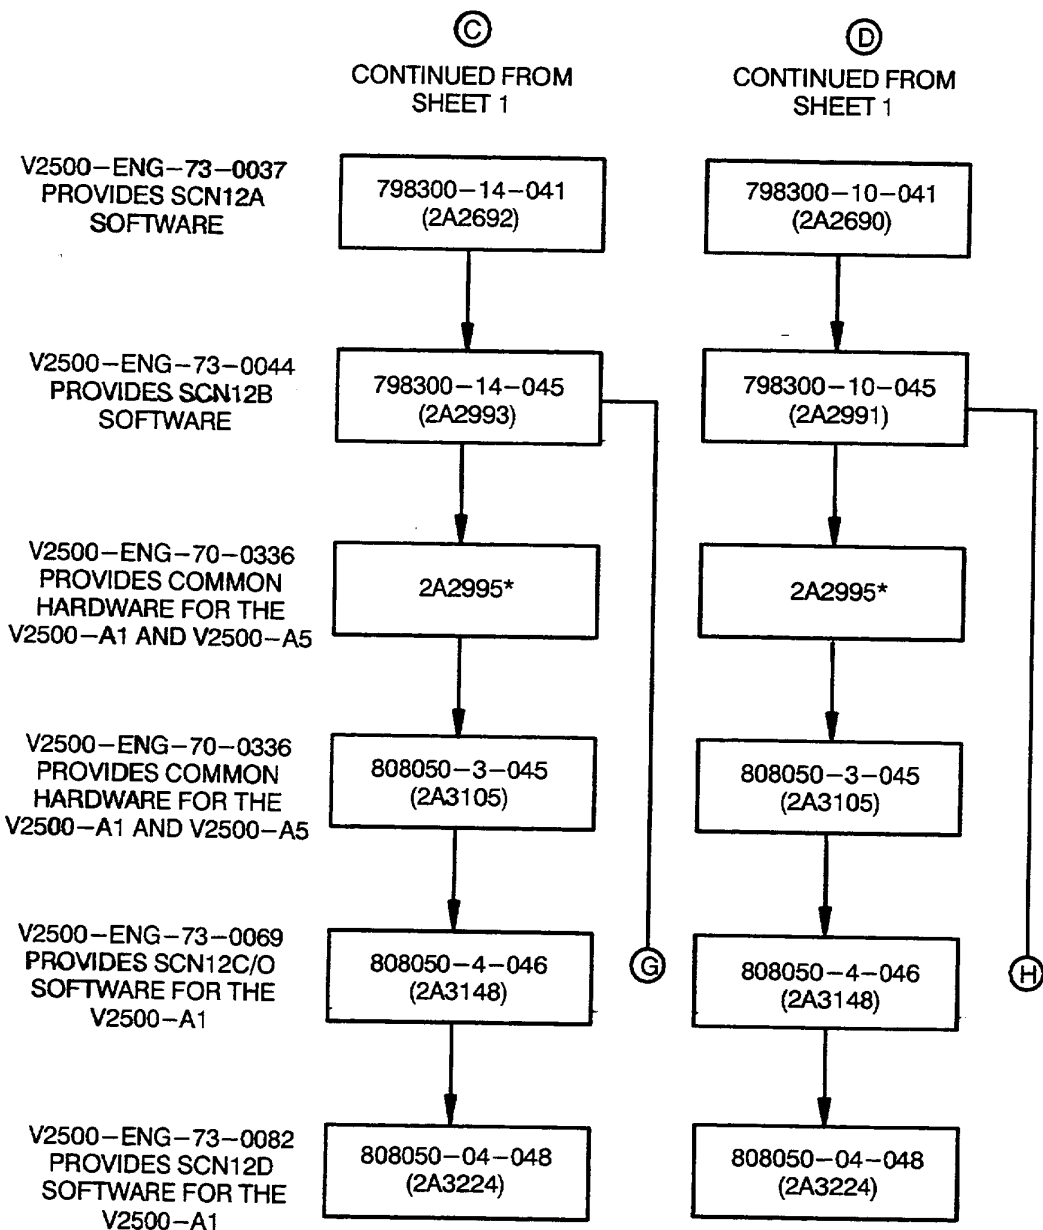
Family Tree - Electronic Engine Control (EEC) Ref. Catalog Sequence No. 73-22-34. Fig. 01 Item 280
Fig.3 (Sheet 3)

*THIS PART IS SHOWN FOR THE RECORD ONLY

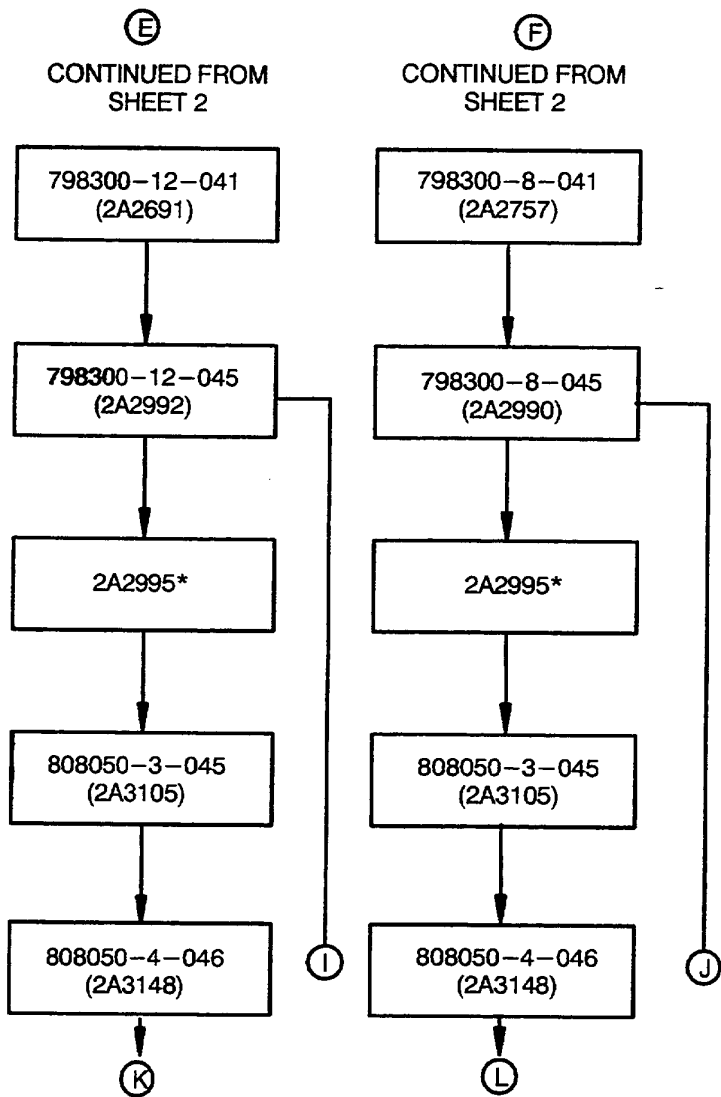
Family Tree - Electronic Engine Control (EEC) Ref. Catalog Sequence No. 73-22-34. Fig.
01 Item 280
Fig.3 (Sheet 4)

*THIS PART IS SHOWN FOR THE RECORD ONLY
