DATE ~~R~~ Aug.10/01**V2500-A5/D5 PROPULSION SYSTEMS SERVICE BULLETIN**

This document transmits Revision 5 to Service Bulletin EV2500-73-0094

ENGINE – FUEL AND CONTROL – REROUTE THE LEFT AND RIGHT PRESSURE CONTROL TUBE  
ASSEMBLIES

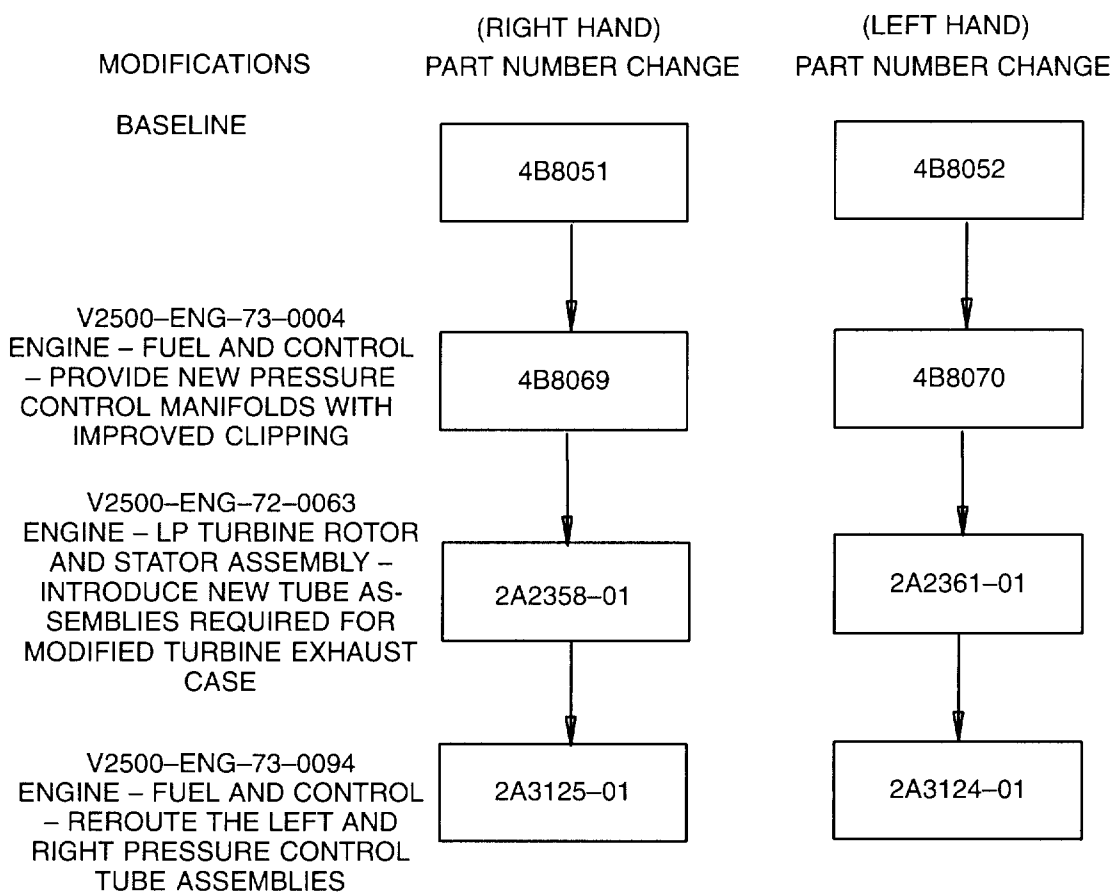
Fig 3

Family tree – Right and left pressure control tube assemblies (V2500-A1) Ref.  
catalogue sequence no. 73-22-51, Fig 1 items 050 and 180
