Subject: Transmittal of Revision 4 to Service Bulletin V2500-ENG-73-0130.

ENGINE - FUEL AND CONTROL - FUEL SYSTEM AIR TUBES - INTRODUCTION OF REVISED PB  
SENSE LINE TUBES WITH INCREASED DIAMETER

V2525-D5

# V2500-ENG-73-0130

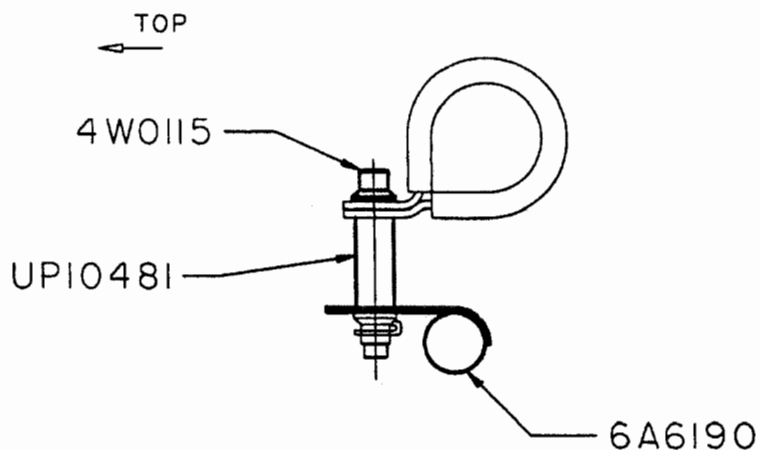
Figure 25  
Clip point 2198 - Before and after alteration

VIEW LOOKING FORWARD  
CLIP POINT 2198 AFTER ALTERATION

- (iii) With the bolt 4W0115, the spacer UP10481 and the initial nut, install CP2198. (Refer to Figure 25)
- (b) Install CP2694 to 6A6190, Harness A and the vibration transducer loom. (Refer to Figure 37).

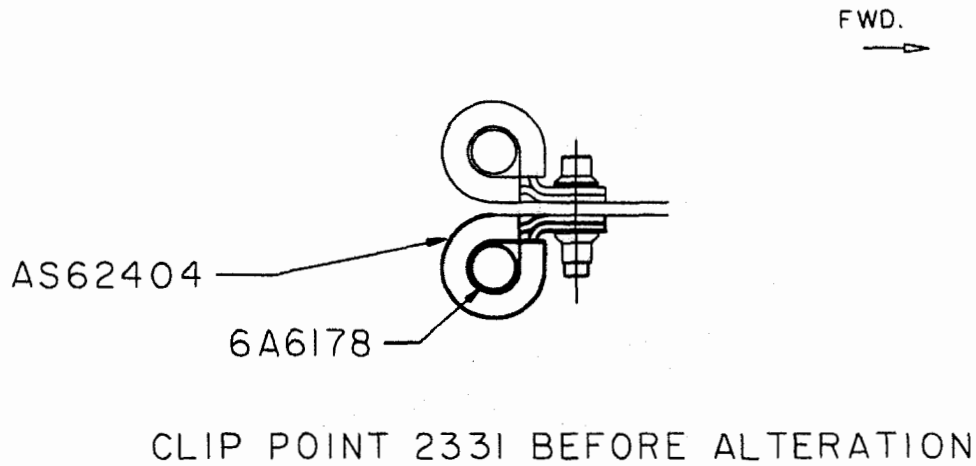
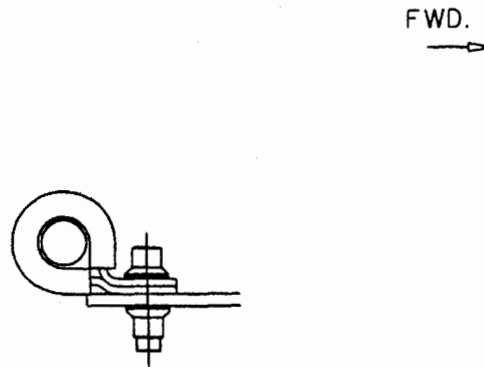
Figure 26  
Clip point 2331 - Before and after alteration

CLIP POINT 2331 AFTER ALTERATION

- (ii) Discard bolt AS20908, clip AS62404 and nut 4W0001.
    - (iii) With bolt 4W0102 and nut 4W0043, install CP2444 to the bracket.
  - (j) Disconnect CP2331 from tube 6A6178. (Refer to Figure 26).

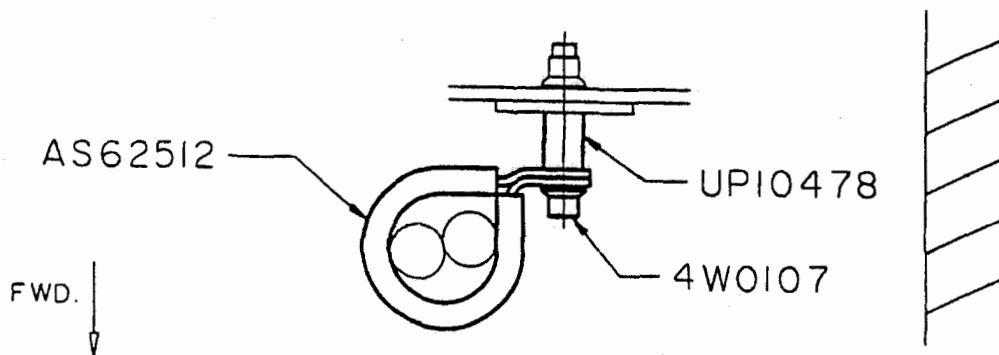
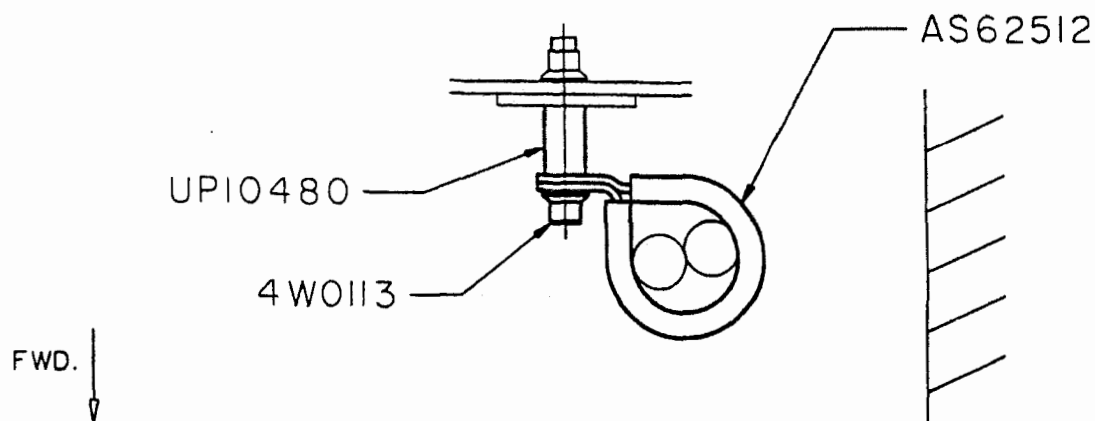
Figure 27

CLIP POINT 2351RH BEFORE ALTERATION

CLIP POINT 2351RH AFTER ALTERATION

- (m) For the right engine only, move clip AS62512 to a different position at CP2351R. (Refer to Figure 27).
  - (i) Disassemble CP2351R.
  - (ii) Remove and discard bolt 4W0107 and spacer UP10478.

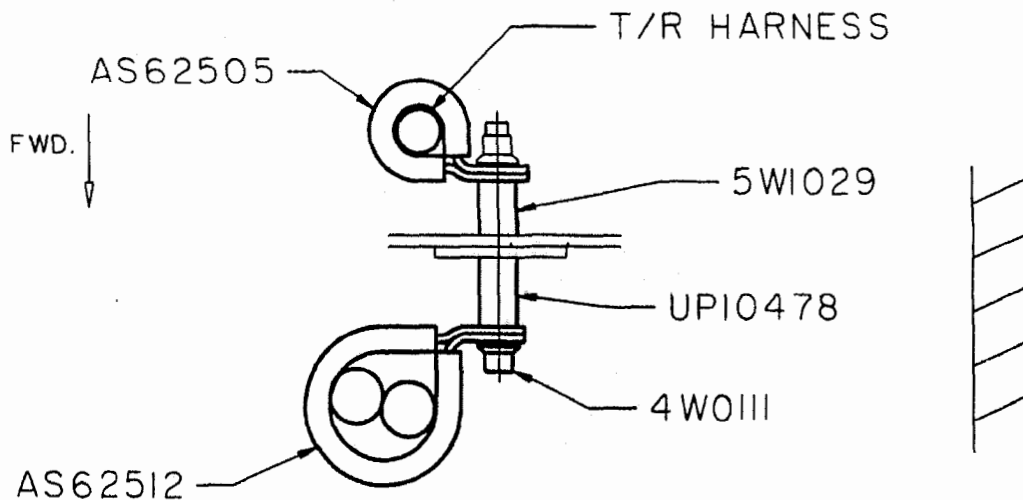
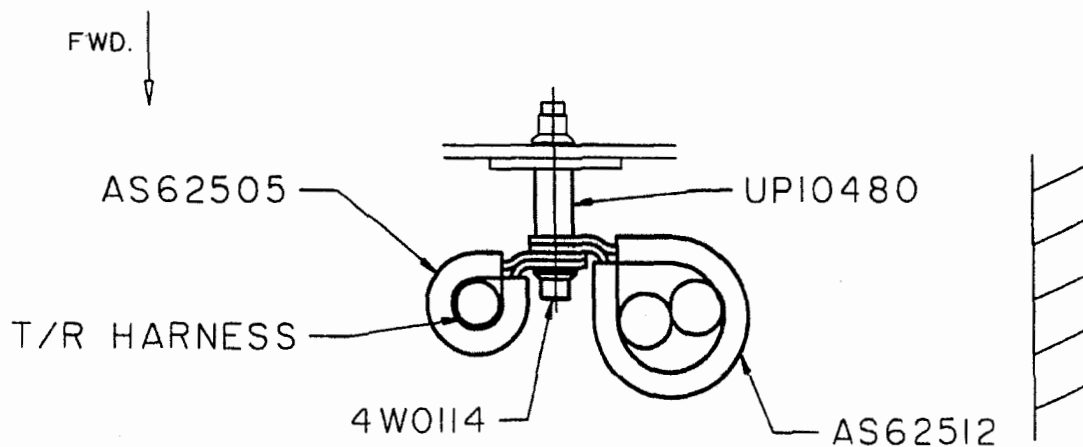
Figure 28  
Clip point 2351L - Before and after alteration

CLIP POINT 2351LH BEFORE ALTERATION

CLIP POINT 2351LH AFTER ALTERATION

- (l) For the left engine only, move the thrust reverser harness to a different position at CP2351L. (Refer to Figure 27).
  - (i) Disassemble CP2351L, then remove and discard bolt 4W0111 and spacer UP10478.

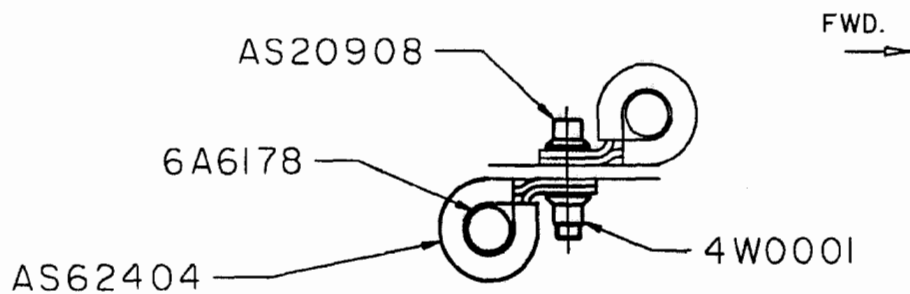
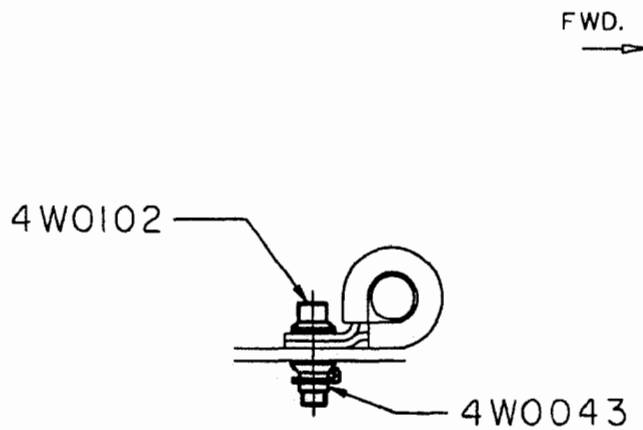
Figure 29  
Clip point 2444 - Before and after alteration

CLIP POINT 2444 BEFORE ALTERATION

CLIP POINT 2444 AFTER ALTERATION

- (iii) With bolt 4W0103 and nut 4W0043, install CP2513 to the bracket.
  - (i) Disconnect CP2444 from tube 6A6178. (Refer to Figure 29).
    - (i) Remove CP2444 from the bracket.

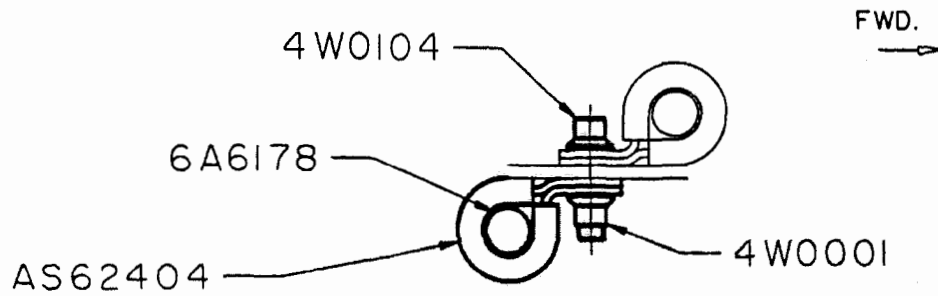
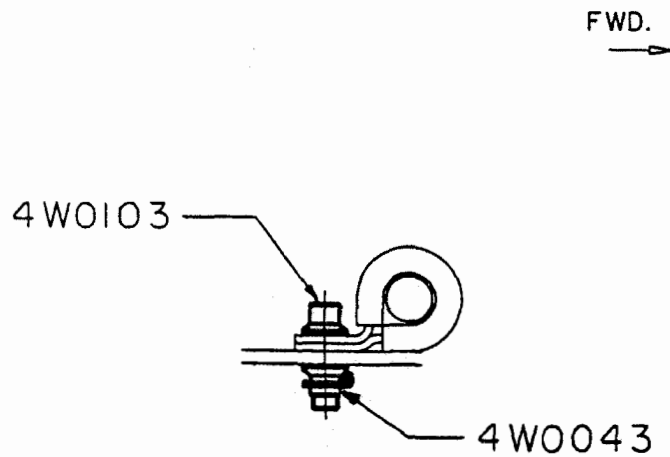
Figure 31  
Clip point 2513R - Before and after alteration

CLIP POINT 2513RH BEFORE ALTERATION

CLIP POINT 2513RH AFTER ALTERATION

- (h) For the right engine only, disconnect CP2513 from tube 6A6178 as follows. (Refer to Figure 31):
    - (i) Remove CP2513 from the bracket.
    - (ii) Discard bolt 4W0104, clip AS62404 and nut 4W0001.

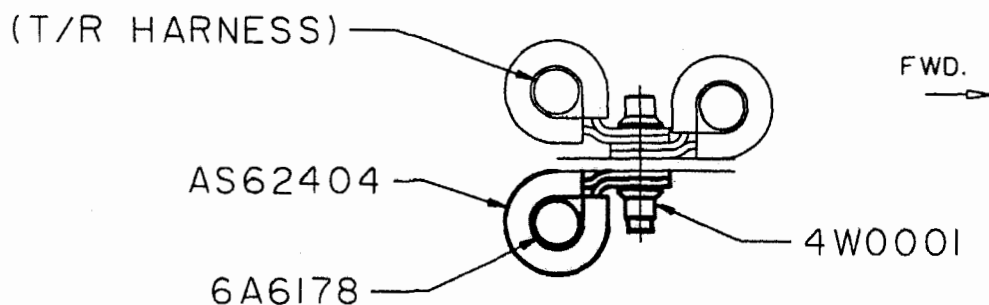
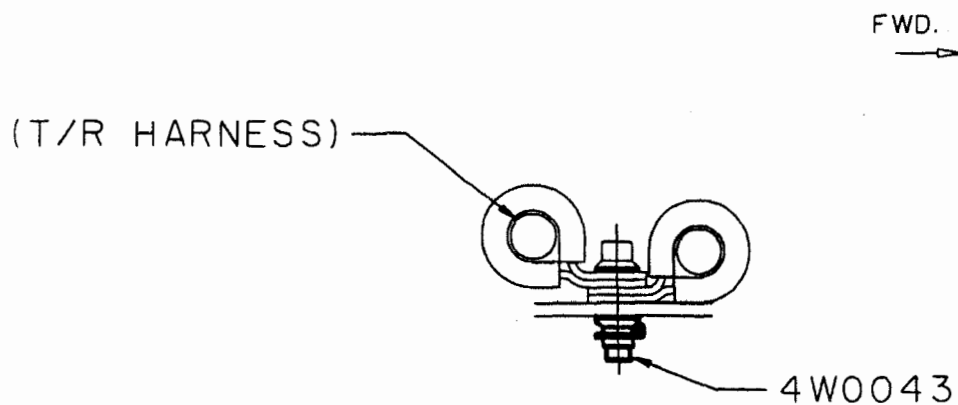
Figure 32  
Clip point 2513L - Before and after alteration

CLIP POINT 2513LH BEFORE ALTERATION

CLIP POINT 2513LH AFTER ALTERATION

- (iii) With bolt 4W0102 and the initial nut, install CP2512 to the bracket.
  - (f) For the right engine only, remove and discard CP2512.
  - (g) For the left engine only, disconnect CP2513 from tube 6A6178 as follows. (Refer to Figure 32):

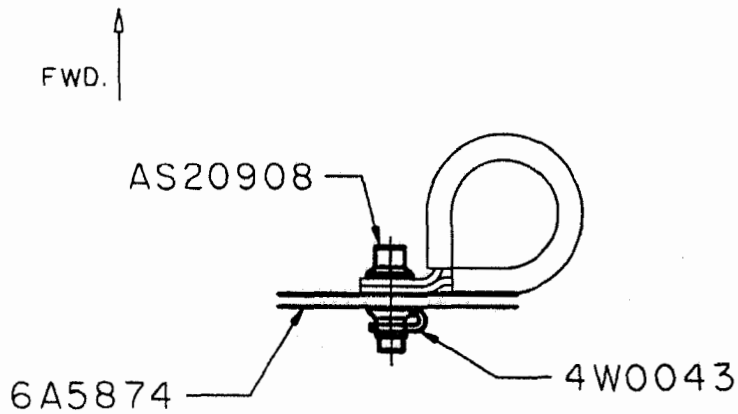
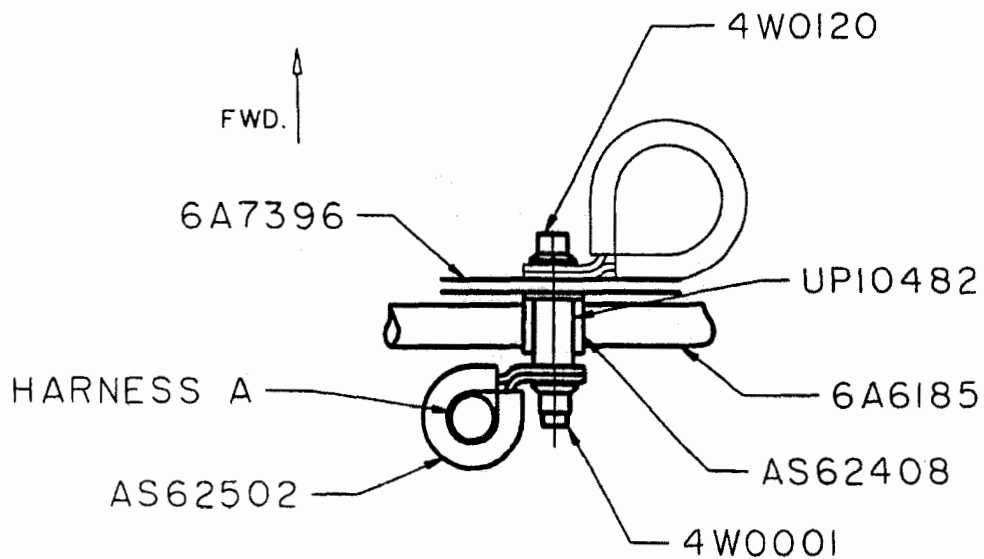
Figure 33  
Clip point 2636 - Before and after alteration

CLIP POINT 2636 BEFORE ALTERATION

CLIP POINT 2636 AFTER ALTERATION

- (6) Install tube 6A6185 between tube 6A6186 and the Pb connector of the bifurcation panel. (Refer to Figures 2, 5, 8, 10, 16, 17, 18 and 33).
  - (a) Connect tube 6A6185 to CP2636. (Refer to Figure 33).

- (i) Disassemble CP2636 and discard the bolt AS20908 and the nut 4W0043.
    - (ii) Replace bracket 6A5874 with bracket 6A7396. (Refer to Figure 2). (For the correct removal/installation procedures refer to the MD-90 Engine Manual (EM), Chapter/Section 72-00-32, Removal-05 CONFIG-1 and CONFIG-2 and Installation-01 CONFIG-2 and CONFIG-3).

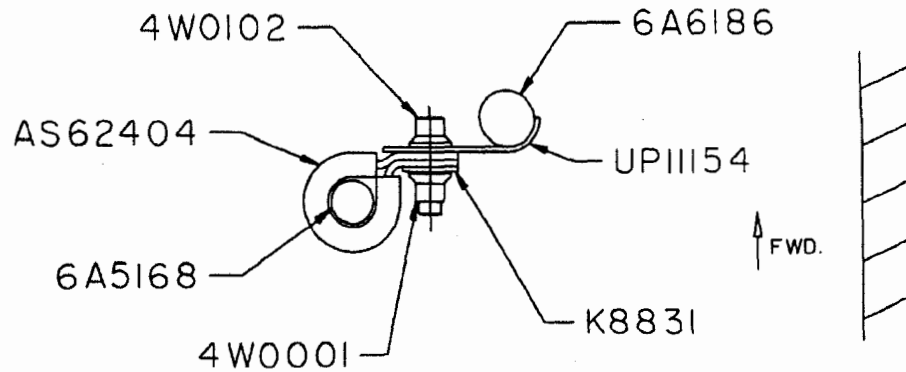
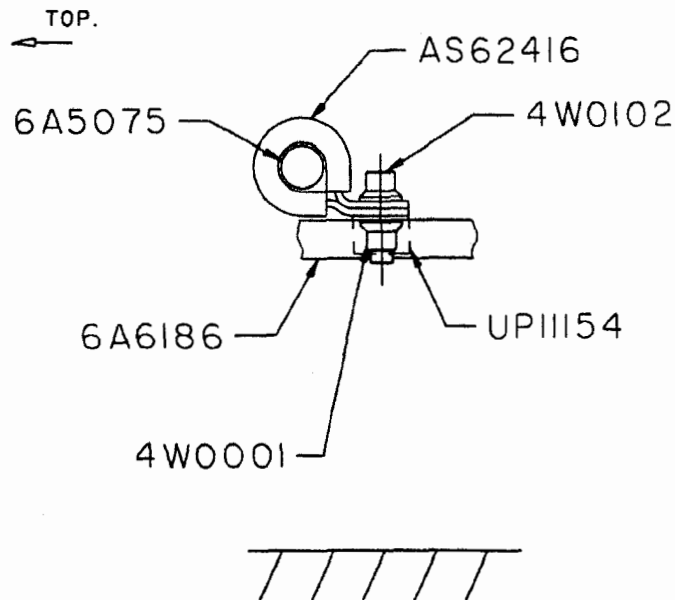
Figure 34  
Clip point 2688 and 2689 - Added

CLIP POINT 2688 ADDED

VIEW LOOKING FORWARD  
CLIP POINT 2689 ADDED

- (g) Install clip AS62406 to tube 6A6186 and then connect the clip to CP2689. (Refer to Figure 34).

- (h) Install clip AS62404 to tube 6A6186 and then connect the clip to CP2688. (Refer to Figure 34).
- (i) Connect tube 6A6186 to CP2118 and CP2122. (Refer to Figures 6 and 7).

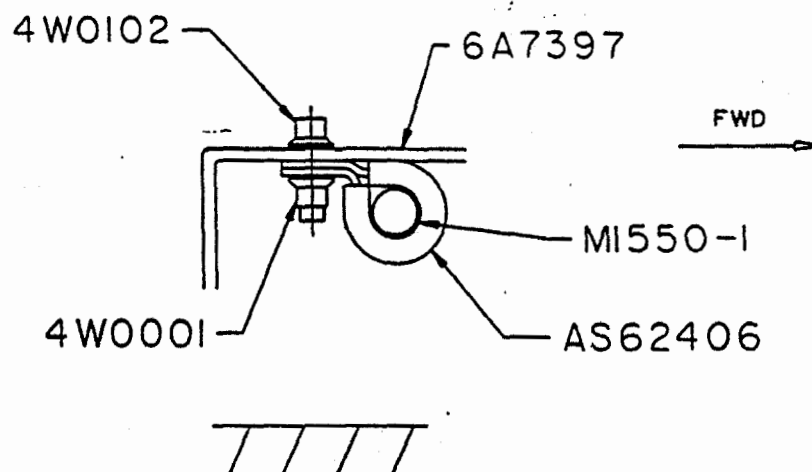
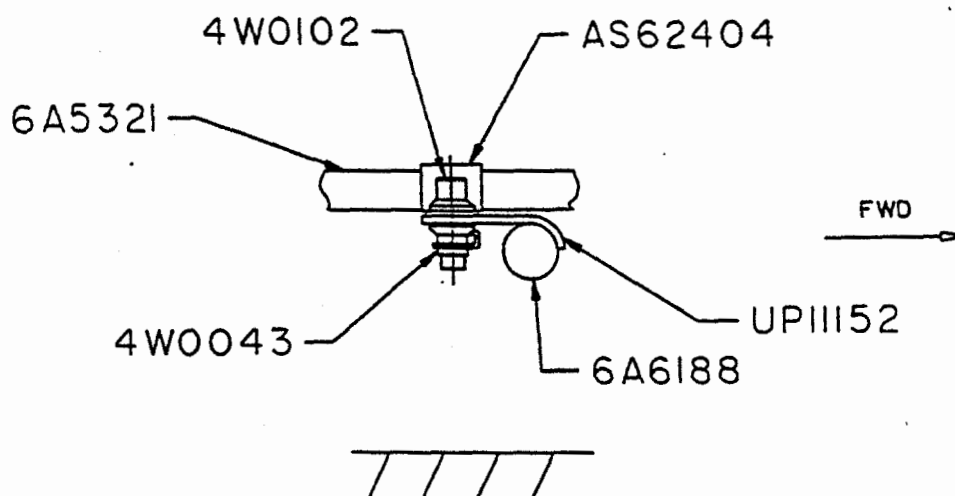
Figure 36  
Clip point 2692 and 2693 - Added

CLIP POINT 2692 ADDED

CLIP POINT 2693 ADDED

- (i) Install clip AS62406 to M1550-1.
  - (ii) With bolt 4W0102, washer K8831 and nut 4W0001, install CP2691 to bracket 6A5429.
- (g) Connect M1550-1 to CP2692. (Refer to Figure 36).

- (a) Install CP2693. (Refer to Figure 36).
    - (i) Install clip AS62404 to tube 6A5321 adjacent to the brazed-on clip UP11152 of tube 6A6188.
    - (ii) Connect the clips together with the bolt 4W0102 and the nut 4W0043.

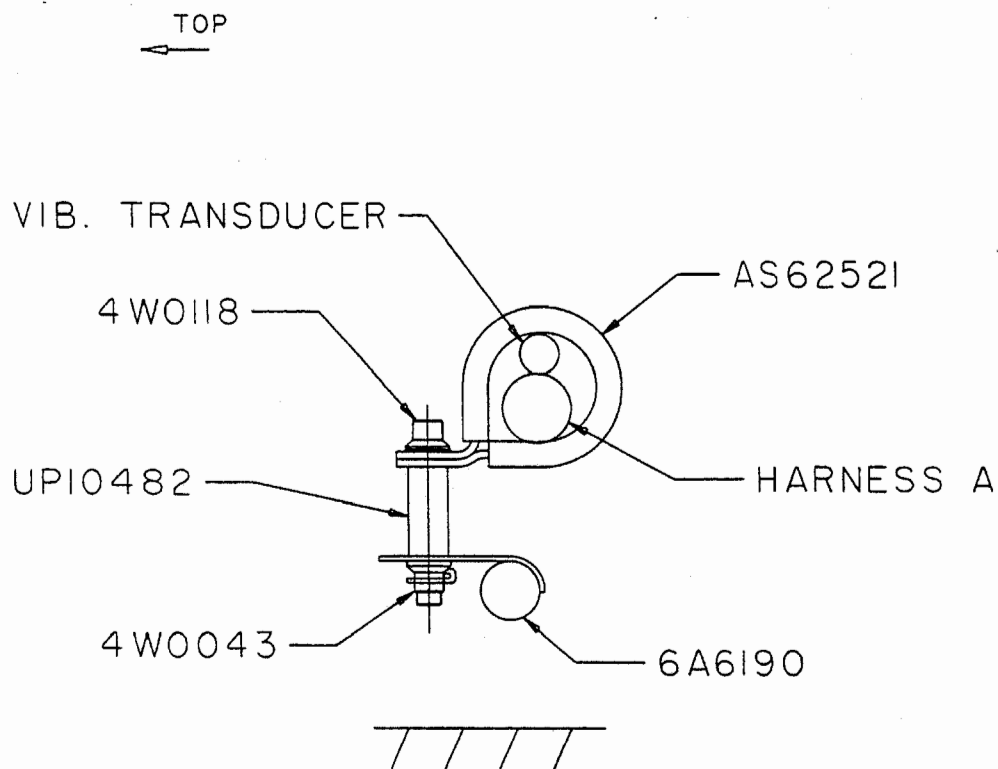
Figure 37  
Clip point 2694 - Added

VIEW LOOKING FORWARD  
CLIP POINT 2694 ADDED

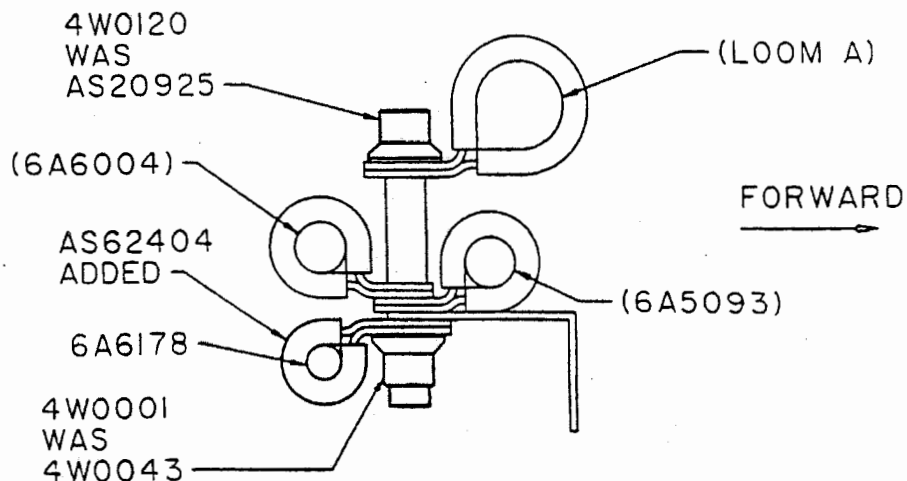
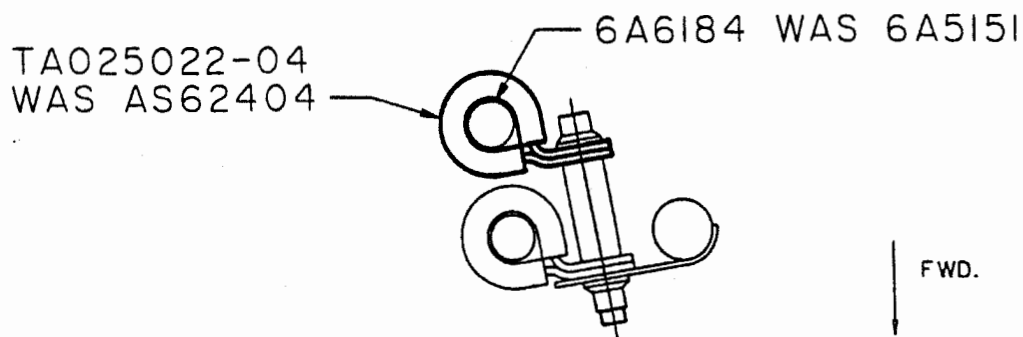
Figure 38

### CLIP POINT 2038 BEFORE (PRE SB ENG 73-0105) AND AFTER ALTERATION

### CLIP POINT 7066 BEFORE AND AFTER ALTERATION

- (d) Remove and discard the tube.
- (10) Remove the tube 6A5151. (Refer to Figure 4 and 38).
  - (a) Disconnect tube 6A5151 from CP7066. (Refer to Figure 38).

- (b) Connect tube 6A6184 to CP7066. (Refer to Figure 38).
  - (c) Connect tube 6A6184 to the clip points that follow: CP7074, CP8034, CP7092, CP8033, CP8032, CP7073 and CP7834.
