**ENGINE FUEL AND CONTROL - LP/HP FUEL PUMPS - INTRODUCTION OF A REVISED LP/HP
FUEL PUMP WITH REDUCED GEARSHAFT BENDING**

V2500-ENG-73-0143

NO. 5008735-73-003

ENGINE - FUEL AND CONTROL - MODIFICATION OF LP/HP FUEL PUMPS IMPELLER/INDUCER AND CENTER PLATE

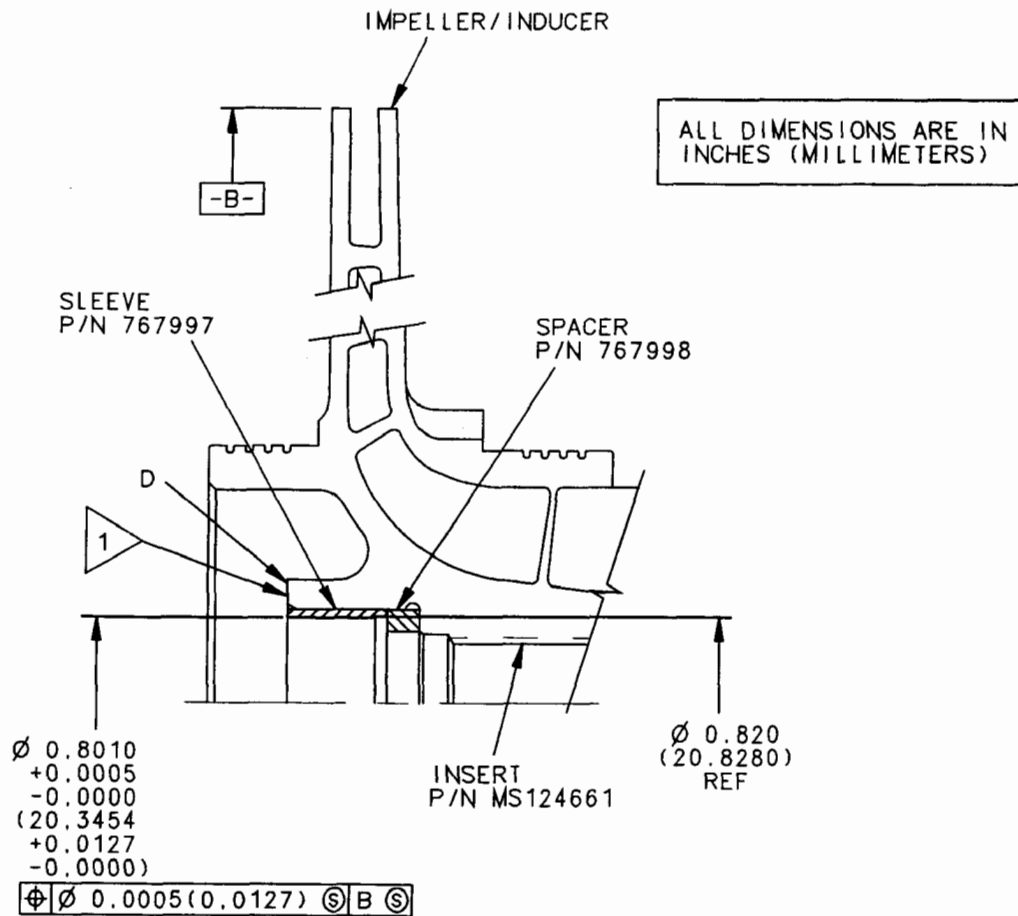
A77669

Fracture of the LP/HP fuel pump gearshaft can occur and in extreme conditions it can result in reduced flow from the fuel pump outlet.

- B. Machine the impeller inducer (refer to Figure 2 of this bulletin).
- C. Visually check labyrinth surface finish. If it is more than 32 micro inch (0.813 micrometer) Ra, or if it is already worn and anodize has been removed, do not perform steps C. and F.

- G. Anodize two labyrinth outside diameters according to MIL-A-8625, TYPE 3 (Refer to Figure 2 of this service bulletin) to build up 0.001 to 0.002 inch (0.026 to 0.050 millimeter) diameter.
- H. Install helical coil insert (P/N MS124661) 1 to 1-1/2 pitches below the entering surface, taking care not to damage the entering surface, and install spacer (P/N 767998).
