V2500-A1/A5 SERIES PROPULSION SYSTEM SERVICE BULLETIN

This document transmits the Initial Issue of Service Bulletin V2500-ENG-73-0202.

ENGINE – FUEL AND CONTROL – P4.9 TUBE ASSEMBLIES, PRESSURE CONTROL AND BOX AND CABLE,  
TC – REPLACE THE P4.9 TUBE ASSEMBLIES TO PREVENT FRACTURES AND REPOSITION THE EXHAUST  
GAS TEMPERATURE (EGT) CABLE TO PREVENT CHAFING

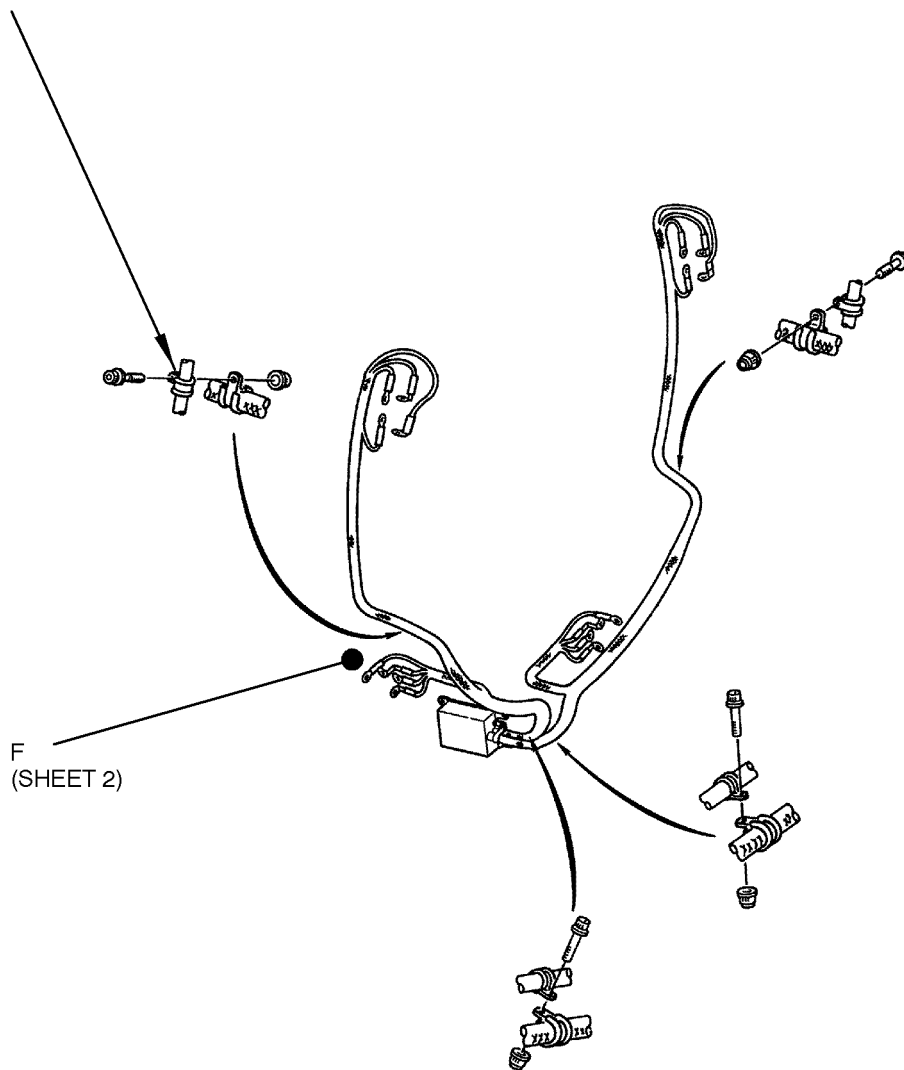
LOCATION OF THE CLAMP OR CUSHION LOOP CLAMP AND EGT HARNESS CLAMPING AND ROUTING 77-21-43  
FIGURE 10, SHEET 1

277398  
CLAMP  
OR  
ST1428-02  
CUSHION LOOP CLAMP  
DISCARD

- (e) Replace Loop Clamp bracket Assembly, P/N 2A1763-01 with P/N 2A4041-01. See Figure 9 for the location of the bracket.
  - (f) Discard Clamp, P/N 277398 or Cushion Loop Clamp, P/N ST1428-02. See Figure 10, Sheet 1 for the location of the clamp. See Figure 10, Sheet 2 for EGT harness clamping and routing.

**NOTE:** This Service Bulletin introduces a new left pressure control tube assembly. The new tube assembly includes an integral clamp. The integral clamp performs the same function as the clamp removed by this step. See Figure 10, Sheet 2 for location of the integral clamp.

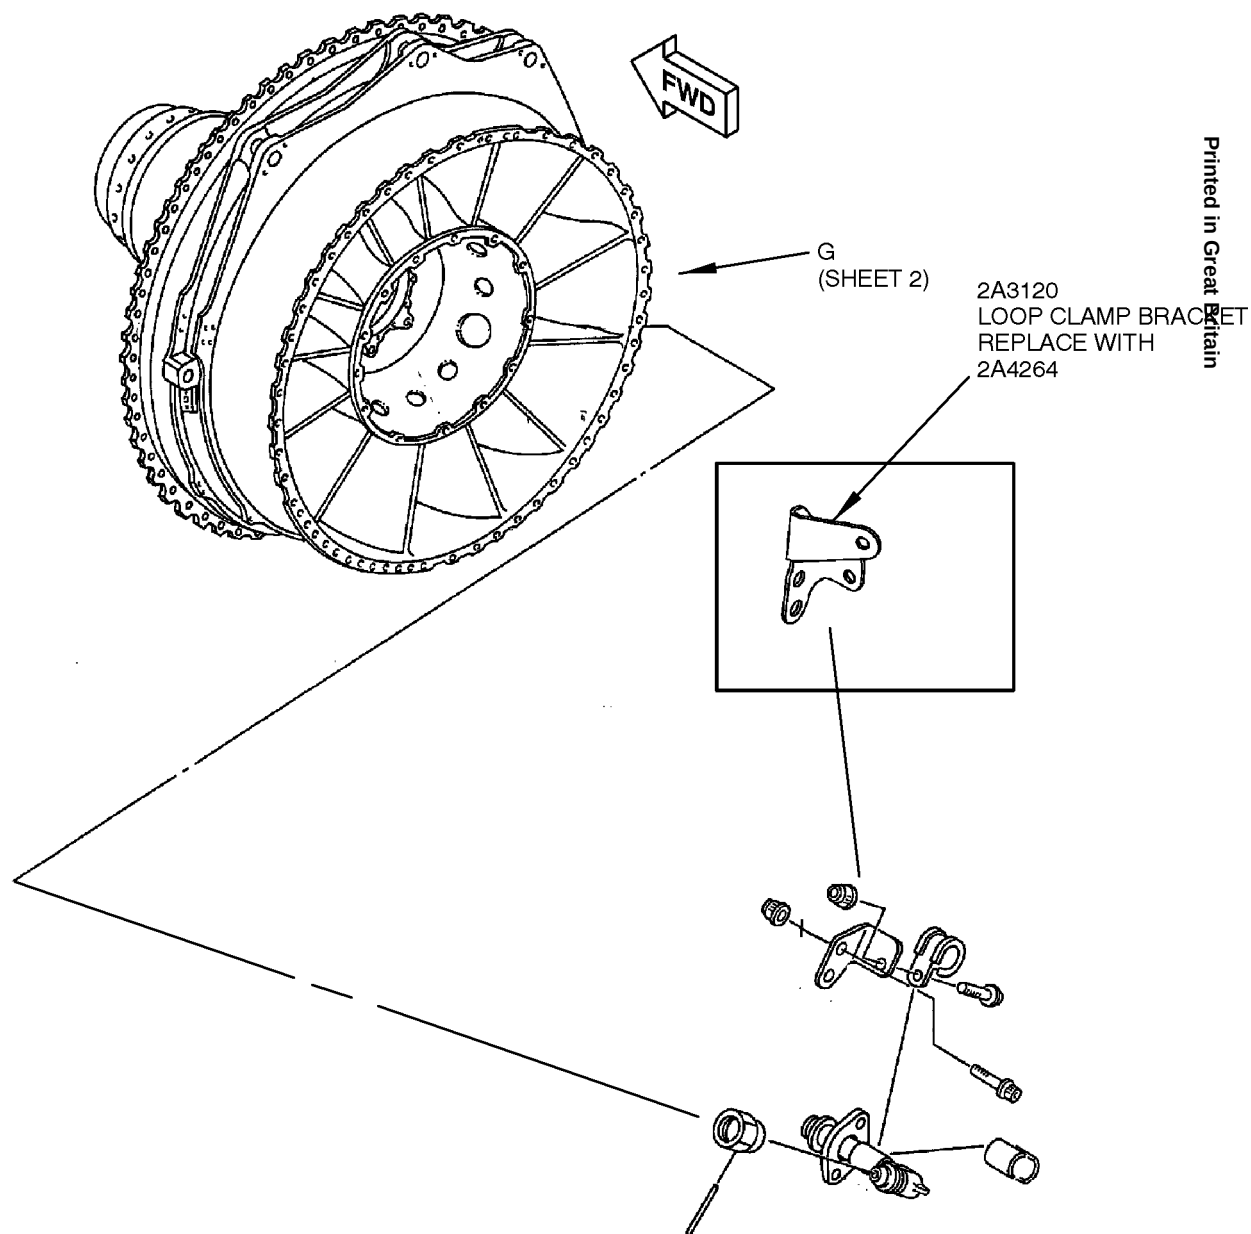
LOCATION OF THE RIGHT PRESSURE CONTROL TUBE ASSEMBLY  
73-22-51  
FIGURE 12

2A3125-01  
RIGHT PRESSURE CONTROL  
TUBE ASSEMBLY  
REPLACE WITH  
2A4036-01

- (2) Do the following procedures on the right side of the turbine exhaust case group during engine assembly:
- (a) Replace Loop Clamp Bracket, P/N 2A3120 with P/N 2A4264. See Figure 11, Sheet 2 for the location of the bracket.
  - (b) Replace the Right Pressure Control Tube Assembly, P/N 2A3125-01 with P/N 2A4036-01. See Figure 12 for the location of the tube assembly.

- (i) Install two new Metal Seal Rings, P/N 2A2256 on Right Pressure Control Tube Assembly, P/N 2A4036-01.
  - (ii) Install Safety Wire, P/N 4W2627 on the bolts that attach the new tube at one end and on the nut that connects the new tube at the other end. See Reference 11, Standard Practices Manual, Chapter/Section 70-42-05, General Instructions for the Uses of Lockwire.
- (c) Replace four Loop Clamp Brackets, P/N 2A1629 with P/N 2A4044. See Figure 13 for the location of the brackets.
  - (d) Replace two Loop Clamp Bracket Assemblies, P/N 2A1854-01 with P/N 2A4042-01. See Figure 14 for the location of the brackets.
  - (e) Discard Clamp, P/N 277398 or Cushion Loop Clamp, P/N ST1428-02. See Figure 15, Sheet 1 for the location of the clamp. See Figure 15, Sheet 2 for EGT harness clamping and routing.
