V2500-A5 SERIES PROPULSION SYSTEM SERVICE BULLETIN

This document transmits the Initial Issue of Service Bulletin V2500-ENG-73-0203

V2500-ENG-73-0203

ENGINE – FUEL AND CONTROL – PROVIDE A NEW ELECTRONIC ENGINE CONTROL (EEC) WITH A5
SCN20/Y SOFTWARE

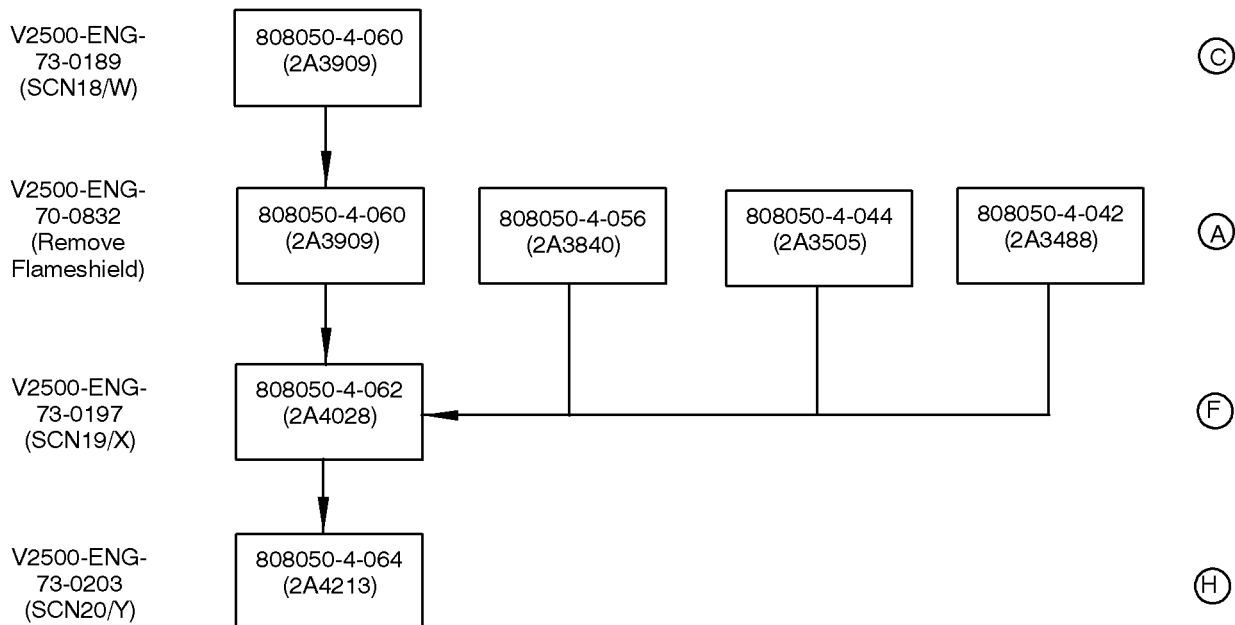
FAMILY TREE - ELECTRONIC ENGINE CONTROL (EEC) REF. CATALOG SEQUENCE NO. 73-22-34.
FIG. 01 ITEM 280 - FOR V2500-A5 DELIVERED ENGINES
CHART A (SHEET 2 OF 4)

PART NUMBER CHANGE
EEC 150-20

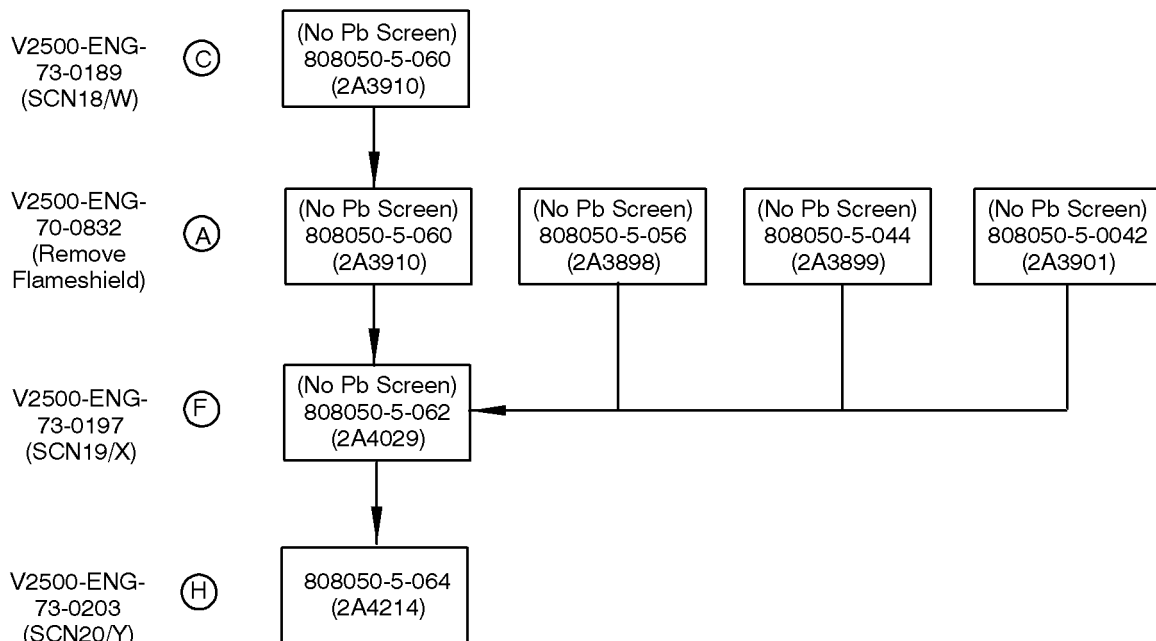
FAMILY TREE – ELECTRONIC ENGINE CONTROL (EEC) REF. CATALOG SEQUENCE NO. 73-22-34.
FIG. 01 ITEM 280 – FOR V2500-A5 DELIVERED ENGINES
CHART A (SHEET 3 OF 4)

PART NUMBER CHANGE
EEC 150-20
