AIR - HPT/LPT ACC VALVE ACTUATOR - INSTALLATION OF PIN RETAINER ON SERVO VALVE -
CATEGORY CODE 3 - MOD.ENG-75-0027

AIR - V2500 - HP/LP ACC ACTUATOR, PART NUMBER 5860017-109, -111, -113 AND -114.
INCORPORATION OF PIN RETAINER CLIP ON SERVO VALVE.

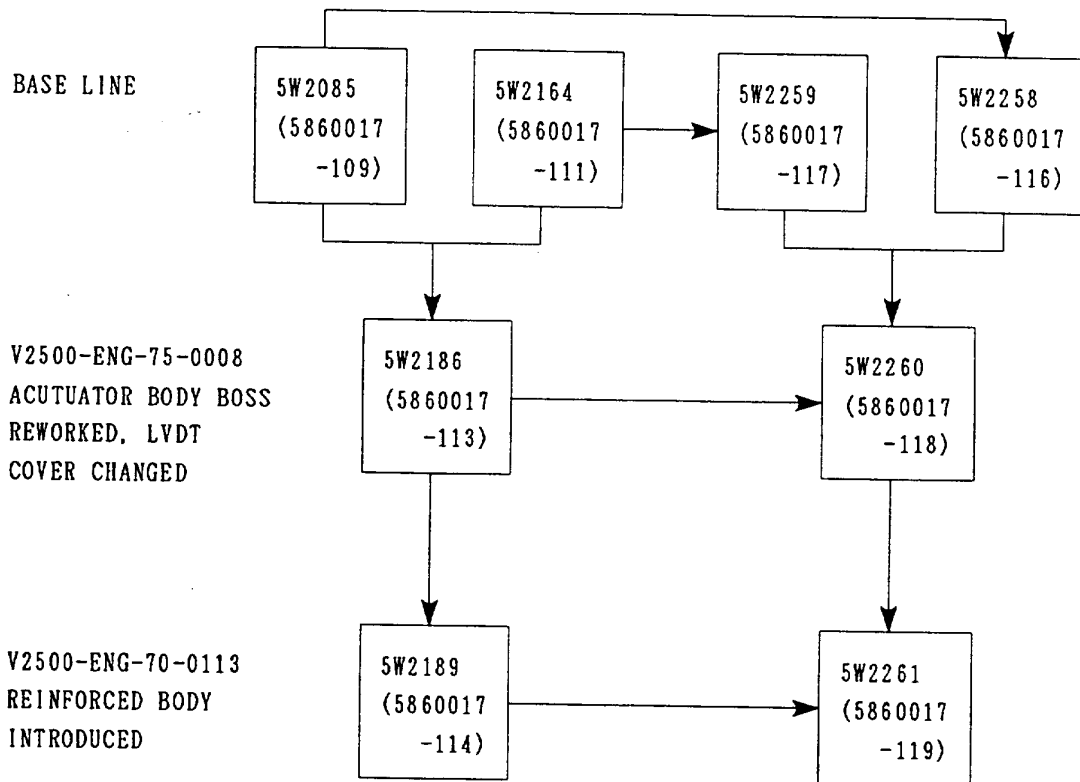
V2500-ENG-75-0027
PIN RETAINER ADDED
TO ABEX SERVO
VALVE

:ACC ACTUATOR WHICH IS ACCOMPLISHED THIS MODIFICATION, IS
TO BE RE-IDENTIFIED FROM LEFT HAND PART NUMBER FLOW CLUSTER
TO RIGHT HAND PART NUMBER FLOW CLUSTER.
PART NUMBERS IN RIGHT HAND PART NUMBER FLOW CLUSTER SHOW
ACC ACUTUATORS WHICH ARE ACCOMPLISHED THIS MODIFICATION.
