## SERVICE BULLETIN

ENGINE - AIR - REVISE THE ORIENTATION OF CLIPPING POINT CP5560 - CATEGORY CODE 7, 6 -  
MOD.ENG-75-0035

V2500-ENG-75-0035

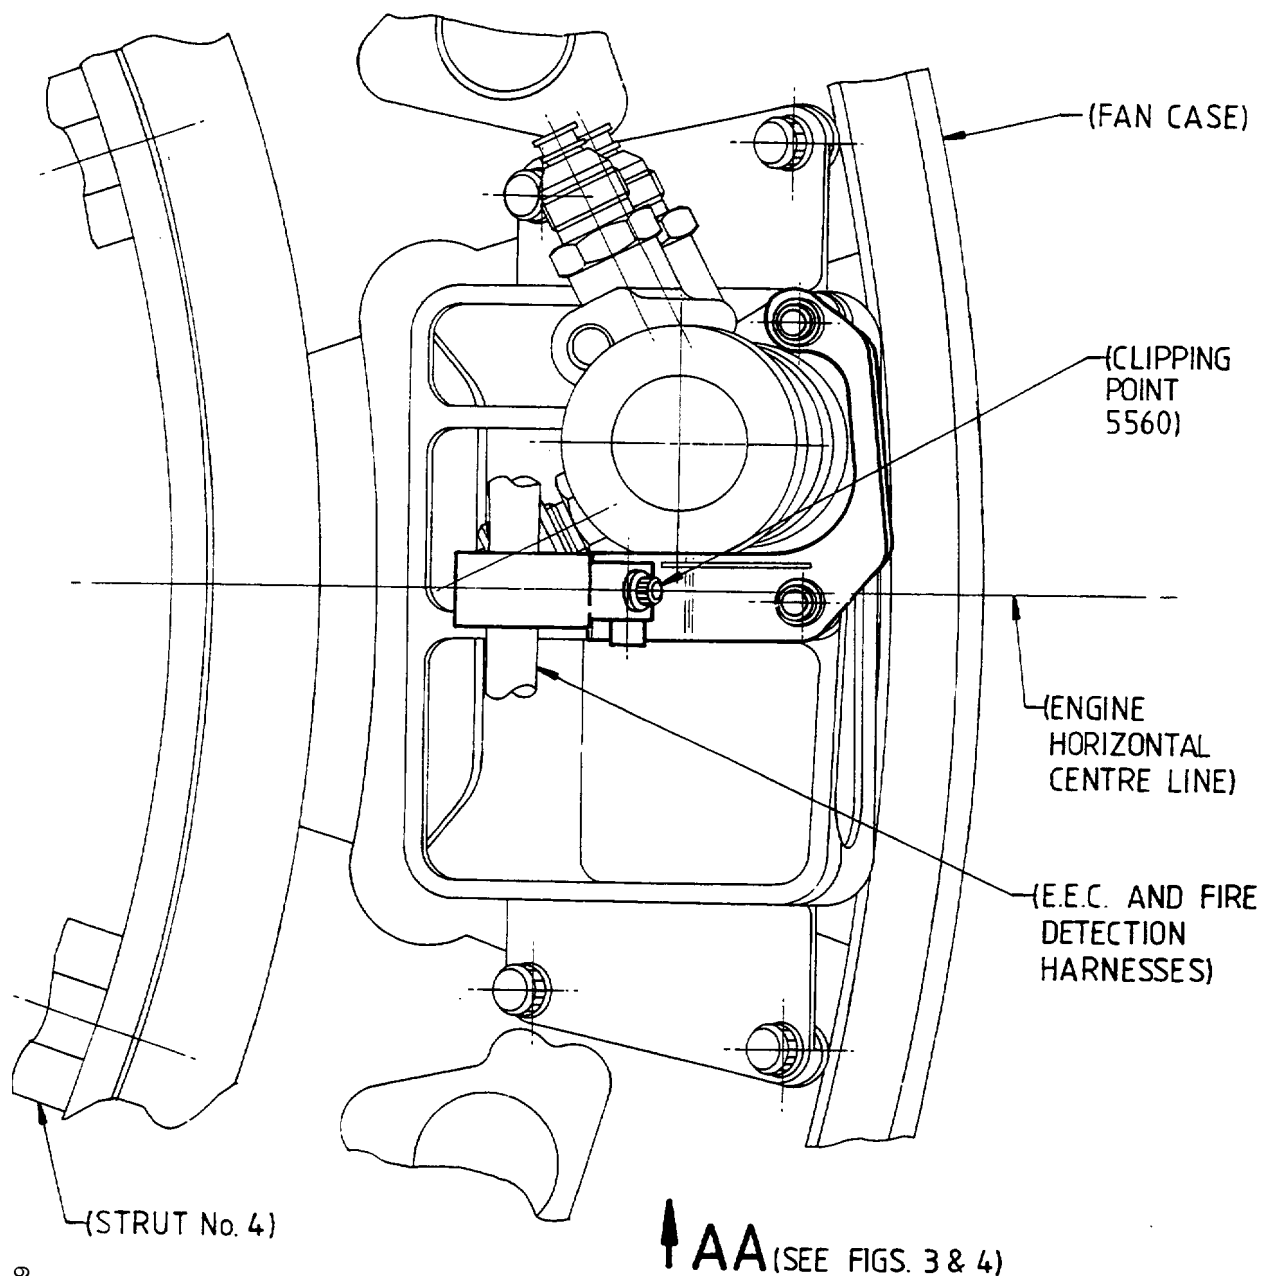
View on fan frame at B.S.B.V. slave actuator looking forward  
Fig.2

Limited clearance between the support bracket for harness clipping point CP5560 and the inner fan frame has been reported on engine build of the V2500-A5.

During build of the V2500-A5 first production engine it was highlighted that a possible interference could exist between the EEC harness clip support bracket for CP5560 and the inner frame.

The bracket is mounted from the B.S.B.V. slave actuator attachment flange.

- (1) A new support bracket is introduced to replace the existing bracket mounted from the B.S.B.V. slave actuator for EEC harness clipping point CP5560.
- (2) The washer at the clipping point is deleted and a shorter bolt is introduced to suit.
- (3) To maintain commonisation of manufacture, the modified bracket is also introduced on the A1 model.
