SERVICE BULLETIN

AIR - BEARING COMPARTMENT COOLING HPC AIR BLEED TUBES - ADDITIONAL CLIPPING FOR CORE
TUBES - SERVO AIR TO HANDLING BLEED SOLENOID VALVES - CATEGORY CODE 4 -
MOD.ENG-75-0049

V2500-ENG-75-0049

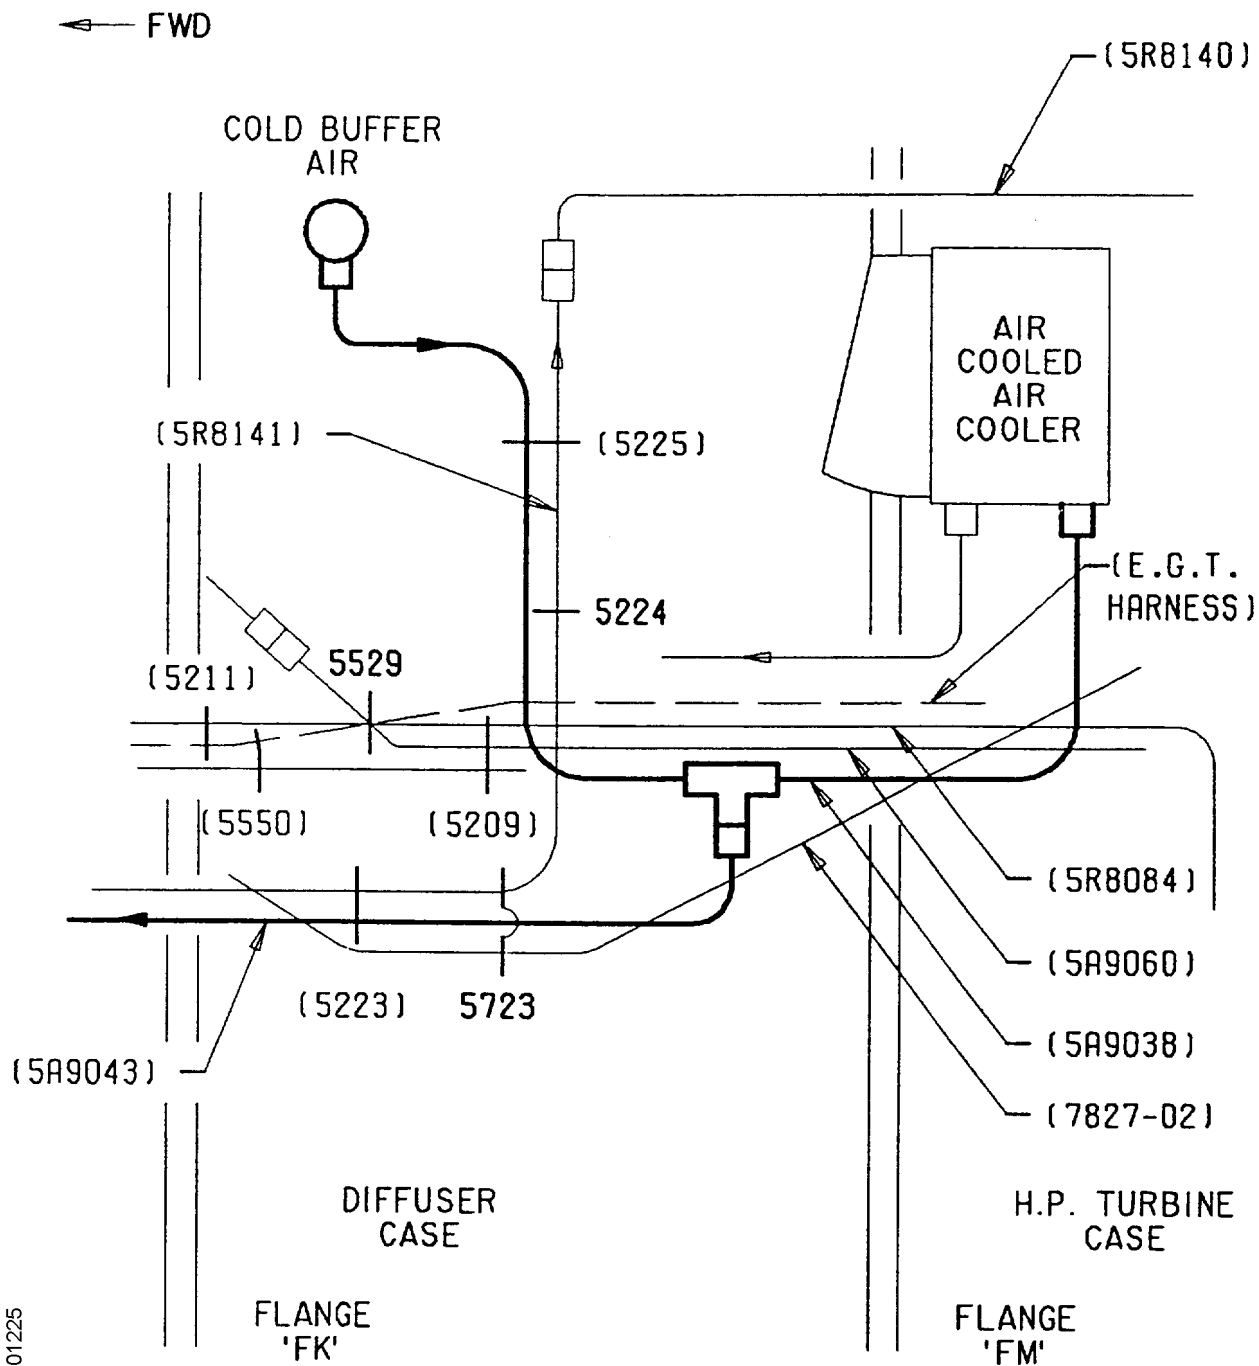
Fig.2

Loosening of the coupling nut on the air supply tube to the handling bleed solenoid valves can occur.

Schematic view of bearing compartment cooling and HPC air bleed tubes showing clipping point arrangement before alteration

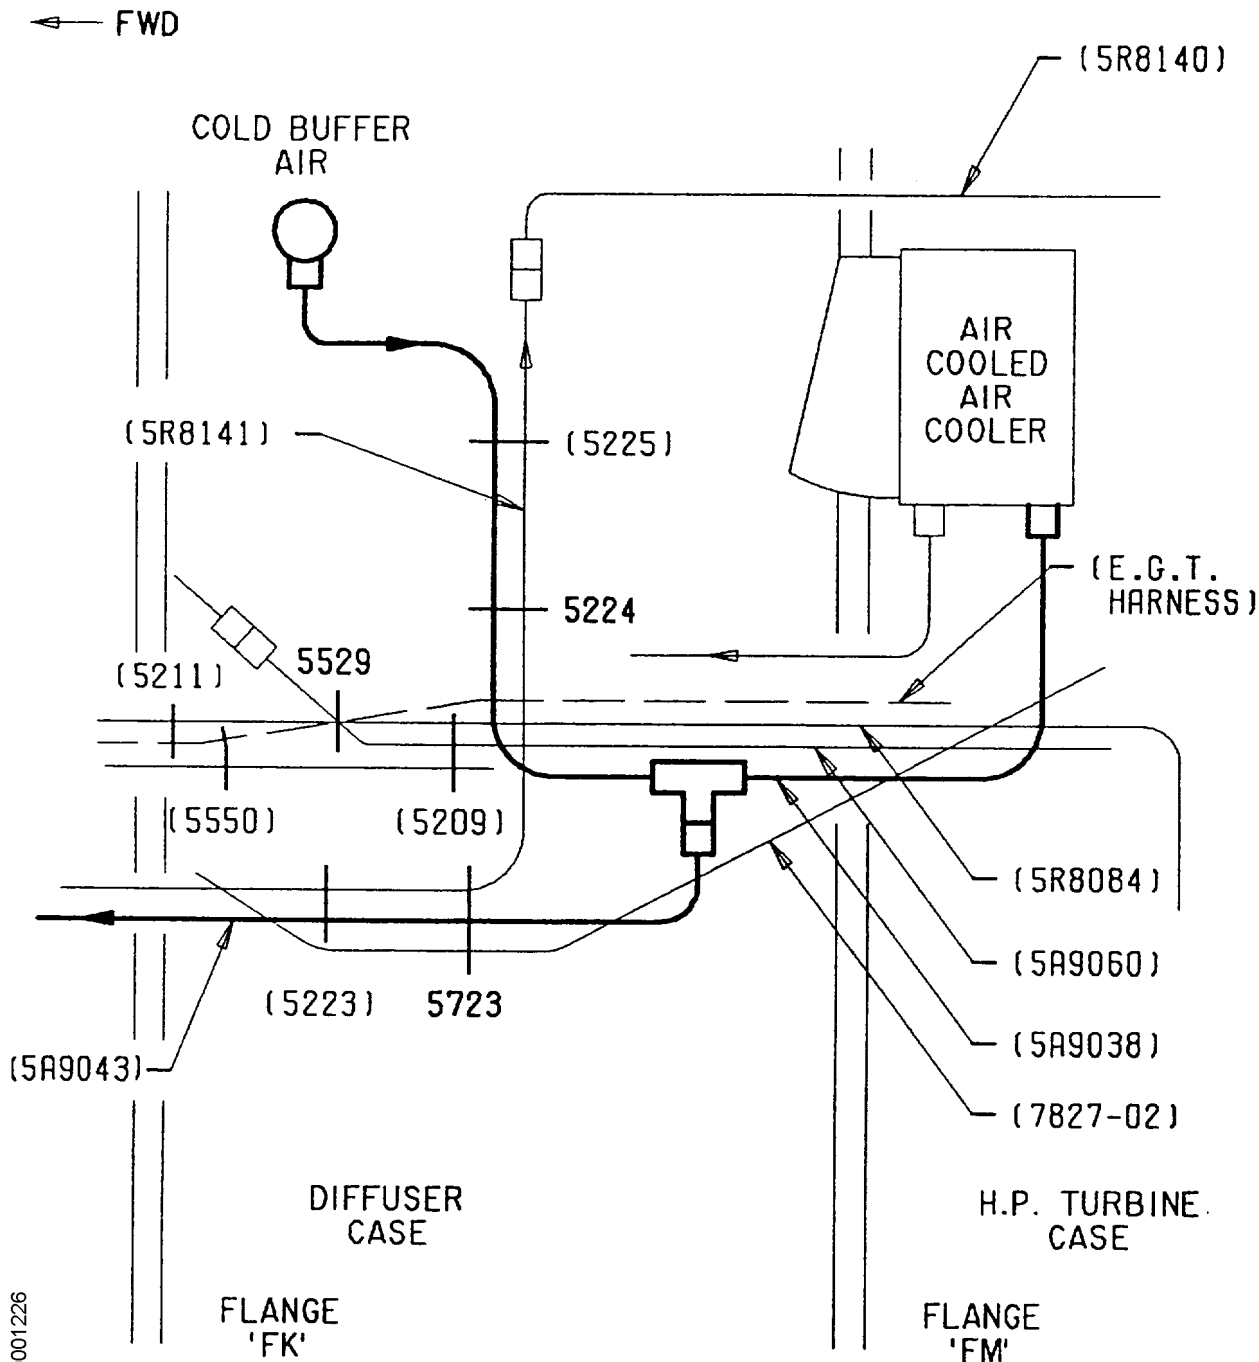
Fig.3

Schematic view of bearing compartment cooling and HPC air bleed tubes showing clipping point arrangement after alteration

- (1) Install the new 6A5555 bracket to the No.11 fuel spray nozzle using MS9573-13 bolts (2 off). Torque the bolts to 65 to 85 lbfin (7,3 to 9,6 Nm). Safety the bolts with V02-141 lockwire, as instructed in the A320 Aircraft Maintenance Manual, TASK 70-40-11-911-012. Refer to figures 3 and 4.
- (2) Re-assemble existing clipping point 5224. Install new TA0210046FT12 clip to 5A9038 tube. Install new 4W0116 bolt to 5R8141 tube clip, 6A5555 bracket, LK56556 spacer, TA0210046FT12 clip and the 4W0001 nut. Torque the nut to 36 to 45 lbfin (4 to 5 Nm). Refer to figures 3 and 4.
- (3) Re-assemble existing clipping point 5529. Remove harness clip, rotate and reinstall to harness. Install new 4W0114 bolt to harness clip, LK67295 spacer, 5R8040 tube, 5A9060 tube and the 4W0001 nut. Torque the nut to 36 to 45 lbfin (4 to 5 Nm). Refer to figures 3 and 5.

- (4) Re-assemble existing clipping point 5723. Install new TA0210046FT08 clip to 5A9043 tube. Install new 4W0127 bolt to TA0210046FT08 clip, LK67295 spacer, 5R8141 tube, LK56556 spacer, 7827-02 firerail and new 4W0001 nut. Torque the nut to 36 to 45 lbfin (4 to 5 Nm). Refer to figures 3 and 6.
