**V2500-A1/A5/D5 PROPULSION SYSTEMS SERVICE BULLETIN**

**V2500-ENG-75-0063**

ENGINE - AIR - INTRODUCTION OF A HPT/LPT ACC AIR VALVE WITH NEW SLOTTED ENTRY TYPE  
ROD END ASSEMBLY

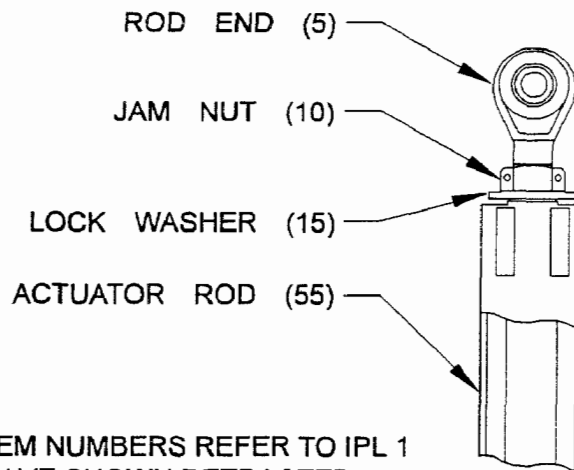
Figure 1

Some operators have noticed excessively worn rod end bearing of HPT/LPT ACC Air Valve.

- (4) Install the adjustment aid, F80-0-50625, onto the clevis end of the tube and fitting assembly (20), using the pins supplied with the adjustment aid. (See Figure 2)

- (5) Adjust the rod end (5) to 3.366 to 3.388 inch (85,496 to 86,055 mm).
  - (6) Make sure that the tang of the lock washer (15) is in the groove of the actuator rod assembly (55).
