OIL - OIL REPLACE THE CLIPPING BRACKET ON THE AIR COOLED OIL COOLER AT CP0533 -
CATEGORY CODE 3 - MOD.ENG-79-0005

- (1) Aircraft: Airbus A320
- (2) Engine: V2500-A1 Engines, Serial No.'s V0014 through V0039

V2500-ENG-79-0005

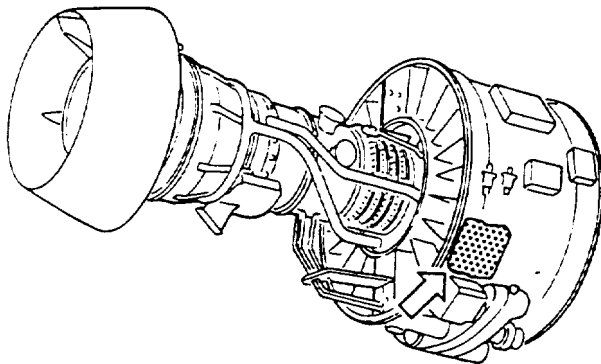
STARBOARD LOWER REAR

Unacceptable vibration of the EEC Fan Harness and bend/twisting of the Raceway Lug may occur because of a resonance of the Clipping Bracket which holds the Harness at CP0534 through the Raceway attached to the Clipping Bracket on the Air Cooled Oil Cooler (ACOC) at CP0533.

To replace the Clipping Bracket on the ACOC with a new thicker gusset-reinforced Bracket to maintain engine reliability.

(2) The existing Bracket must be replaced with the new Bracket.
