V2500-A1/A5/D5 PROPULSION SYSTEMS SERVICE BULLETIN

V2500-ENG-80-0015

STARTING – PNEUMATIC STARTER – INTRODUCTION OF A REVISED PNEUMATIC STARTER WITH A
MODIFIED SYNCHRONOUS ENGAGEMENT CLUTCH ASSEMBLY

HAMILTON SUNDSTRAND 80-2515 STARTING - PNEUMATIC STARTER - INSPECTION OF THE SYNCHRONOUS ENGAGEMENT CLUTCH AND REPLACEMENT OF THE WAVE SPRINGS

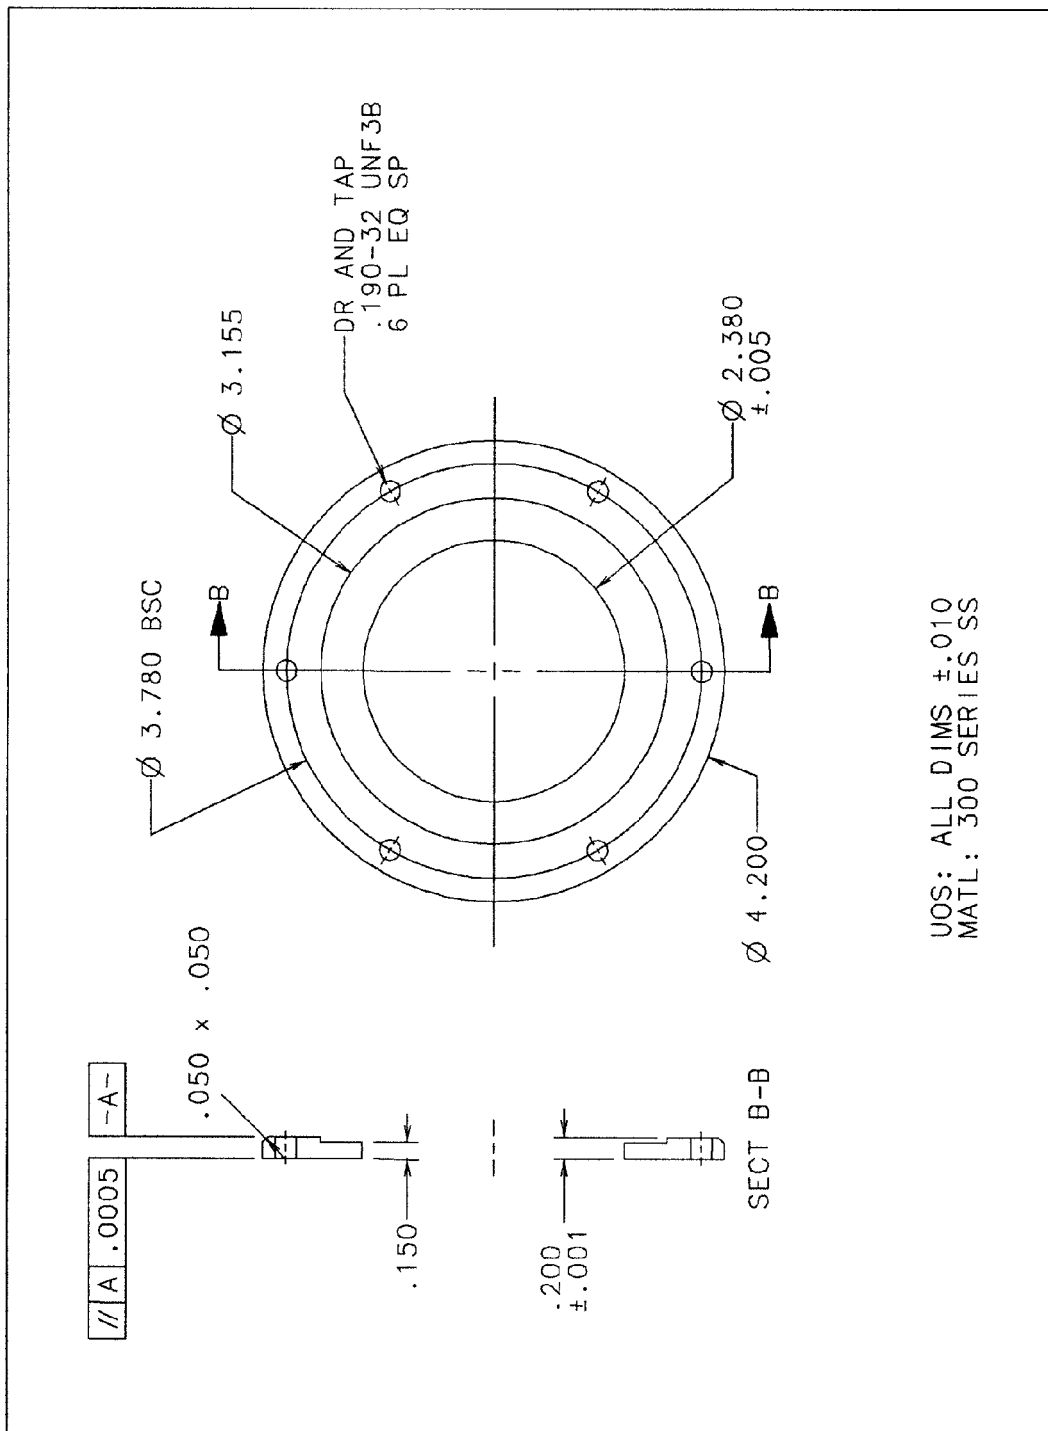
Figure 8. Clutch Inspection Fixture 1 (PN 63001010)

- (j) Install clutch inspection Fixture 1, PN 63001010, shown in **Figure 8** on ring gear carrier and secure with bolts PN 69274-253. This will hold the assembly together and the wave springs provide the force to hold the parts in directions F and G.

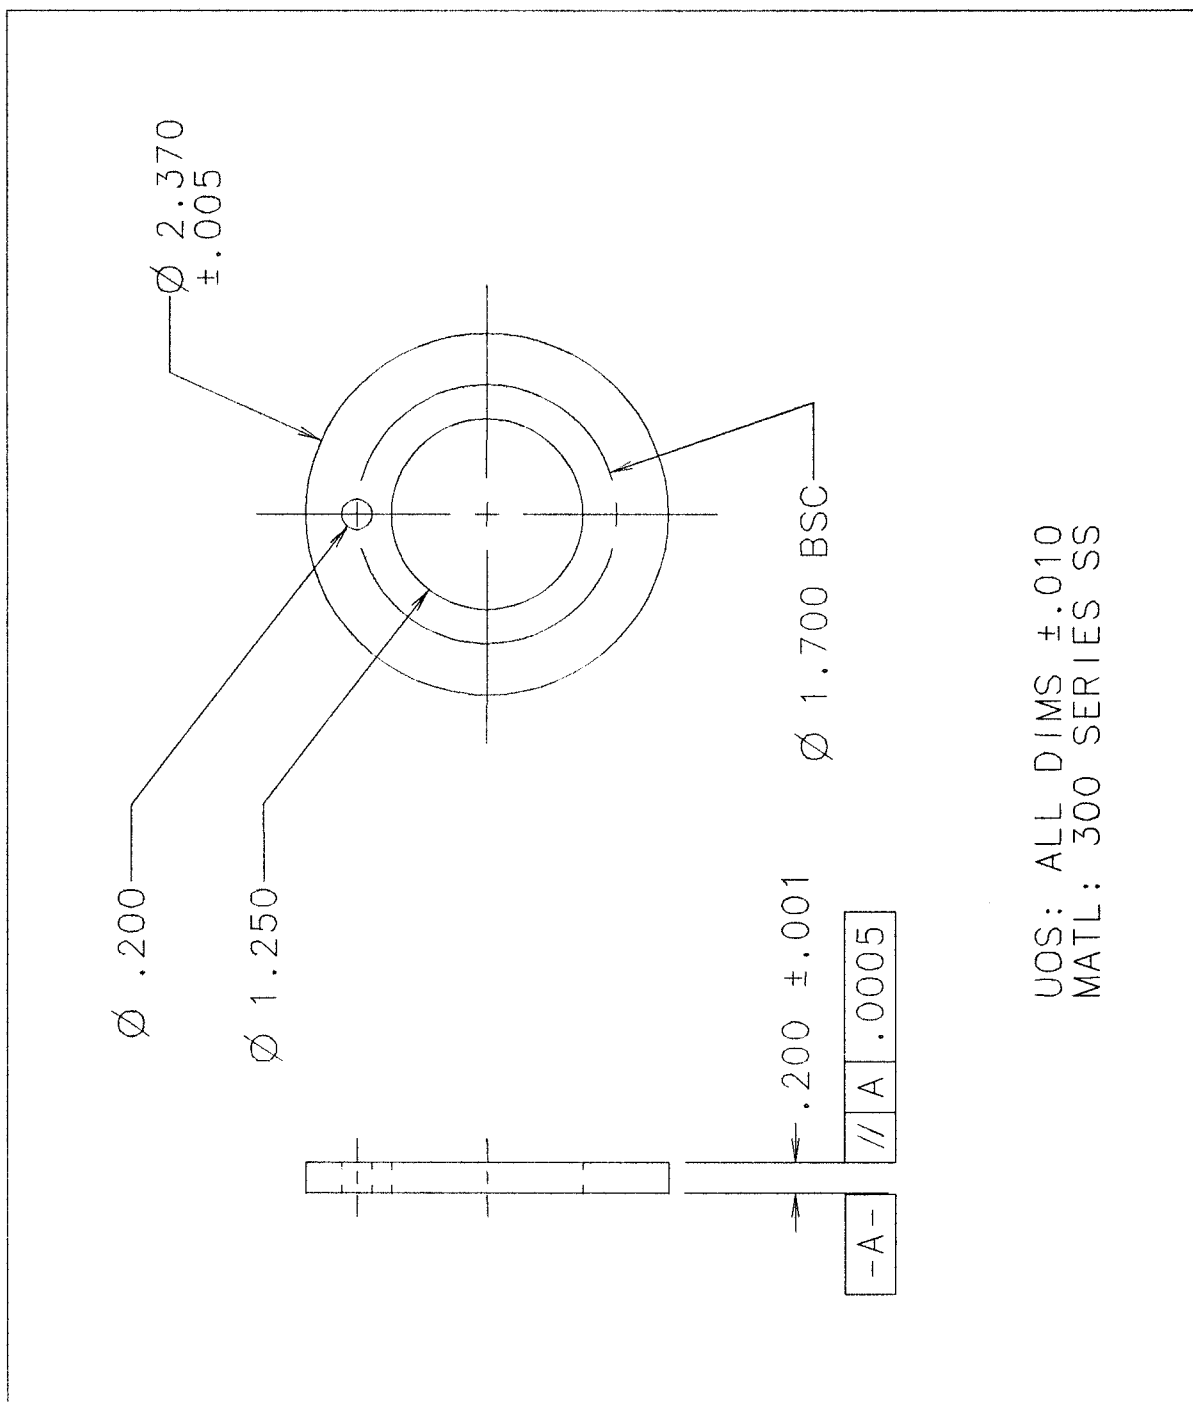
Figure 9. Clutch Inspection Fixture 2 (PN 63001011)

- (k) Put three balls PN 813425-1 in to three of the six pockets equally spaced apart.
- (l) Place Clutch Inspection Fixture 2, PN 63001011, shown in **Figure 9** on top of the three balls to take dimension N. Measure from the top of fixture 2 to the top of fixture 1 in three equally spaced locations. The average of the three measurements is dimension N.

- (m) Add dimension H average from step 7 to dimension N average. If the sum of H plus N is equal to or greater than 0.185 inch, proceed with the following steps. If it is less than 0.185 inch, the clutch assembly must be replaced.

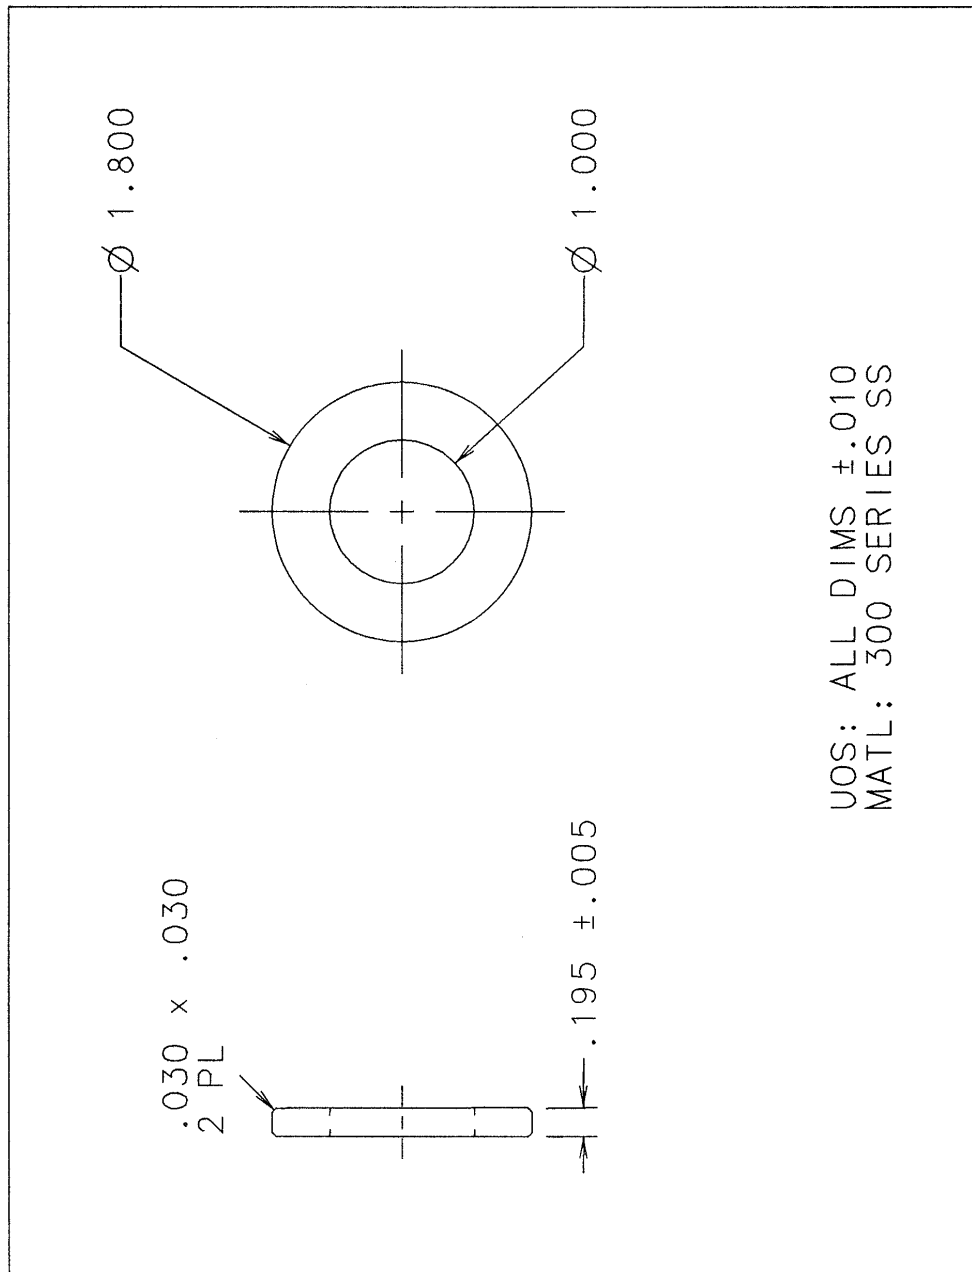
Figure 10. Measurement Spacer Tool (PN 63001012)

- (a) Put the output shaft in ring gear carrier.
- (b) Put clutch jaw PN 813393-1 in ring gear carrier. Load the output shaft and jaw against the ring gear carrier in direction F.
- (c) Measure and record dimension M.
- (d) Take the clutch jaw PN 813393-1 out of the ring gear carrier.
- (e) Put measurement spacer tool PN 63001012 shown in **Figure 10** on the output shaft over the three ball pockets.
