**International
Aero Engines**

V2500 Propulsion System — Nacelle

NACELLE - EXHAUST - SUPPORT BRACKETS, OVERHEAT DETECTOR, THRUST REVERSER
MODIFICATION OF

V2500-NAC-26-0011

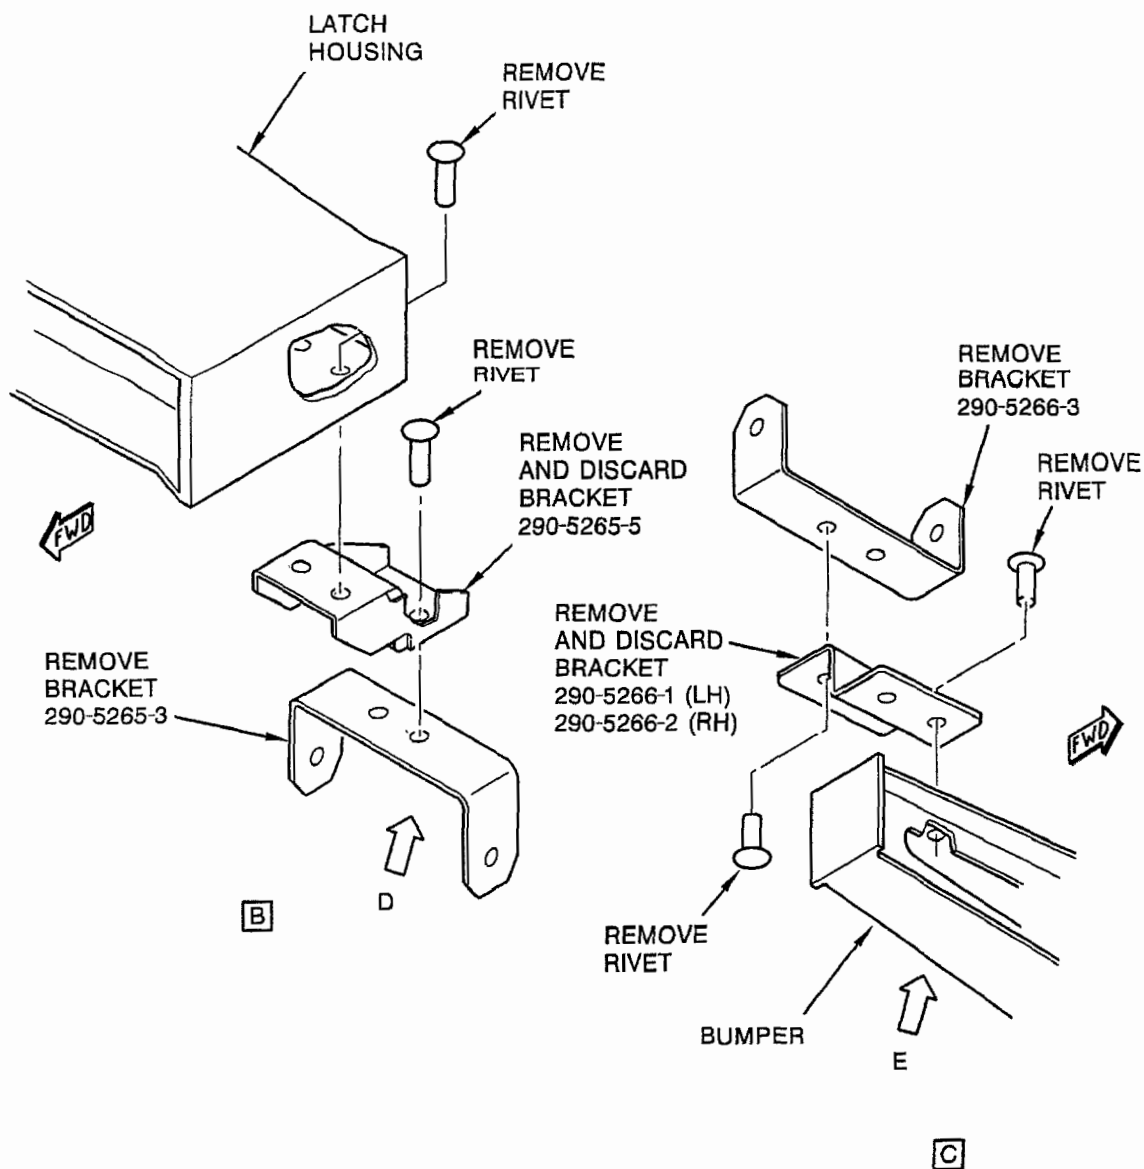
Overheat Detector Support Bracket Modification
Figure 1 (Sheet 2)

The fasteners which attach the thrust reverser outboard bifurcation overheat detector sensor support brackets to the thrust reverser have failed in service.

Modify the overheat sensor support bracket installation to prevent the possibility of failure.
