SERVICE BULLETIN

NACELLE POWER PLANT - FAN COWL DOOR - HOLD-OPEN STRUT BRACKET - REWORK OF - CATEGORY
CODE 4 - MOD.NAC-71-0102

V2500-NAC-71-0102

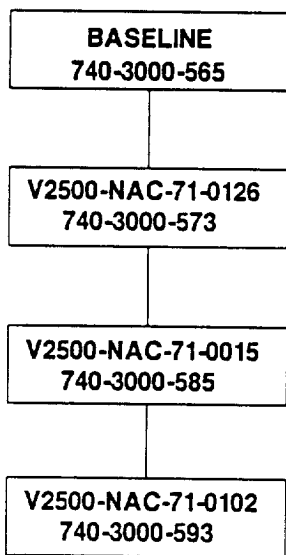
Inlet Cowl Family Tree
Fig.1

The bracket for locating the forward hold-open strut-rod on the right fan cowl door may cause a foul with the insulation blanket around the gimbal joint on the TAI air supply pipe.

- (a) The hold-open strut bracket on the rear bulkhead of the inlet cowl is removed. The bracket is modified and reinstalled (ref: Figures 1 AND 2).
