V2500-A1 SERIES PROPULSION SYSTEMS SERVICE BULLETIN

V2500-NAC-71-0272
Transmittal - Page 1 of 1

NACELLE – ENGINE BUILD UNIT (EBU) – REPLACEMENT AND REROUTING OF SEVERAL EBU SYSTEMS
TO ACCOMMODATE THE REROUTING OF THE OIL SCAVENGE TUBES

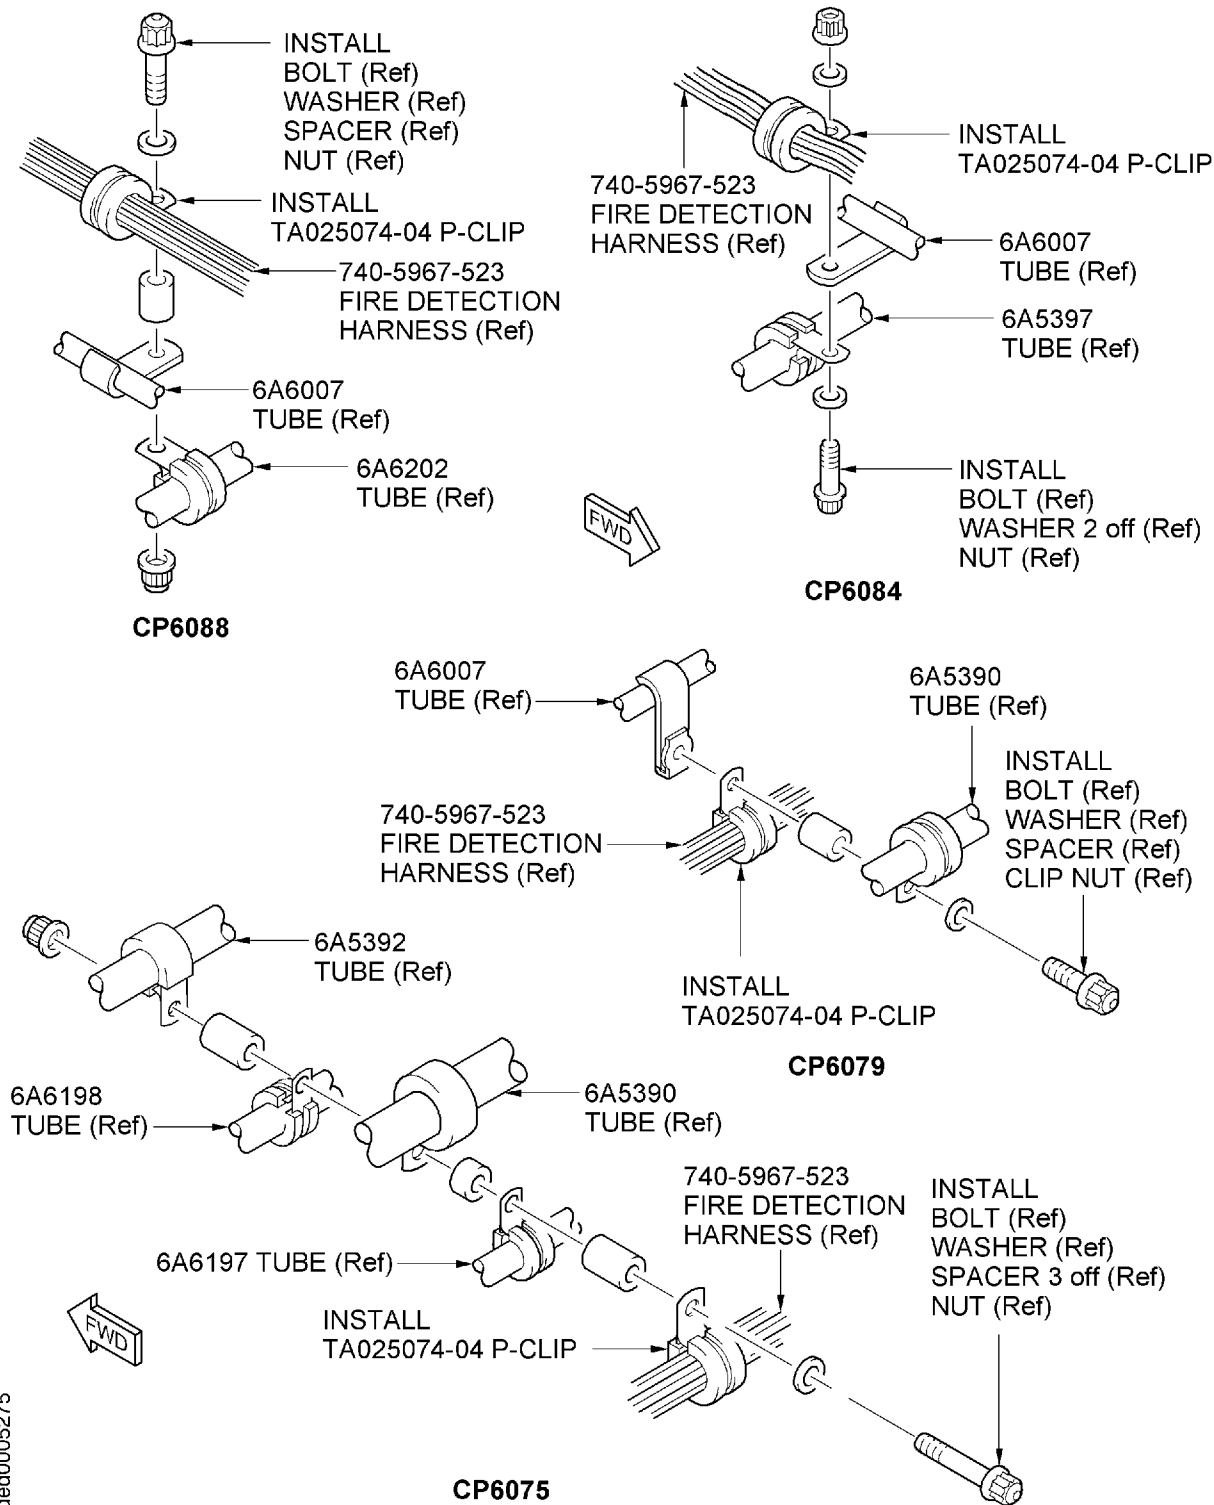
Partial Installation of the Fire Detection Harness (System A)
Figure 9 Sheet 5 of 6

(a) The Fire Detection Harness (System A) is removed and replaced with a Longer Harness to accommodate new routing.

- (e) CP5906 - Attach the Harness to the 6A6021 Tube with the TA025074-03 P-Clip, the AS21411 Bolt, the ST1698D47 Spacer and the AS20624 Nut Refer to Figure 9. Lubricate all Clipping Point Bolts and Nuts with Engine oil CoMat 10-039 or CoMat 10-040.
