V2500 Propulsion System - Nacelle **SERVICE BULLETIN**

NACELLE - EXHAUST - ACTUATOR, THRUST REVERSER, - REPLACEMENT OF

V2500-NAC-78-0173

ENGINE - INNER ACTUATOR TY1801-03

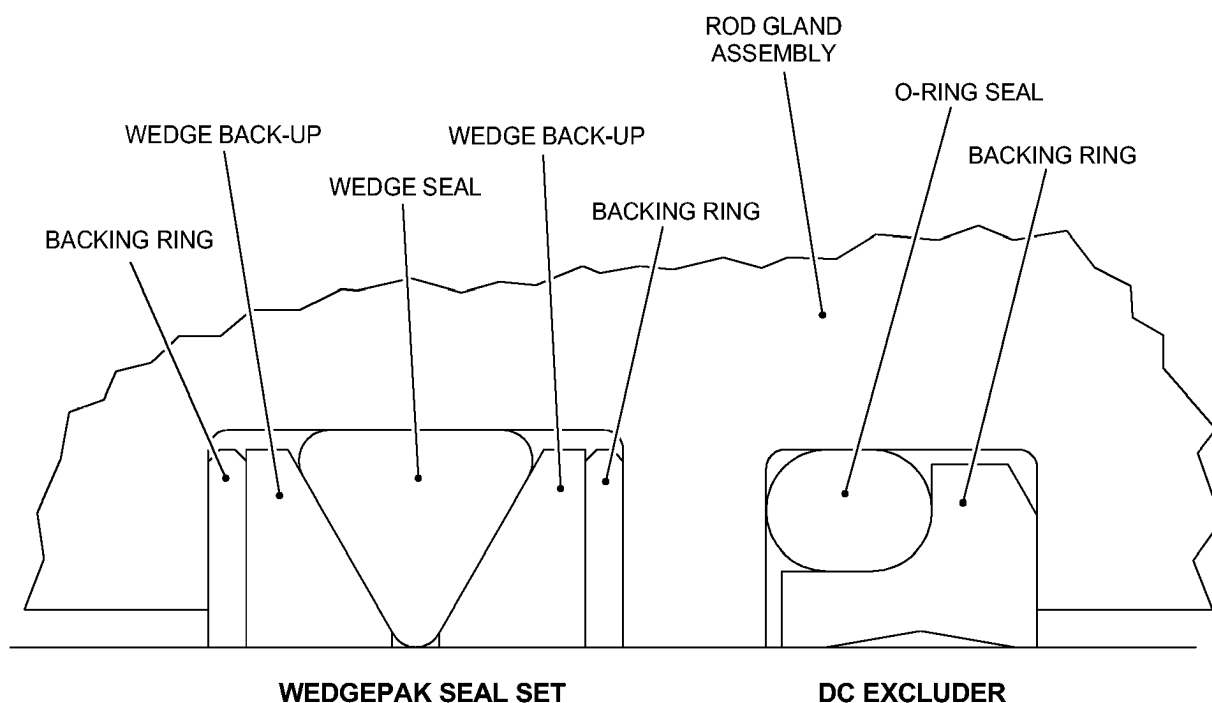
Rod Seal and Scraper
Figure 3

ENGINE - INNER ACTUATOR TY1801-03
Introduction of an Actuator with Improved Piston Rod Sealing.

- (l) Install the Settling Block CHA1542-0041 on the piston seal (340, Fig 302), refer to ASSEMBLY para 1C (1).
 - (m) Install the Settling Plug CH1542-0043 in the wedgepak seal set (RAZHAK0027), refer to ASSEMBLY para 1C (1).
 - (n) Put the rod gland assembly (CH1541P0218) and assembled parts in Cardice, refer to ASSEMBLY para 1C (2).
- WARNING:** PROTECTIVE CLOTHING, GLOVES AND GOGGLES MUST BE WORN WHEN CARDICE IS USED.
- (p) Remove the rod gland assembly (CH1541P0218) from the Cardice.

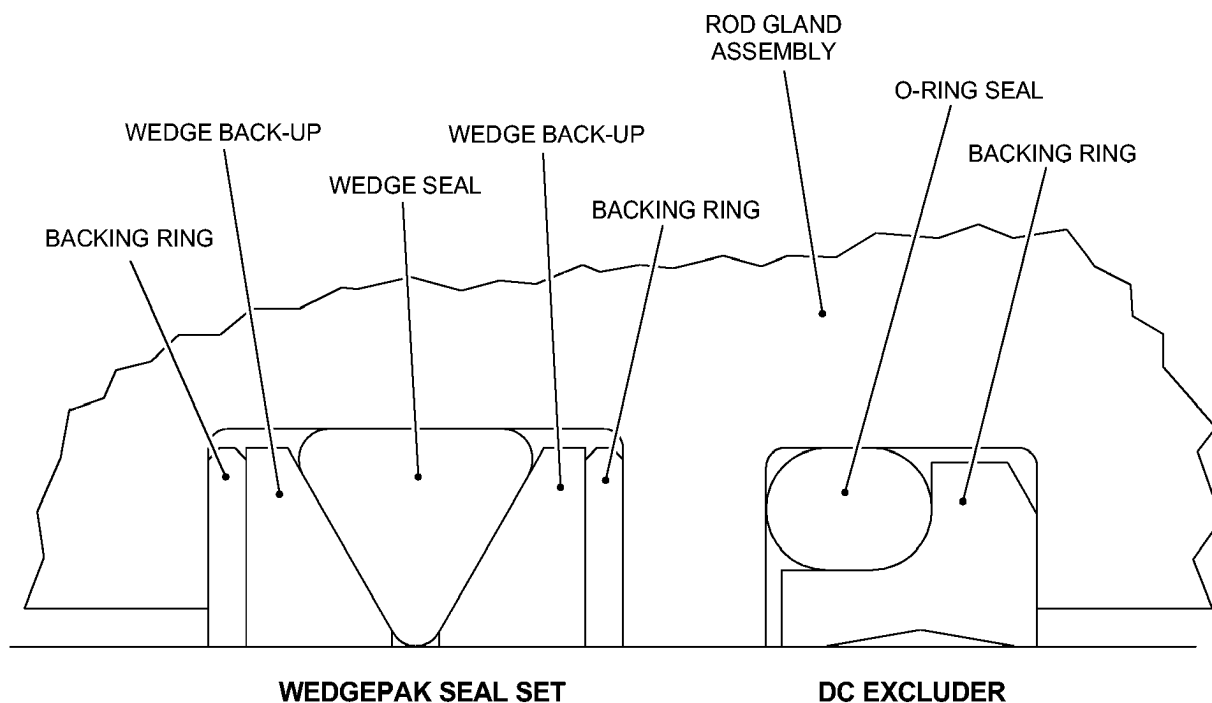
Post Mod Rod Seal and Scraper
Figure 3

ENGINE - LOCKING FEEDBACK ACTUATOR TY1802-04
Introduction of an Actuator with Improved Piston Rod Sealing.
