# International Aero Engines INFORMATION BULLETIN

ENGINE - INFORMATION - PROVIDE NEW FRONT AND REAR NO. 4 BEARING FACE SEALS

V2500-A1  
V2522-A5  
V2524-A5  
V2527-A5  
V2527E-A5  
V2527M-A5  
V2530-A5  
V2533-A5  
V2525-D5  
V2528-D5

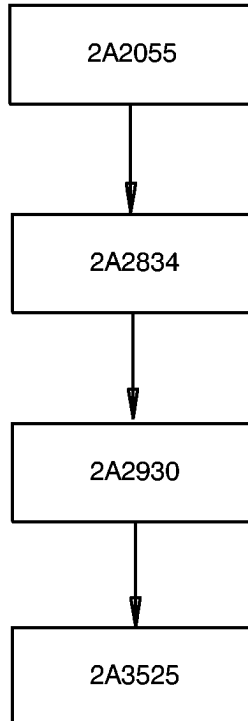
E8375

Family Tree - Seal Assembly, No. 4 Bearing, Front  
Ref. Catalog Sequence No 72-42-33. Fig. 01 Item 010  
Figure 1

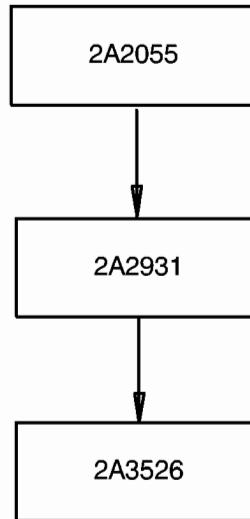
E8376

Family Tree - Seal Assembly, No. 4 Bearing, Rear  
Ref. Catalog Sequence No 72-43-20. Fig. 01 Item 020  
Figure 2
