V2500-A1/A5/D5 SERIES PROPULSION SYSTEMS SERVICE BULLETIN

ENGINE - HP COMPRESSOR DISCS (STAGES 3-8) - INTRODUCTION OF REVISED DISC ASSEMBLY WITH REDUCED STAGE 7 REAR DAMPER WIRE RETAINING WALL DIAMETER

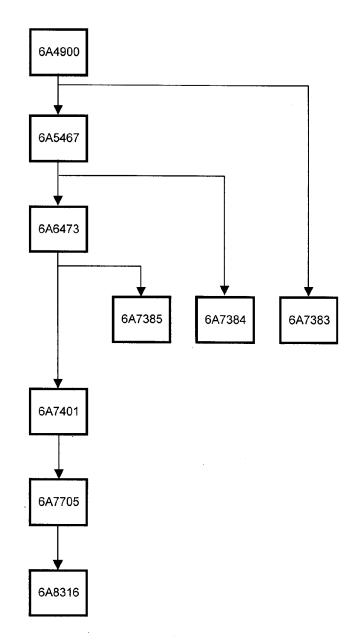
A1 Engines Only - HP Compressor Stage 3-8 Disc Assembly Family Tree Sheet 3 of 3

Baseline

V2500-ENG-72-0178

Engine - HP Compressor Discs - Stage 3 to 8 Drum with Thicker Stage 6 Disk Hub and Damping Wire Location Lips

V2500-ENG-72-0254

Engine - HP Compressor Discs (Stage 3 to 8) Introduction of HPCompressor Drum with Revised Disc Profiles

V2500-ENG-72-0304

Engine - HP Compressor Discs - Introduction of a reworked Stage 3 to 8 disc with revised L shaped sealing wires

V2500-ENG-72-0300

Engine - Stage 3 to 8 - HP Compressor Discs - Introduction of revised stage 3 to 8 disc assembly and revised stage 7 and 8 sealing wires

V2500-ENG-72-0376

Engine - HP Compressor Discs (Stages 3-8) - Introduction of a Revised Stage 3-8 Disc Assembly With Increased Life.

V2500-ENG-72-0470

Engine - HP Compressor Discs (Stages 3-8) - Introduction of a Revised Disc Assembly With Reduced Stage 7 Rear Damper Wire Retaining Wall Diameter

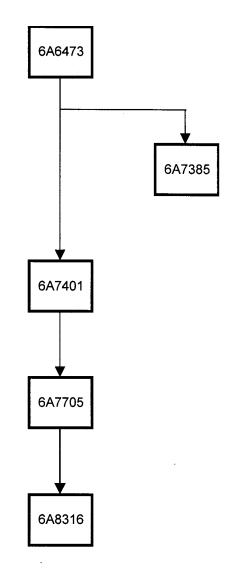
A5 and D5 Engines (not including A533) - HP Compressor Stage 3-8 Disc Assembly Family Tree
Sheet 1 of 1

Baseline

V2500-ENG-72-0304

Engine - HP Compressor Discs Introduction of a reworked Stage 3 to 8 disc assembly with revised L shaped sealing wires

V2500-ENG-72-0300

Engine - Stage 3 to 8 - HP Compressor Discs - Introduction of revised stage 3 to 8 disc assembly and revised stage 7 and 8 sealing wires

V2500-ENG-72-0376

Engine - HP Compressor Discs (Stages 3-8) - Introduction of a Revised Stage 3-8 Disc Assembly With Increased Life.

V2500-ENG-72-0470

Engine - HP Compressor Discs (Stages 3-8) - Introduction of a Revised Disc Assembly With Reduced Stage 7 Rear Damper Wire Retaining Wall Diameter
