V2500-A1/A5/D5 SERIES PROPULSION SYSTEMS SERVICE BULLETIN

V2500-ENG-72-0472

Engine - HP Compressor Discs (Stages 3-8)
Introduction Of Revised Stage 7 & 8 Seal
Wires

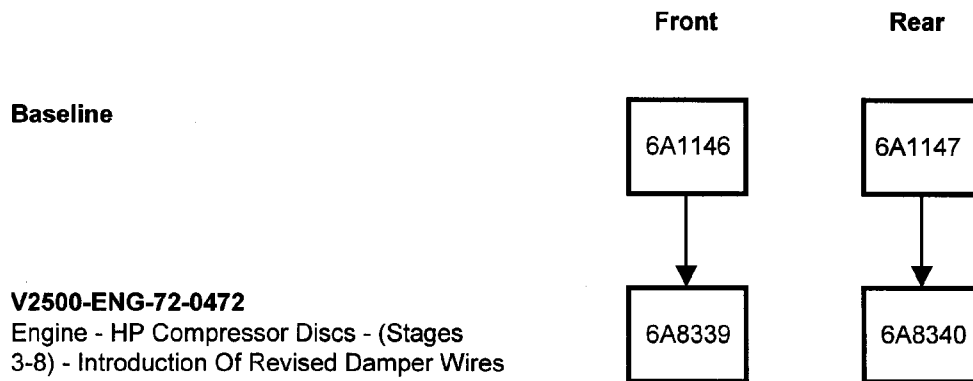
HP Compressor Stage 6 Damper Wire Family Tree

All Engines

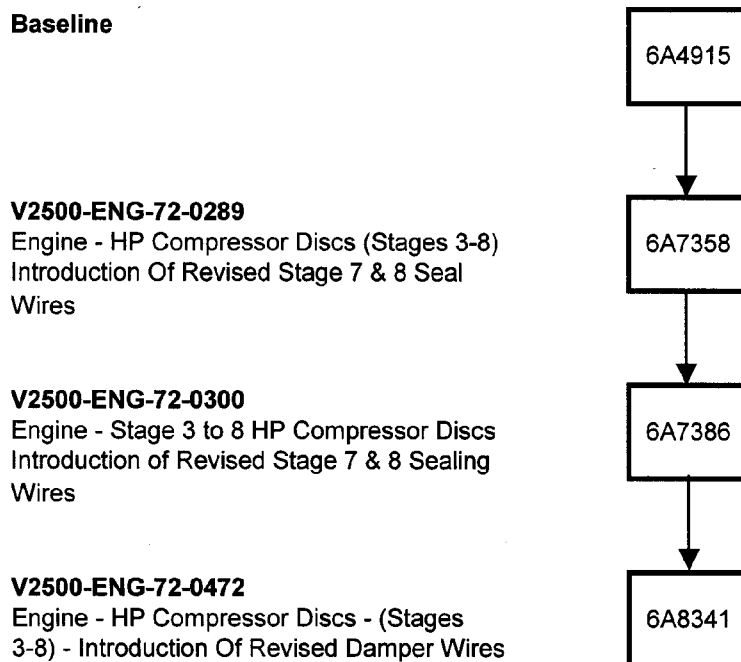
HP Compressor Stage 7 Front Damper Wire Family Tree

All Engines

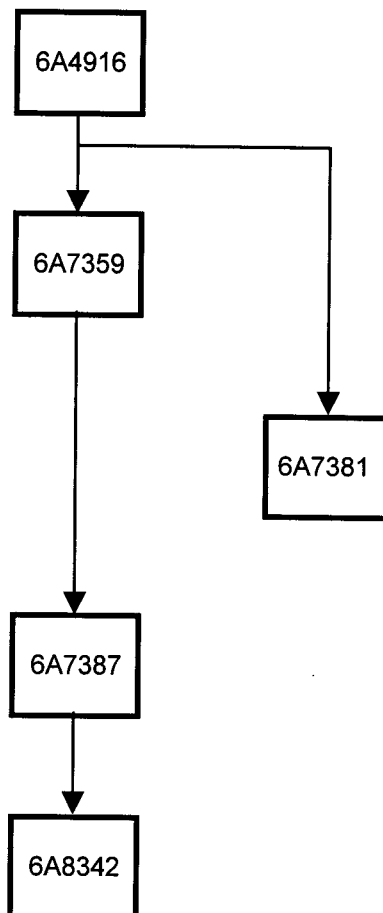
HP Compressor Stage 7 Rear Damper Wire Family Tree

All Engines

Baseline

V2500-ENG-72-0289

V2500-ENG-72-0304

Engine - HP Compressor Discs Introduction
of a Reworked Stage 3 to 8 Disc Assembly
with Revised L Shaped Sealing Wires

V2500-ENG-72-0300

Engine - Stage 3 to 8 HP Compressor Discs
Introduction of Revised Stage 7 & 8 Sealing
Wires

V2500-ENG-72-0472

Engine - HP Compressor Discs - (Stages
3-8) - Introduction Of Revised Damper Wires

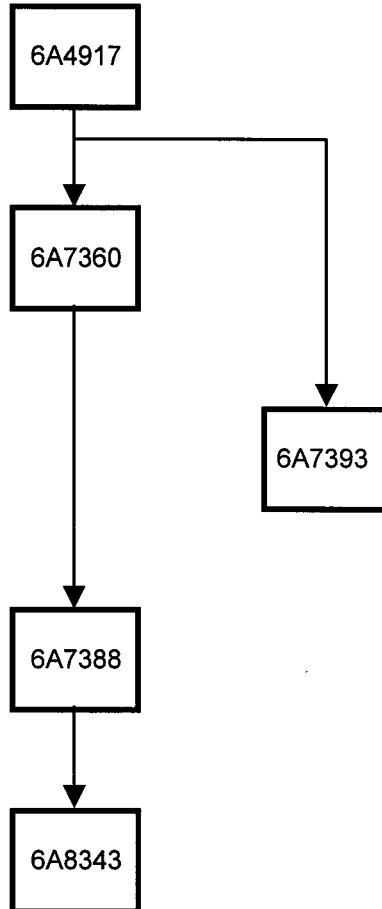
HP Compressor Stage 8 Front Damper Wire Family Tree
All Engines
Baseline
V2500-ENG-72-0289

Engine - HP Compressor Discs (Stages 3-8)
Introduction Of Revised Stage 7 & 8 Seal
Wires

V2500-ENG-72-0304

Engine - HP Compressor Discs Introduction
of a Reworked Stage 3 to 8 Disc Assembly
with Revised L Shaped Sealing Wires

V2500-ENG-72-0300

Engine - Stage 3 to 8 HP Compressor Discs
Introduction of Revised Stage 7 & 8 Sealing
Wires

V2500-ENG-72-0472

Engine - HP Compressor Discs - (Stages
3-8) - Introduction Of Revised Damper Wires
