V2500-A1/A5/D5 PROPULSION SYSTEM SERVICE BULLETIN

This document transmits Revision 1 to Service Bulletin EV2500-73-0073

V2500-ENG-73-0073

POWERPLANT - ENGINE DEDICATED ALTERNATOR (EDA) - MODIFICATION OF 430110 AND 430153 STATORS TO ACCOMMODATE AN INTEGRAL AIR SHROUD OR REPLACE WITH A NEW STATOR THAT INCORPORATES AN INTEGRAL AIR SHROUD

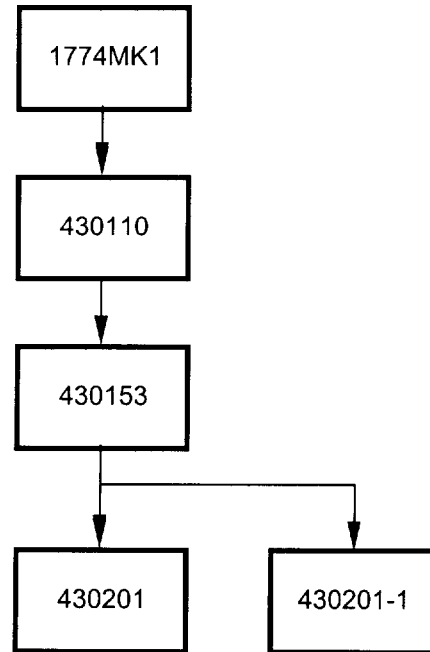
Family Tree
Fig.2

**V2500-A5 (EXCEPT V2533) EDA Family Tree ***

Service Bulletin Number**Unit Mod Plate Endorsement****BASELINE**

V2500-ENG-73-0076EDA - New source of supply -
Unison Industries

V2500-ENG-73-0138EDA - Introduction of new style
receptacles

V2500-ENG-73-0073EDA - Introduction of an integral
cooling shroud

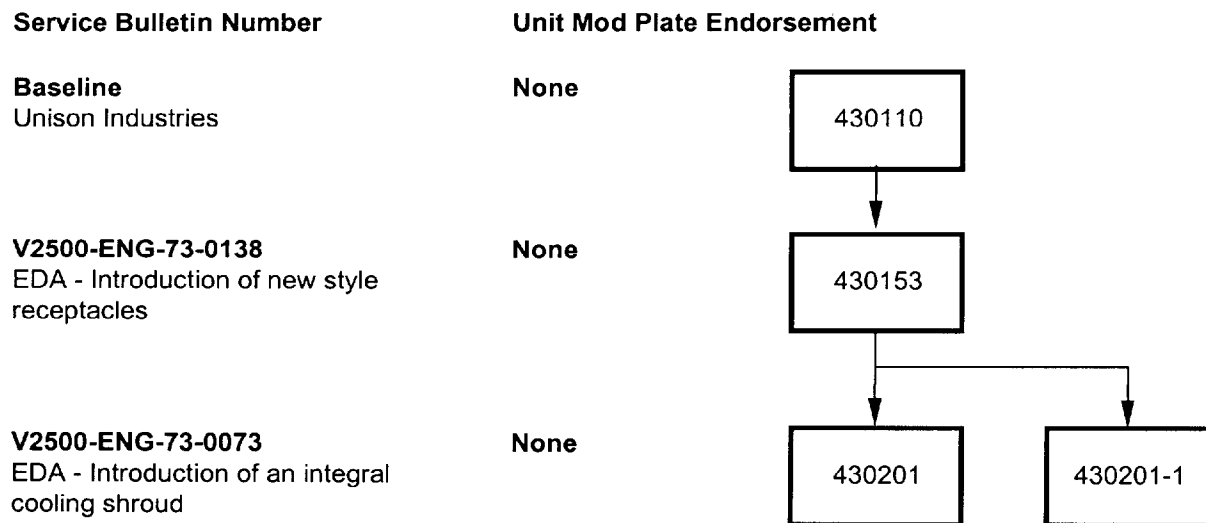
Family Tree
Fig.3

V2533-A5 EDA Family Tree *

* This family tree is not intended to represent the combination of modifications fitted to units in service

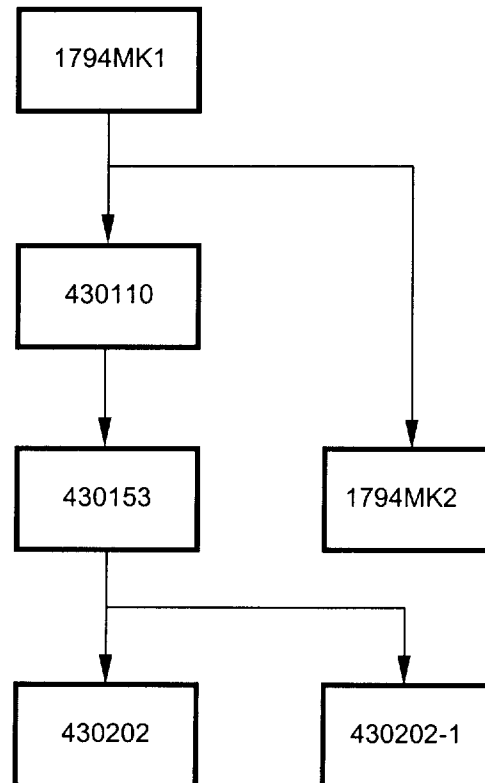
**V2500-D5 EDA Family Tree ***

Service Bulletin Number**Unit Mod Plate Endorsement****Baseline**

None**V2500-ENG-73-0070**EDA - New source of supply -
Unison Industries**None****V2500-ENG-73-0096**EDA - Introduction of new style
receptacles**None****V2500-ENG-73-0073**EDA - Introduction of an integral
cooling shroud**None**
