International Aero Engines

## V2500 A5 PROPULSION SYSTEMS SERVICE BULLETIN

This document transmits Revision 1 to Service Bulletin EV2500-73-0170

V2500-ENG-73-0170

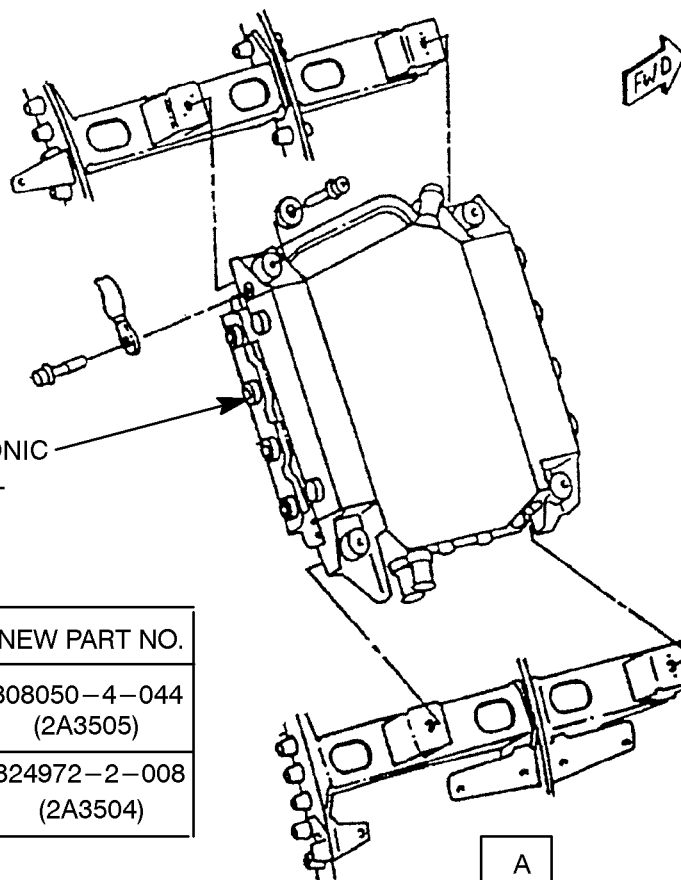
Location of the Electronic Engine Control (EEC)  
Figure 3

\* REPLACE ELECTRONIC  
ENGINE CONTROL

* EEC	OLD PART NO.	NEW PART NO.
150-20	808050-4-042 (2A3488)	808050-4-044 (2A3505)
150-40	824972-2-006 (2A3489)	824972-2-008 (2A3504)

- (i) Remove the Old P/N (See Table 4 Figure 1 Sheet 10) Electronic Engine Control by the procedure given in Reference (15), Chapter/Section 73-22-34, Removal Installation. See Figure 3.

- (1) Send the Electronic Engine Control to the approved vendor to be modified. See Paragraph 1. A. (1) or (2). See Figure 3.
