**V2500-A5/D5 PROPULSION SYSTEM SERVICE BULLETIN**

**V2500-ENG-73-0179**

ENGINE FUEL AND CONTROL – FUEL METERING UNIT – INTRODUCTION OF A WOODWARD AIRCRAFT  
ENGINE SYSTEMS (WAES) REVISED STANDARD OF VESPEL BALL

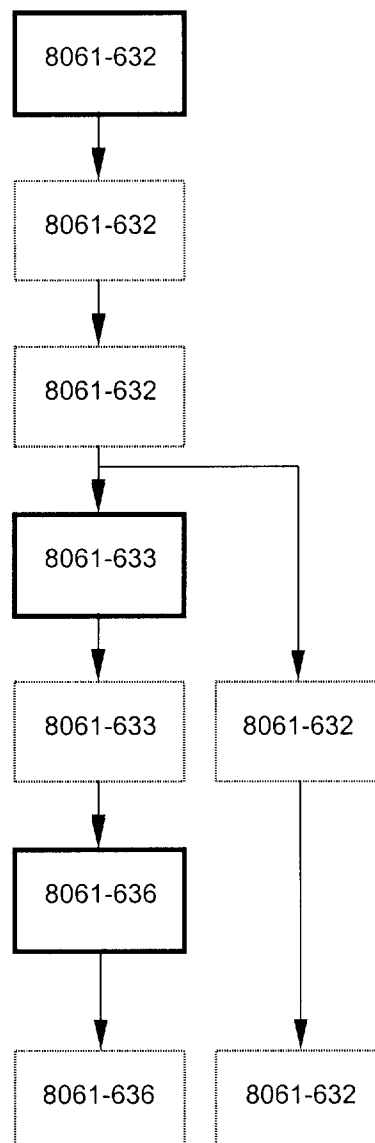
FMU Family Tree - V2527-A5 and V2527E-A5  
Fig.2

Introduction of a WAES FMU with revised standard of Vespel ball

**ENG-73-0179**

\* This family tree is not intended to represent the combination of modifications fitted to units in service

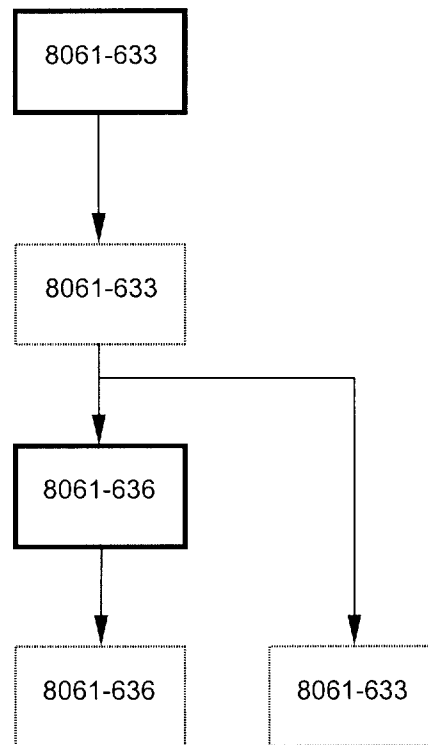
**V2527M-A5 FMU Family Tree \*****Service Bulletin Number****Unit Mod Plate Endorsement****V2500-ENG-73-0158**

Introduction of a WAES FMU with revised standard of Vespel ball

**ENG-73-0179**

\* This family tree is not intended to represent the combination of modifications fitted to units in service

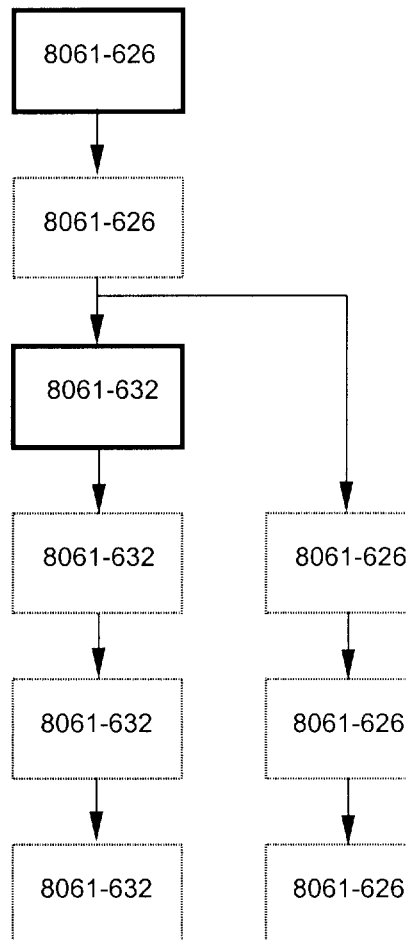
Introduction of a WAES FMU with revised standard of Vespel ball

ENG-73-0179

\* This family tree is not intended to represent the combination of modifications fitted to units in service
