V2500-A5/D5 PROPULSION SYSTEMS SERVICE BULLETIN

This document transmits the Revision 1 of IAE Service Bulletin V2500-ENG-73-0223, the Initial Issue of Woodward Governor Company Service Bulletin 83724-73-0223 and the Initial Issue Woodward Governor Company Service Bulletin 83724-73-0006.

V2500-ENG-73-0223

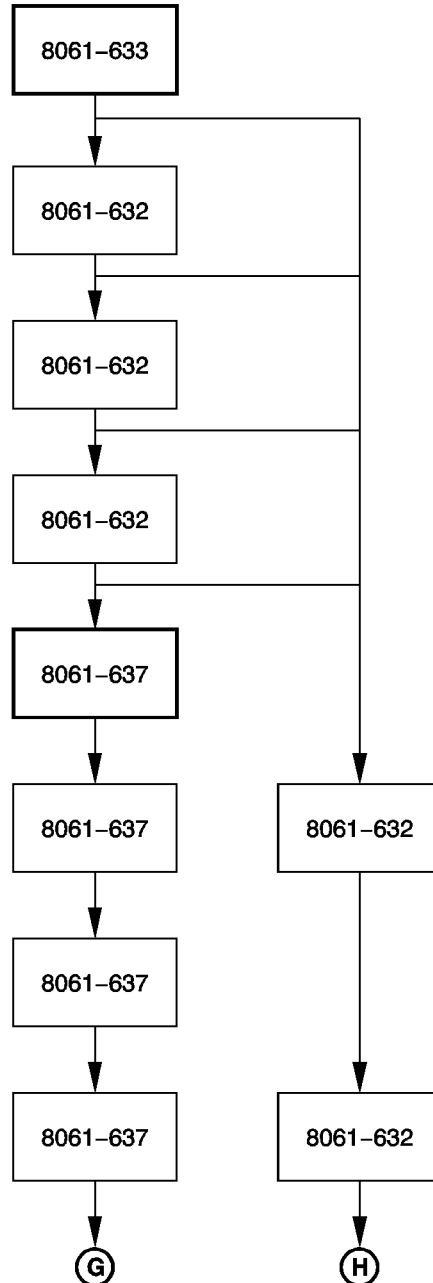
V2530-A5 and V2533-A5 FMU Family Tree
Chart 4 (sheet 1 of 2)

Introduction of a WAES FMU with revised FMV servovalve torquemotor stopscrews

Remove	Incorporate	Reason for change
All pages of the IAE Service Bulletin.	Pages 1 to 17 of the IAE Service Bulletin V2500-ENG-73-0223.	To revise Chart 4. To add conversion instructions between hi/low flow (Woodward Governor Company Service Bulletin 83724-73-0006).

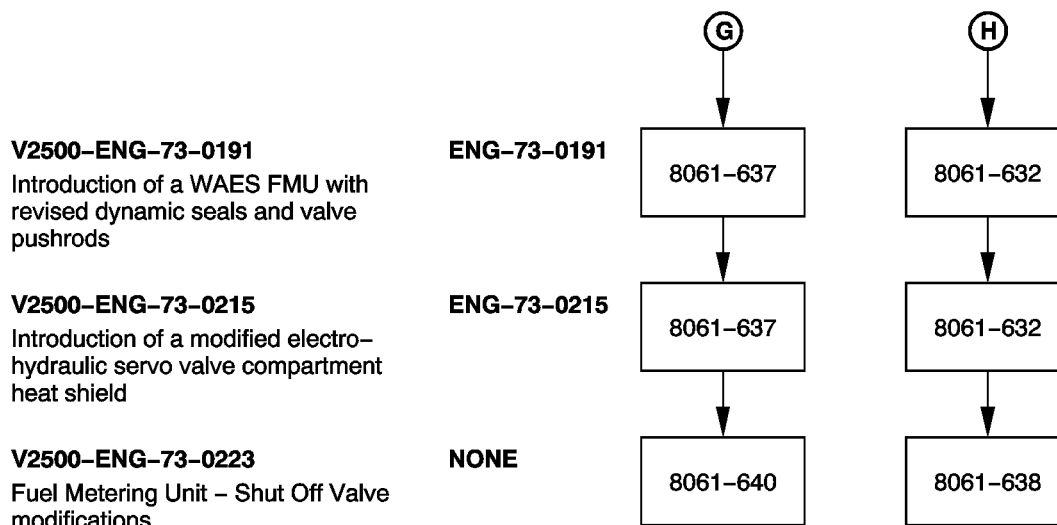
V2530–A5 and V2533–A5 FMU Family Tree
Chart 4 (sheet 2 of 2)

V2530–A5 and V2533–A5, FMU Family Tree*

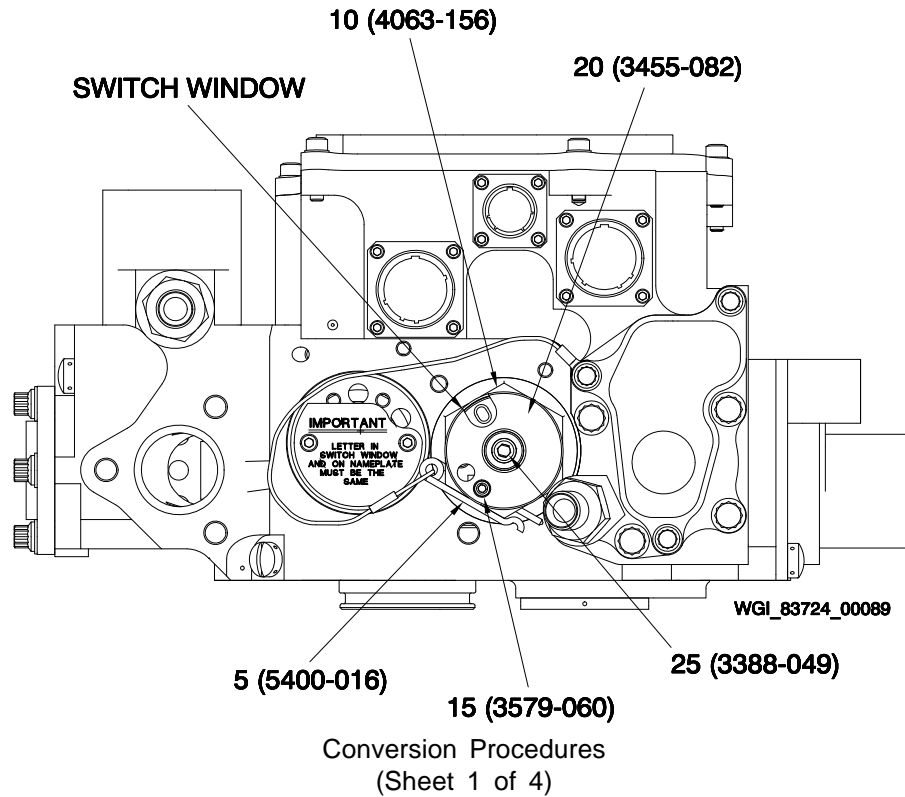
- 5 PIN (P/N 3190-120)
10 PLUG ASSEMBLY (P/N 4063-156)
15 DETENT (P/N 3579-060)
20 CAP (P/N 3455-082)
25 SHAFT (P/N 3388-049)
30 SCREW (2) (P/N 218814)
35 NAMEPLATE (P/N 3082-308)
40 SEAL (2) (P/N 218006)

- (8) Remove 2 screws (30) from nameplate (35).
- (9) Inspect nameplate (35) for damage. If damage is excessive, replace nameplate (35) as shown in REPAIR section of CMM 73-28-06.

- (10) Attach nameplate (35), with side indicating part number 8061-640 visible, with 2 screws (30). If run-on torque is less than 10 oz. in. (0,07 N.m), replace 2 screws (30). If run-on torque still is inadequate, then replace inserts as shown in REPAIR section of CMM 73-28-06. Torque 2 screws (30) to 5.5-6.0 lb. in. (0,62-0,68 N.m).
