AIR - HPT/LPT ACC VALVE ACTUATOR - INTRODUCTION OF A NEW ROD END TO HPT/LPT ACC VALVE  
ACTUATOR - PARKER HANNIFIN SB 5860017-75-91, 5910479-75-92 - CATEGORY CODE 6 -  
MOD.ENG-75-0046

See Vendor Bulletin 5860017-75-91

See Vendor Bulletin 5910479-75-92

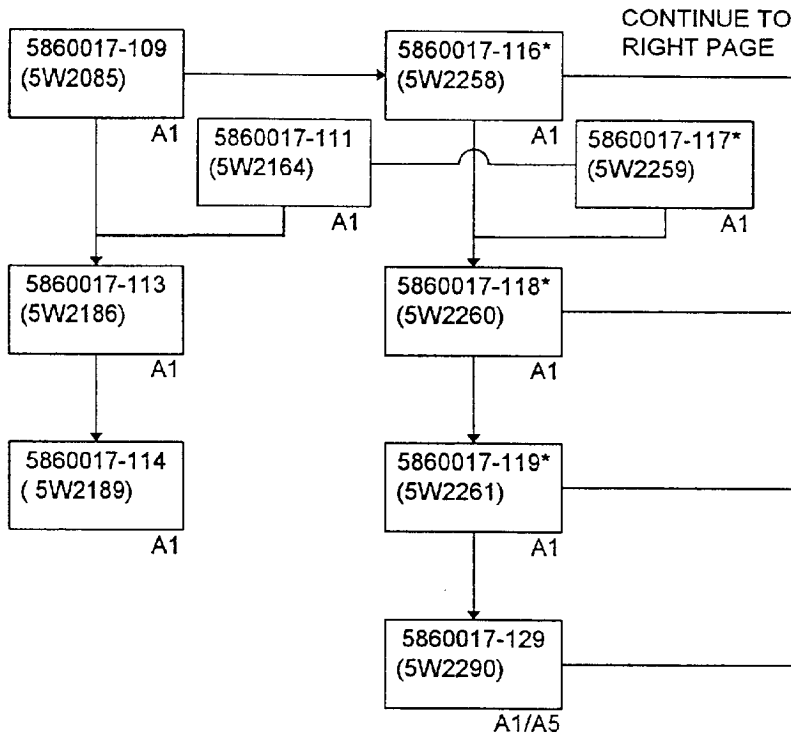
SB75-0046  
(PARKER 5860017-75-91  
AND 5910479-75-92)  
REPLACEMENT OF ROD END

PART NUMBERS WITH "\*" MARK  
SHOW THE PARTS INCORPORATED THIS MODIFICATION

PART NUMBERS WITH "\*\*" MARK  
SHOW THE PARTS INCORPORATED THIS MODIFICATION

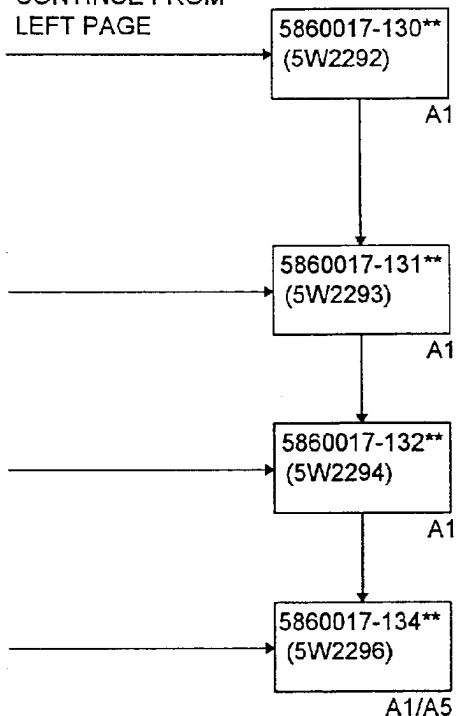
SB75-0046  
(PARKER 5860017-75-91  
AND 5910479-75-92)  
REPLACEMENT OF ROD  
END

NOTE: MODEL CODE SHOWN UNDER THE PART NUMBER  
BOXES INDICATES AFFECTED ENGINE MODELS.

A1 — FOR V2500-A1

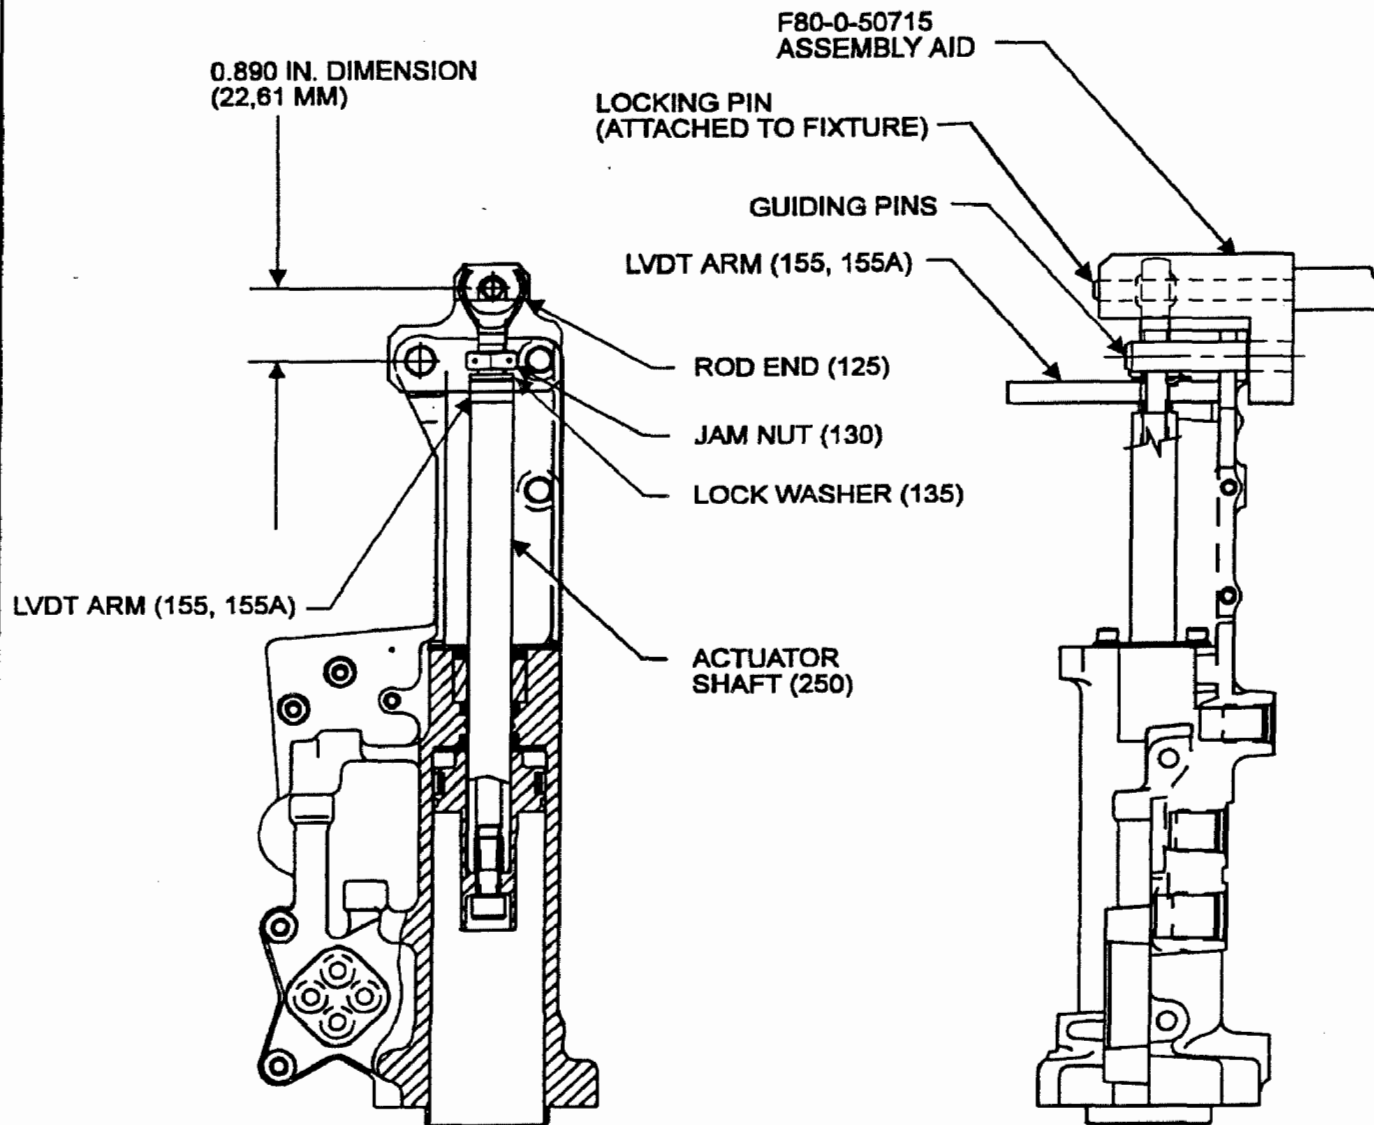
0659-704A

NOTE: LVDT NOT SHOWN FOR CLARITY

**CAUTION:** CAREFULLY LOOSEN JAM NUT (130). EXCESSIVE TORQUE MOTION CAN BREAK THE TAB ON THE TAB WASHER (135)

**CAUTION:** CAREFULLY HANDLE ACTUATOR SHAFT (257, 257A). DAMAGE TO THE SURFACE FINISH OF THE ACTUATOR SHAFT WILL CAUSE EXCESSIVE LEAKAGE DURING TEST AND OPERATION.

- (5) Hold the rod end with a 10-inch (250 mm) crescent wrench, or equivalent, and loosen jam nut (130). Move tab washer (135) apart from LVDT arm (155, 155A).
- (6) Hold flats of actuator shaft (257, 257A) with special wrench, F80-0-50965, or equivalent, to prevent actuator shaft from turning. Loosen rod end (125) with a 10-inch (250 mm) crescent wrench, or equivalent. Remove rod end.

**CAUTION:** CLEAN THE THREADED INSERT OF ACTUATOR SHAFT ASSEMBLY (257, 257A) WITH A COTTON TIPPED SWAB AND ALCOHOL TO PREVENT THREAD DAMAGE WHEN INSTALLING THE ROD END, 5943051-101.

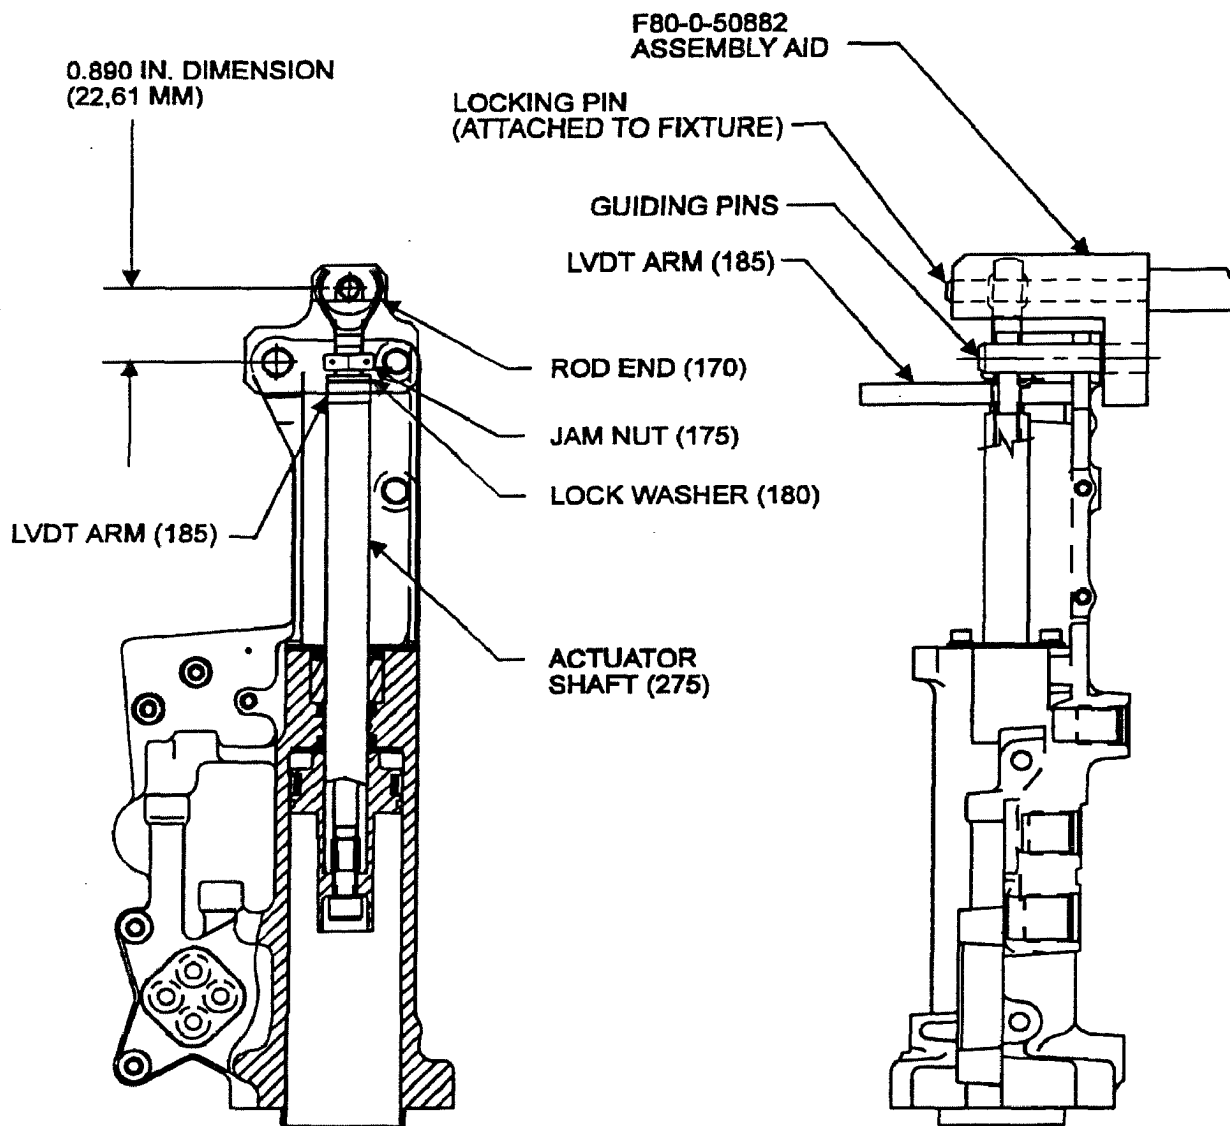
5910479.RG1

NOTE: LVDT NOT SHOWN FOR CLARITY

**CAUTION:** CAREFULLY LOOSEN JAM NUT (175). EXCESSIVE TORQUE MOTION CAN BREAK THE TAB ON THE TAB WASHER (180)

**CAUTION:** CAREFULLY HANDLE ACTUATOR SHAFT (275). DAMAGE TO THE SURFACE FINISH OF THE ACTUATOR SHAFT WILL CAUSE EXCESSIVE LEAKAGE DURING TEST AND OPERATION.

**CAUTION:** CLEAN THE THREADED INSERT OF ACTUATOR SHAFT ASSEMBLY (275) WITH A COTTON TIPPED SWAB AND ALCOHOL TO PREVENT THREAD DAMAGE WHEN INSTALLING THE ROD END, 5943051-101.
