V2500-D5 SERIES PROPULSION SYSTEM SERVICE BULLETIN

This document transmits the Initial Issue of Service Bulletin EV2500-75-0086

AIR - HP COMPRESSOR STAGE 10 BLEED VALVE - INTRODUCTION OF A REVISED PARKER HANNIFIN
BLEED VALVE WITH ADDITIONAL CARBON BEARING, REDESIGNED SPRING AND ADDITIONAL SPRING
GUIDE

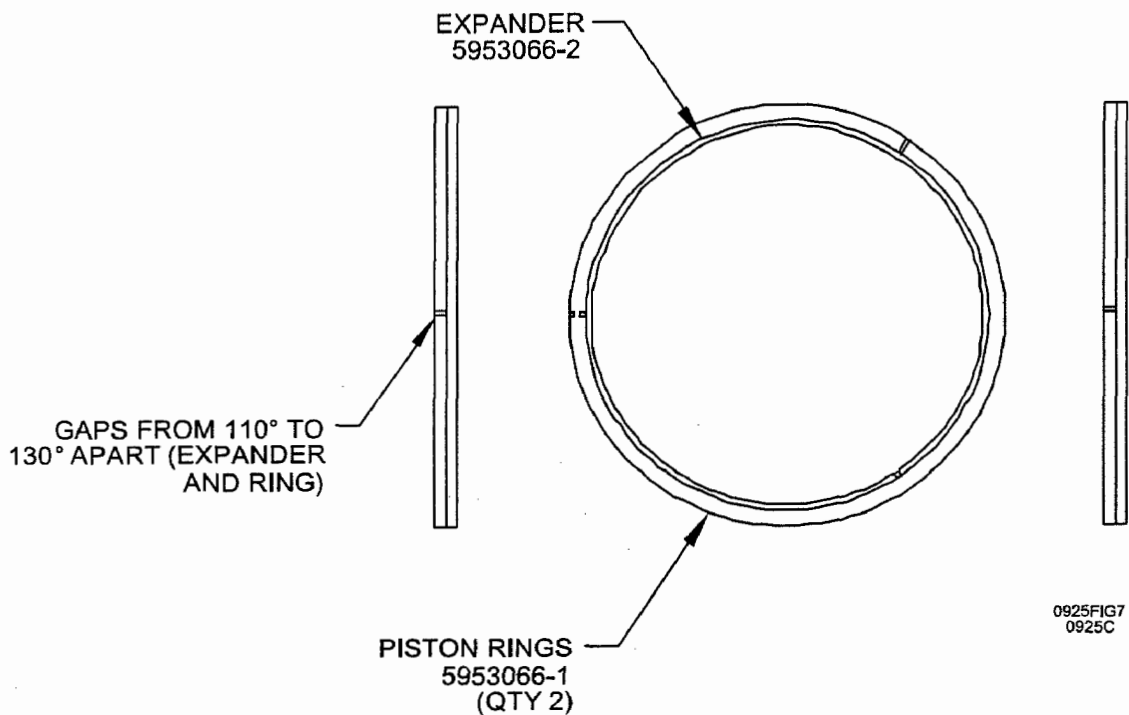
Seal Assembly
Figure 2

- (1) Assembly of seal assembly, P/N 5953066-101, (See Figure 2)
 - (a) Install the expander, P/N 5953066-2, into the groove of the inside diameter of the body assembly, P/N 5952018-103.

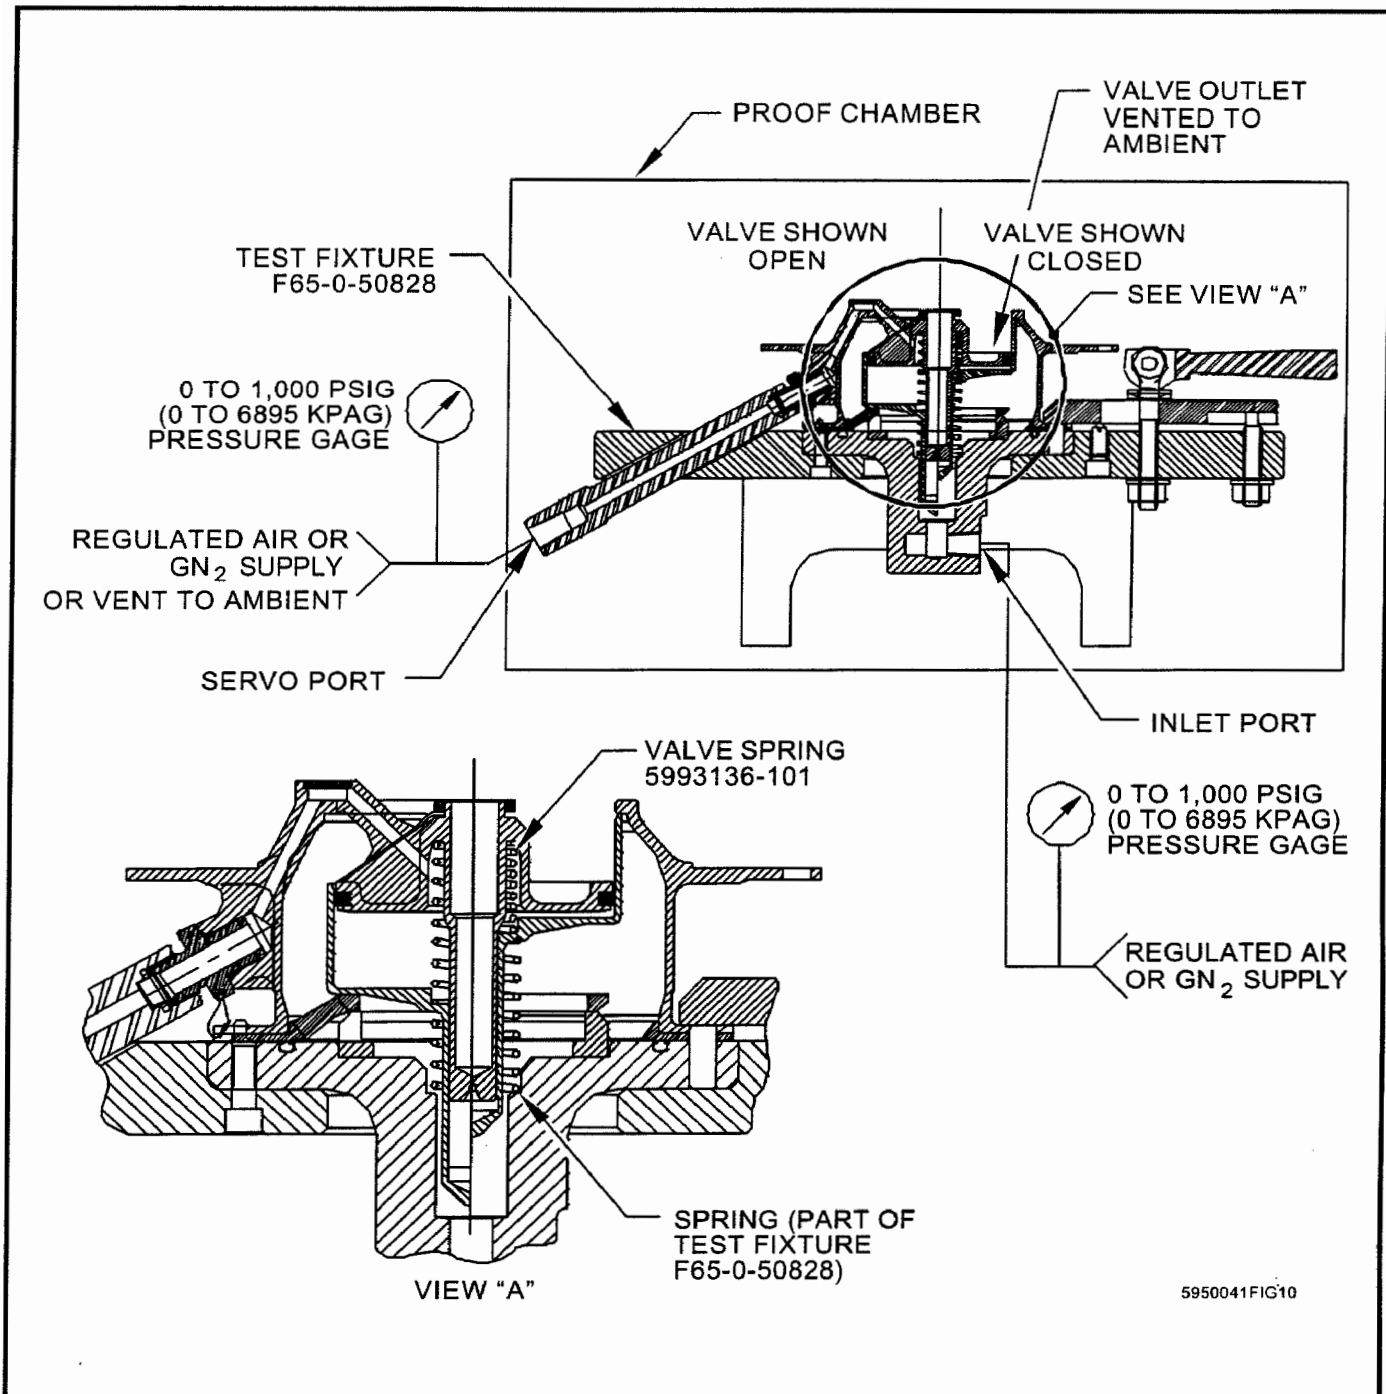
Proof Pressure Test Setup
Figure 3

- (a) Set up the valve, as shown in Figure 3, in test fixture, F65-0-50828, and the outlet and inlet ports of the valve vented to ambient.
- (b) Slowly apply a pressure of 625 to 635 psig (4309 to 4378 kPag) to the servo port and hold the pressure for a minimum of 1 minute.
- (c) Slowly reduce the pressure to zero.
- (d) There must be no deformation or other permanent damage.

- (a) Set up the valve, as shown in Figure 3, in test fixture, F65-0-50828, and the outlet and the servo ports vented to ambient.
- (b) Slowly apply a pressure of 585 to 595 psig (4033 to 4102 kPag) to the inlet port and hold the pressure for a minimum of 1 minute.
- (c) Slowly reduce the pressure to zero.
- (d) There must be no deformation or other permanent damage.

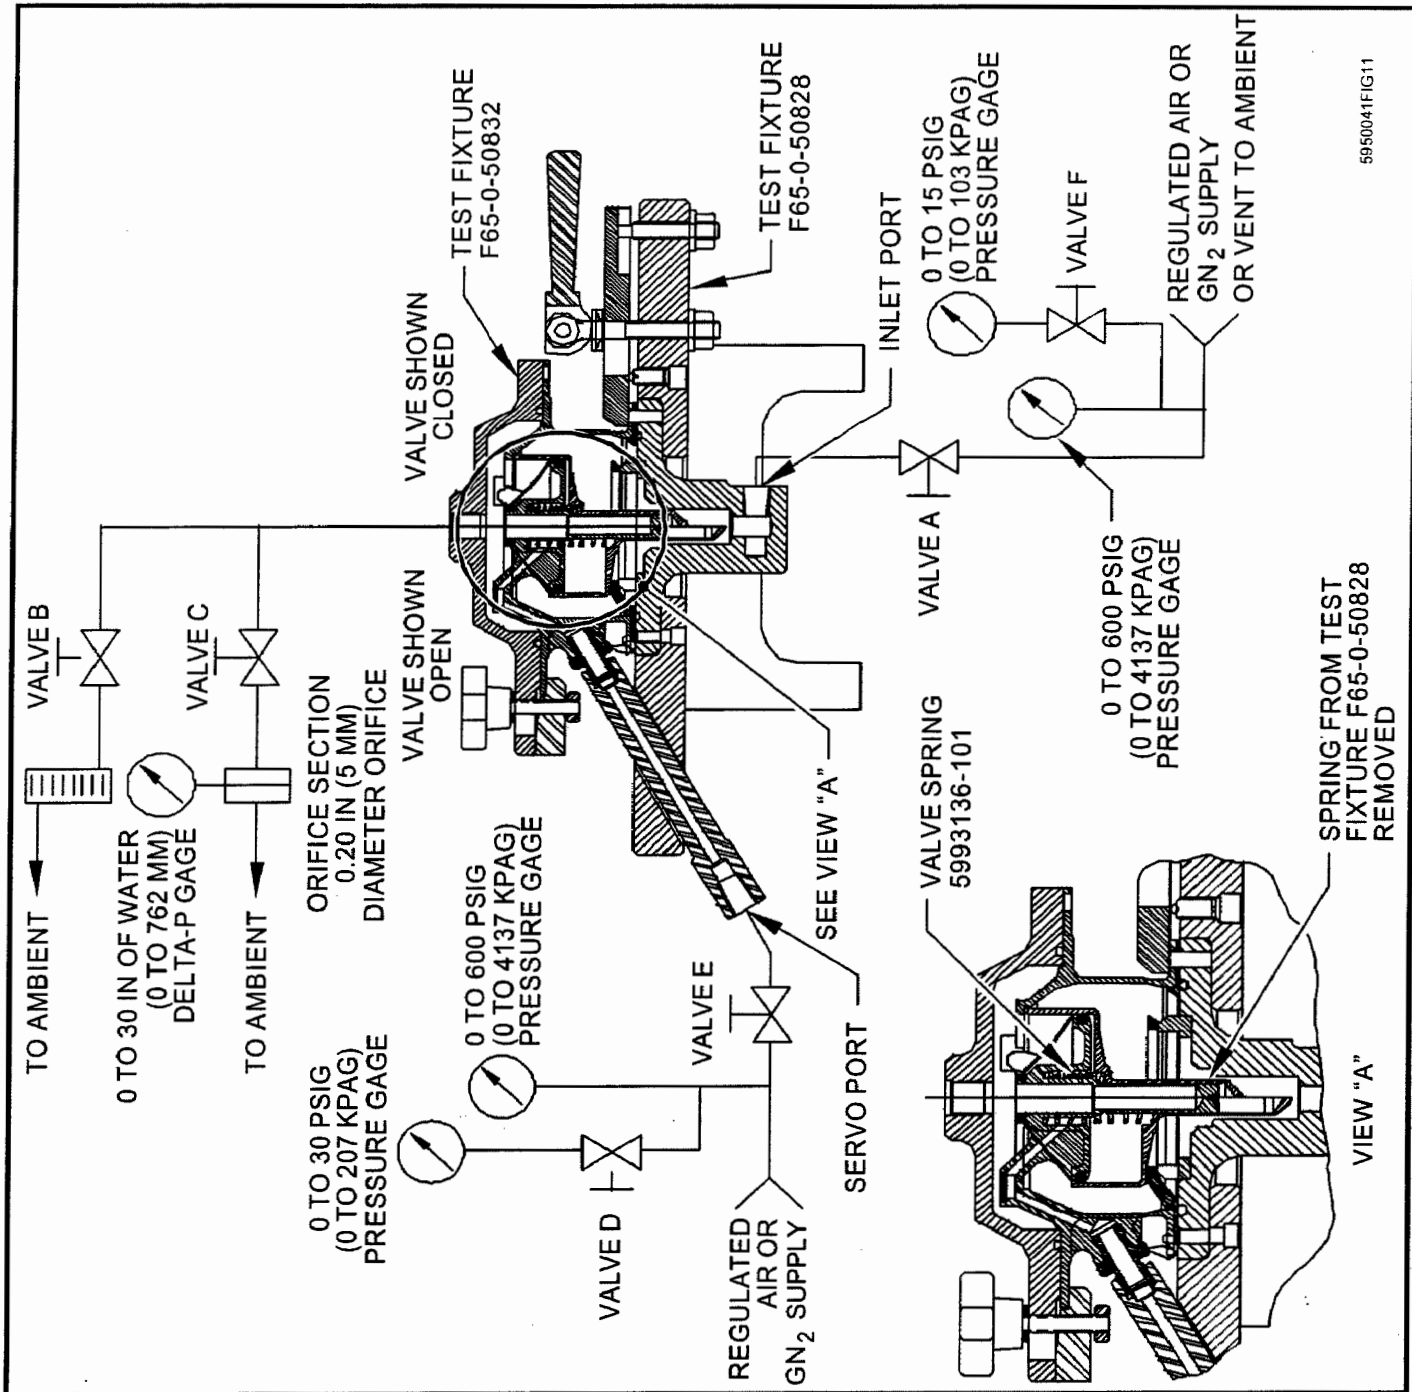
Leakage Test Setup
Figure 4

- (a) Set up the valve, as shown in Figure 4, with the spring removed from the test fixture, F65-0-50828. Close valves A and F and open valves D and E.

- (a) With the spring still removed, set up the valve in test fixture, F65-0-50828, as shown in Figure 4. Close valves D and F. Open valves A and E.
- (b) Slowly apply pressure to the inlet port until the valve closes. Close valve E.
- (c) Slowly increase the pressure to 330 to 340 psig (2275 to 2344 kPag) to the inlet port.
- (d) The leakage must not exceed 2.8 scfm (0,079 scmm) (equivalent to 0.21 lbs/minute (0.10 kg/minute)), as measured at the flowmeter.
- (e) Slowly reduce the pressure to zero.

- (c) The servo leakage must not exceed 0.170 scfm (0,0048 scmm) (equivalent to 0.013 lbs/minute [0,006 kg/minute]), as measured at the flowmeter.
- (d) Slowly reduce the pressure to zero.

- (g) The servo leakage must not exceed 2.6 scfm (0,0736 scmm) (equivalent to 0.20 lbs/minute (0,009 kg/minute)), as measured at the flowmeter.
- (h) Slowly reduce the pressure to zero.

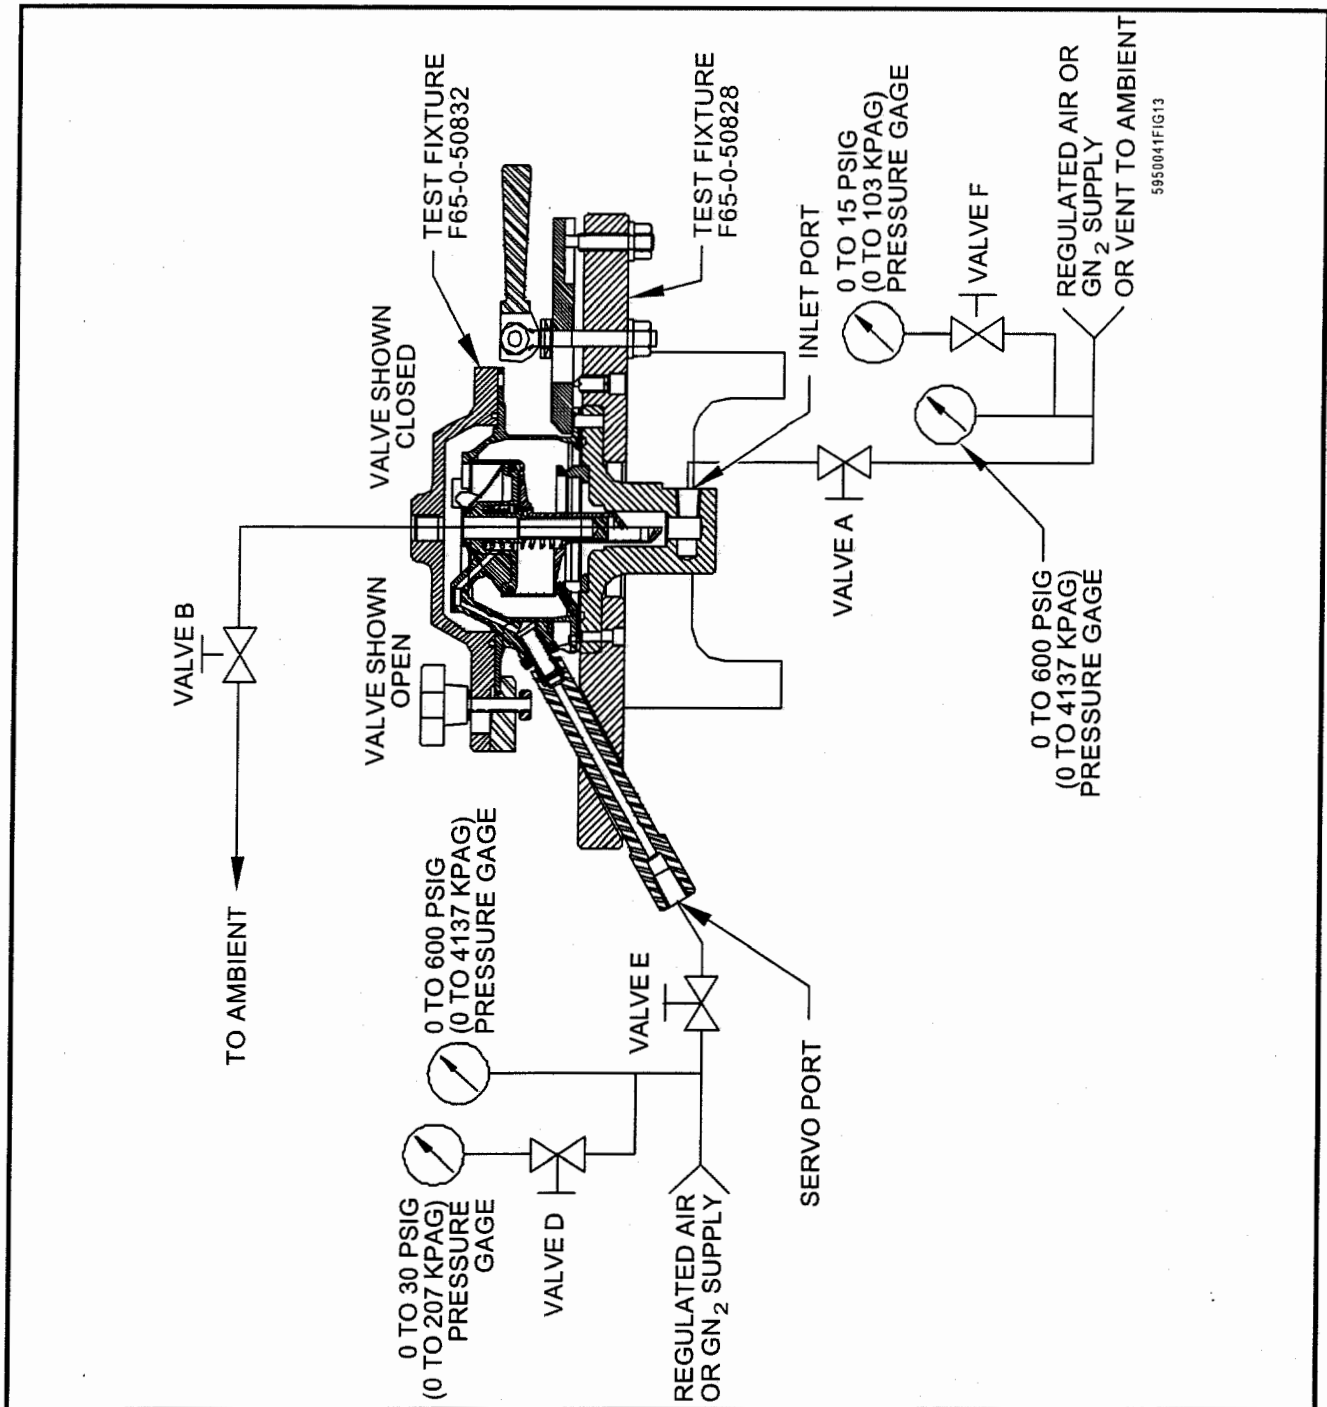
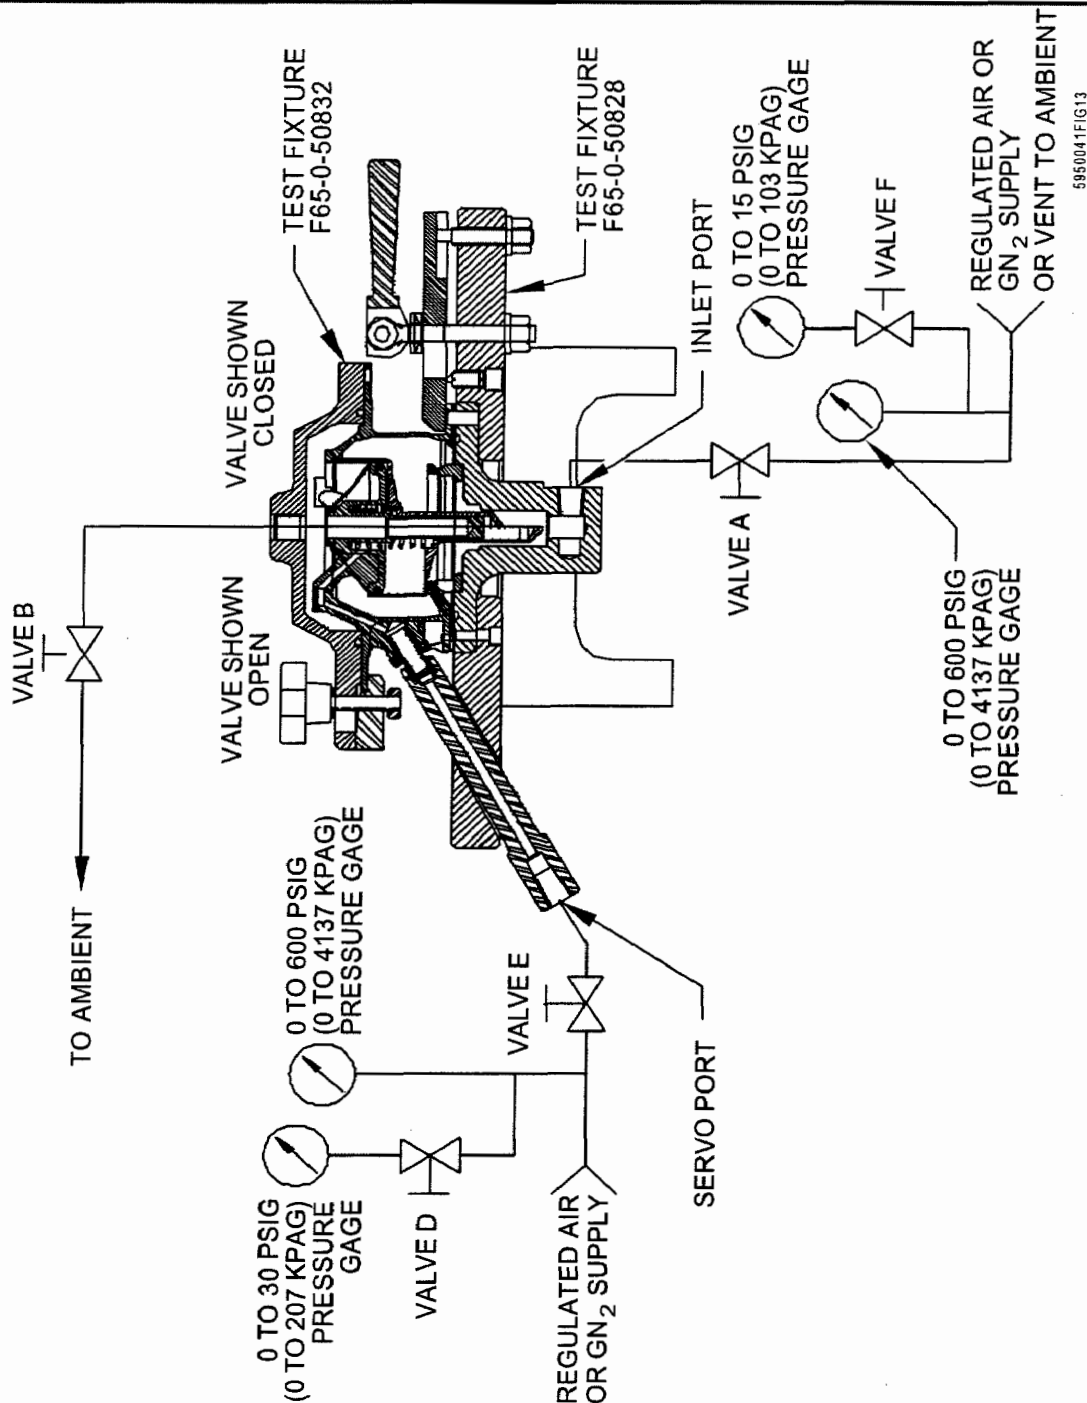
Operating Pressures Test Setup
Figure 5

- (a) With the spring still removed, set up the valve in test fixture, F65-0-50828, as shown in Figure 5. Open valves A, D, E, and F.

NOTE: A sudden increase in pressure as noted on the inlet pressure gage indicates that the valve closes (approximately 1.5 to 3 psig (10 to 21 kPag)).

NOTE: A sudden increase in pressure as noted on the inlet pressure gage indicates that the valve closes (approximately 1.5 to 3 psig (10 to 21 kPag)).
