V2500-A1/A5/D5 SERIES PROPULSION SYSTEMS SERVICE BULLETIN

This document transmits the Initial Issue of Service Bulletin EV2500-75-0090

# <u>AIR - ACTIVE CLEARANCE CONTROL VALVE - INTRODUCTION OF AN ACC VALVE WITH REVISED</u> <u>ACTUATING ROD SLEEVE BEARINGS</u>

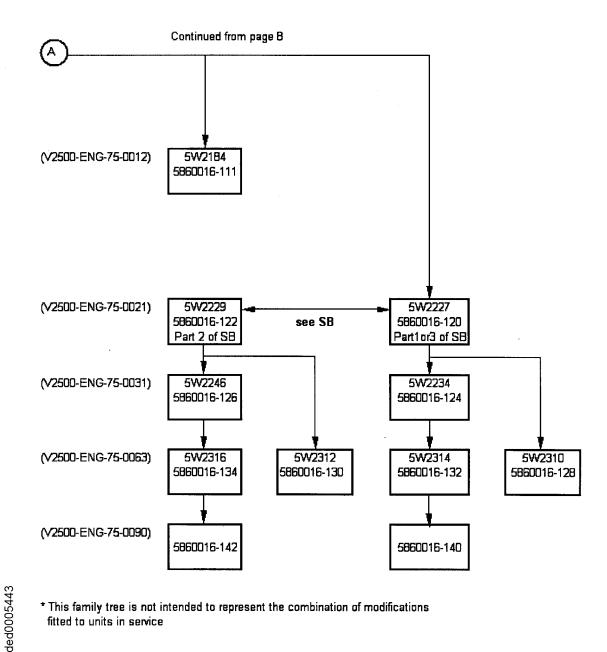
> V2500-A1 ACC Valve Family Tree Figure 1 (sheet 2 of 2)

\* This family tree is not intended to represent the combination of modifications fitted to units in service

Service Bulletin Number

**Unit Mod Plate Endorsement**

**Baseline**

None 5W2233

V2500-ENG-75-0063

Introduction of an ACC Valve with revised slotted entry type rod end assy.

V2500-ENG-75-0090

Introduction of an ACC Valve with revised actuating rod sleeve bearings

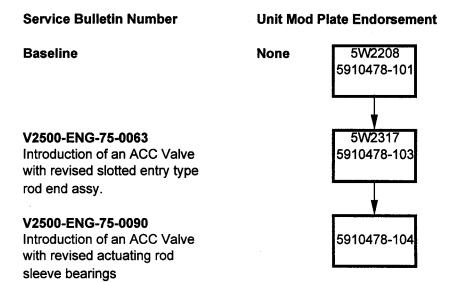
V2500-D5 ACC Valve Family Tree Figure 3

# V2500-D5 ACC Valve Family Tree\*

\* This family tree is not intended to represent the combination of modifications fitted to units in service
