V2500-A1/A5/D5 SERIES PROPULSION SYSTEMS SERVICE BULLETIN

V2500-ENG-80-0019

STARTING - PNEUMATIC STARTER - INTRODUCTION OF A PNEUMATIC STARTER WITH REVISED
DYNAMIC 'O' RING SEALS

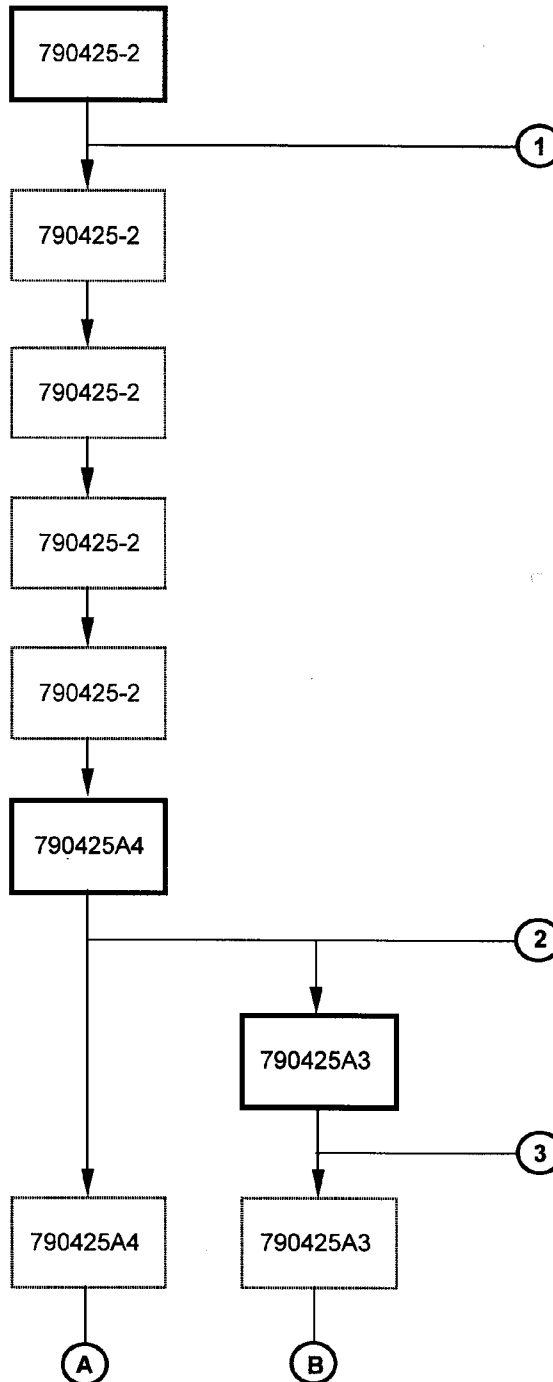
V2500-A1 Pneumatic Starter - Family Tree
Figure 1 (Sheet 1 of 3)

**V2500-A1 Pneumatic Starter Family Tree *****Service Bulletin Number****Unit Mod Plate Endorsement****Baseline****None**

Introduction of a revised Pneumatic Starter with improved clutch and oil distribution

Introduction of a revised Pneumatic Starter with oil sight glass & increased oil quantity

Introduction of a revised Pneumatic Starter with improved turbine torque loading, oil flow & carbon seal sealing

Introduction of a revised Pneumatic Starter with revised transmission housing

Introduction of a revised Pneumatic Starter with synchronous engagement clutch

Introduction of a revised Pneumatic Starter with oil pressure fill facility (Customer Option)

Introduction of a revised Pneumatic Starter with revised carbon seal retention

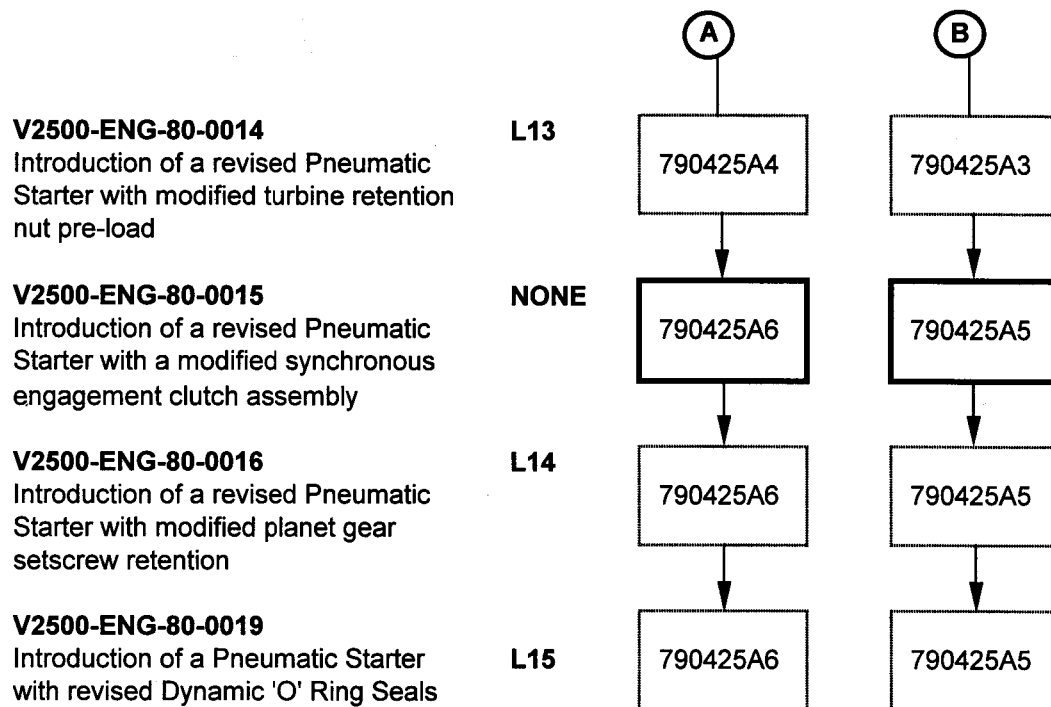
V2500-A1 Pneumatic Starter - Family Tree
Figure 1 (Sheet 2 of 3)

**V2500-A1 Pneumatic Starter Family Tree * (cont.)**

* This family tree is not intended to represent the combination of modifications

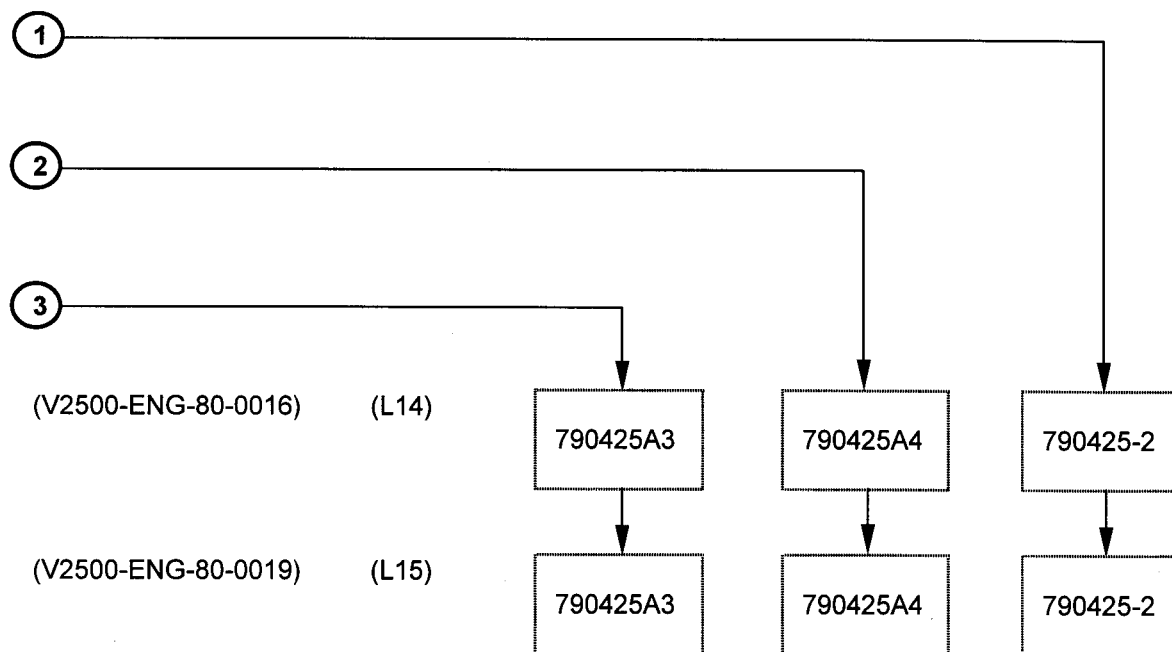
V2500-A1 Pneumatic Starter - Family Tree
Figure 1 (Sheet 3 of 3)

V2500-A1 Pneumatic Starter Family Tree * (cont.)

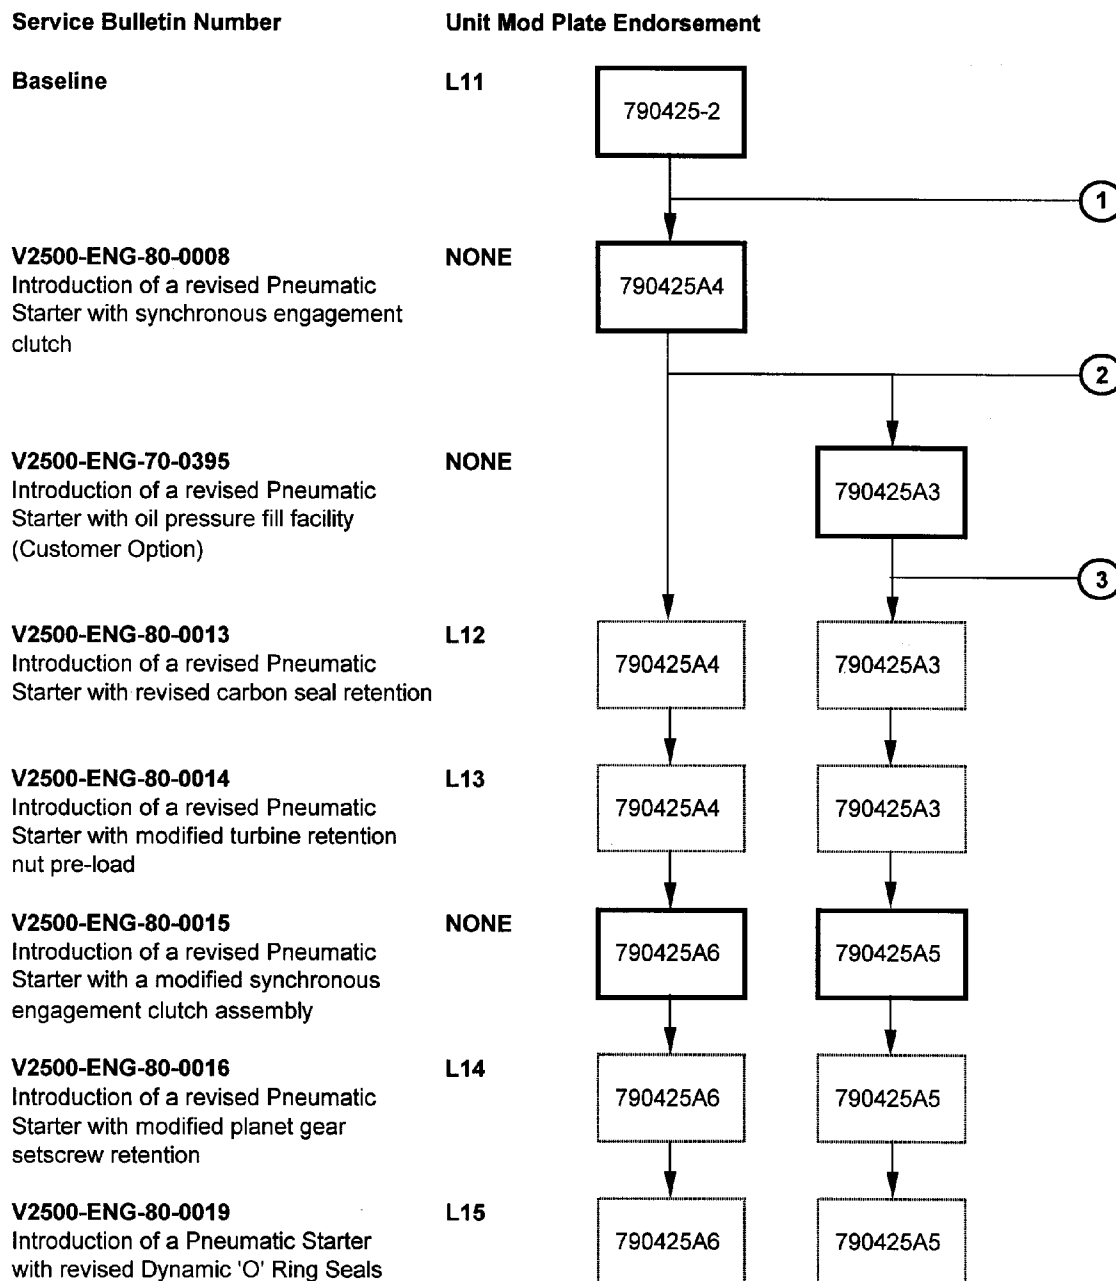
V2500-A5 (Except V2533-A5) Pneumatic Starter - Family Tree
Figure 2 (Sheet 1 of 2)

V2500-A5 (EXCEPT V2533-A5)
Pneumatic Starter Family Tree

* This family tree is not intended to represent the combination of modifications fitted to units in service

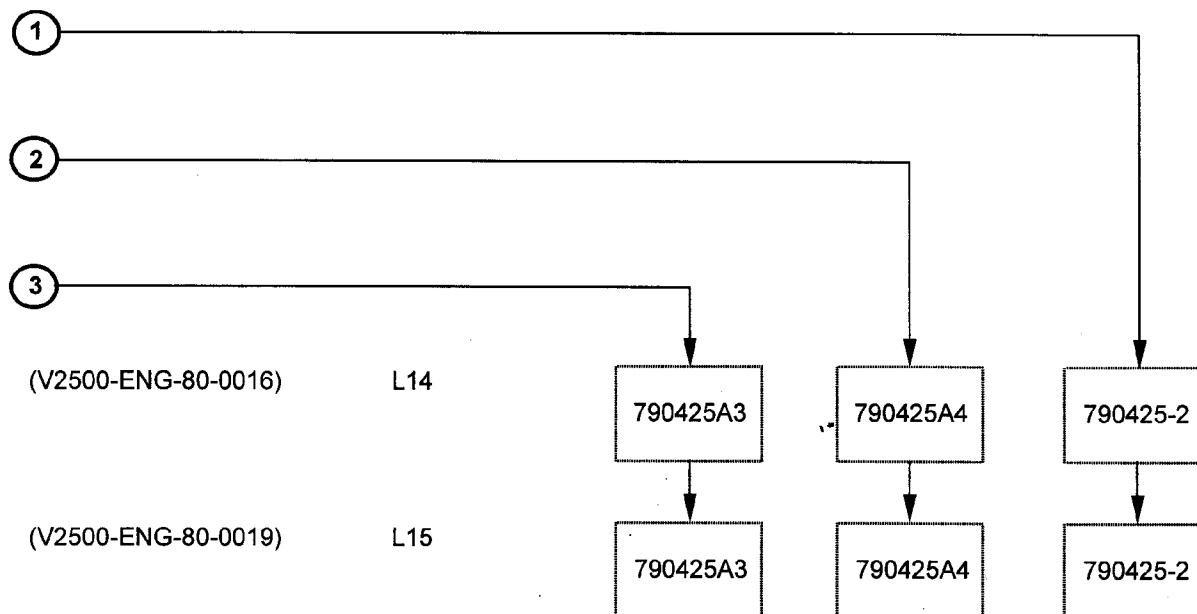
V2500-A5 (Except V2533-A5) Pneumatic Starter - Family Tree
Figure 2 (Sheet 2 of 2)

V2500-A5 (EXCEPT V2533-A5)
Pneumatic Starter Family Tree (cont.)

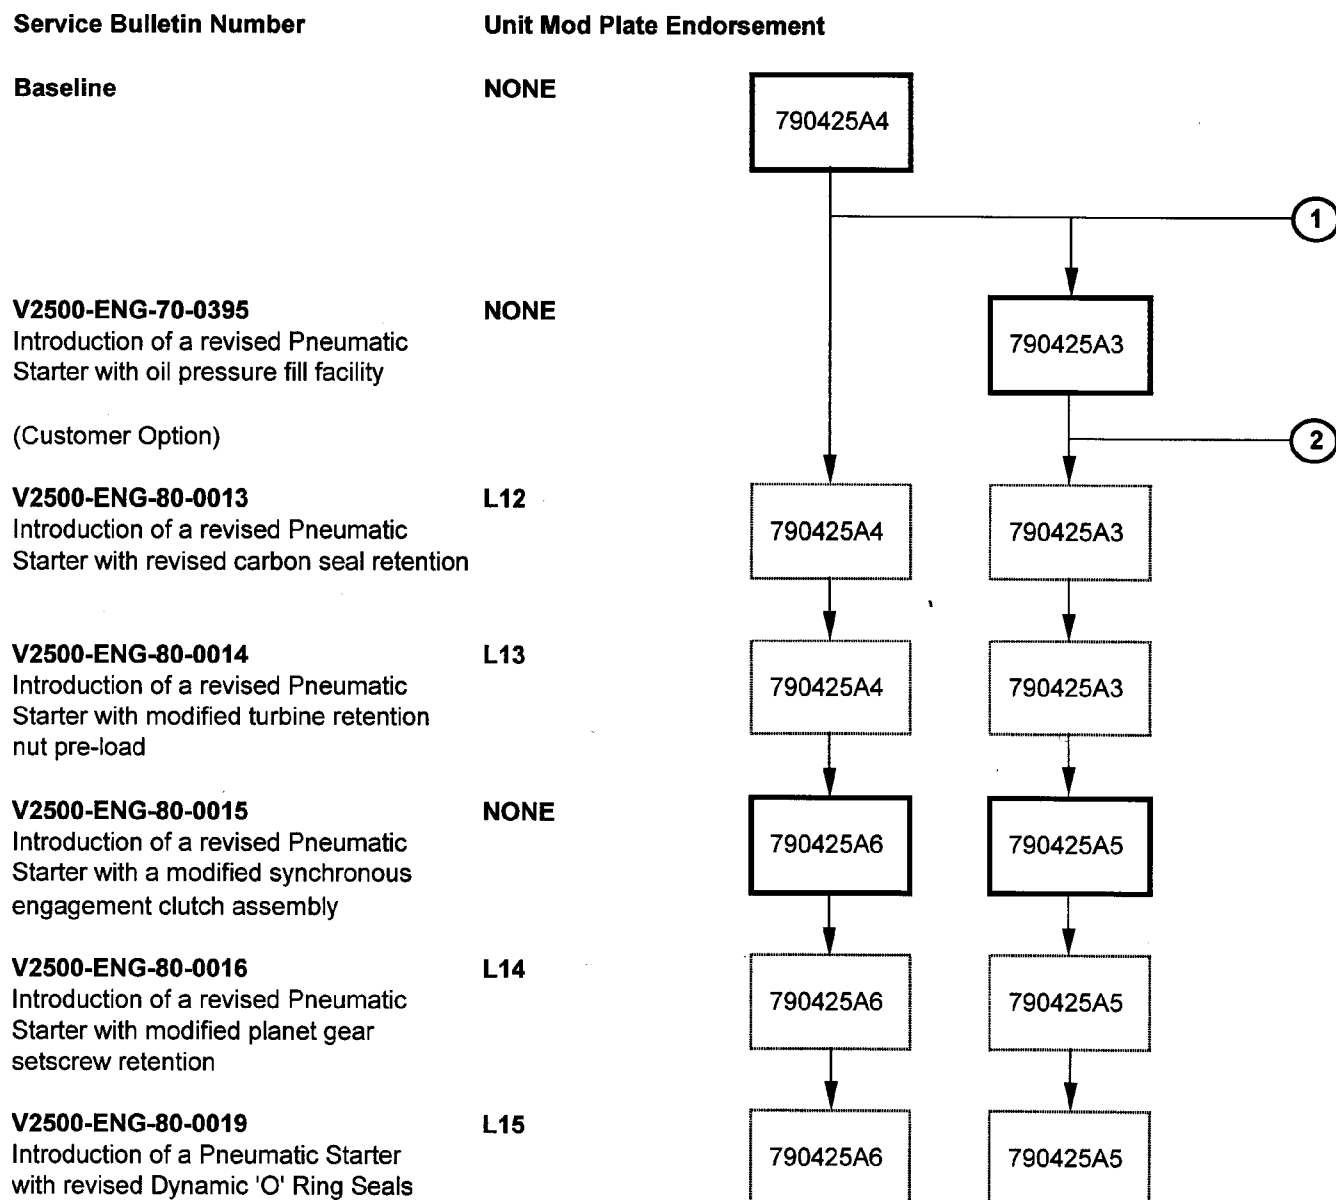
V2533-A5 Pneumatic Starter - Family Tree
Figure 3 (Sheet 1 of 2)

V2533-A5 Pneumatic Starter Family Tree*

* This family tree is not intended to represent the combination of modifications fitted to units in service

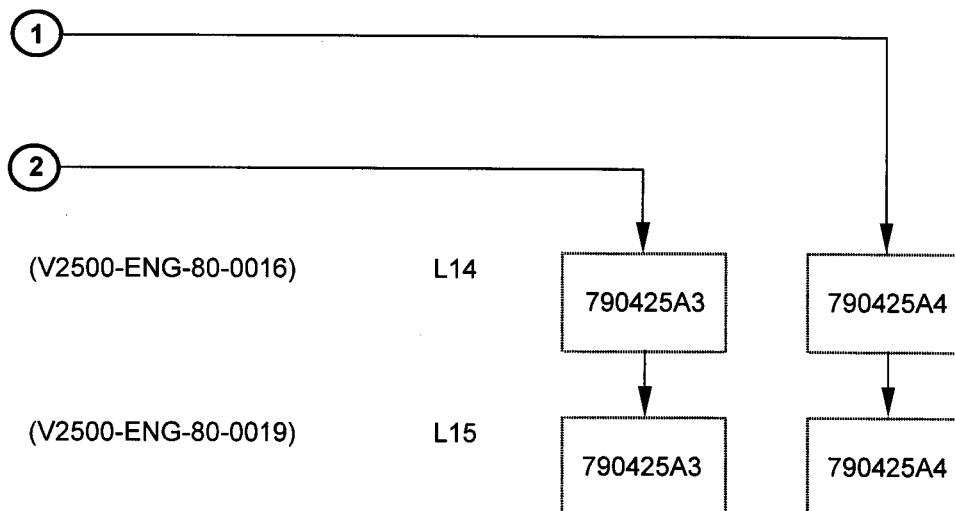
V2533-A5 Pneumatic Starter - Family Tree
Figure 3 (Sheet 2 of 2)

V2533-A5 Pneumatic Starter Family Tree* (cont.)

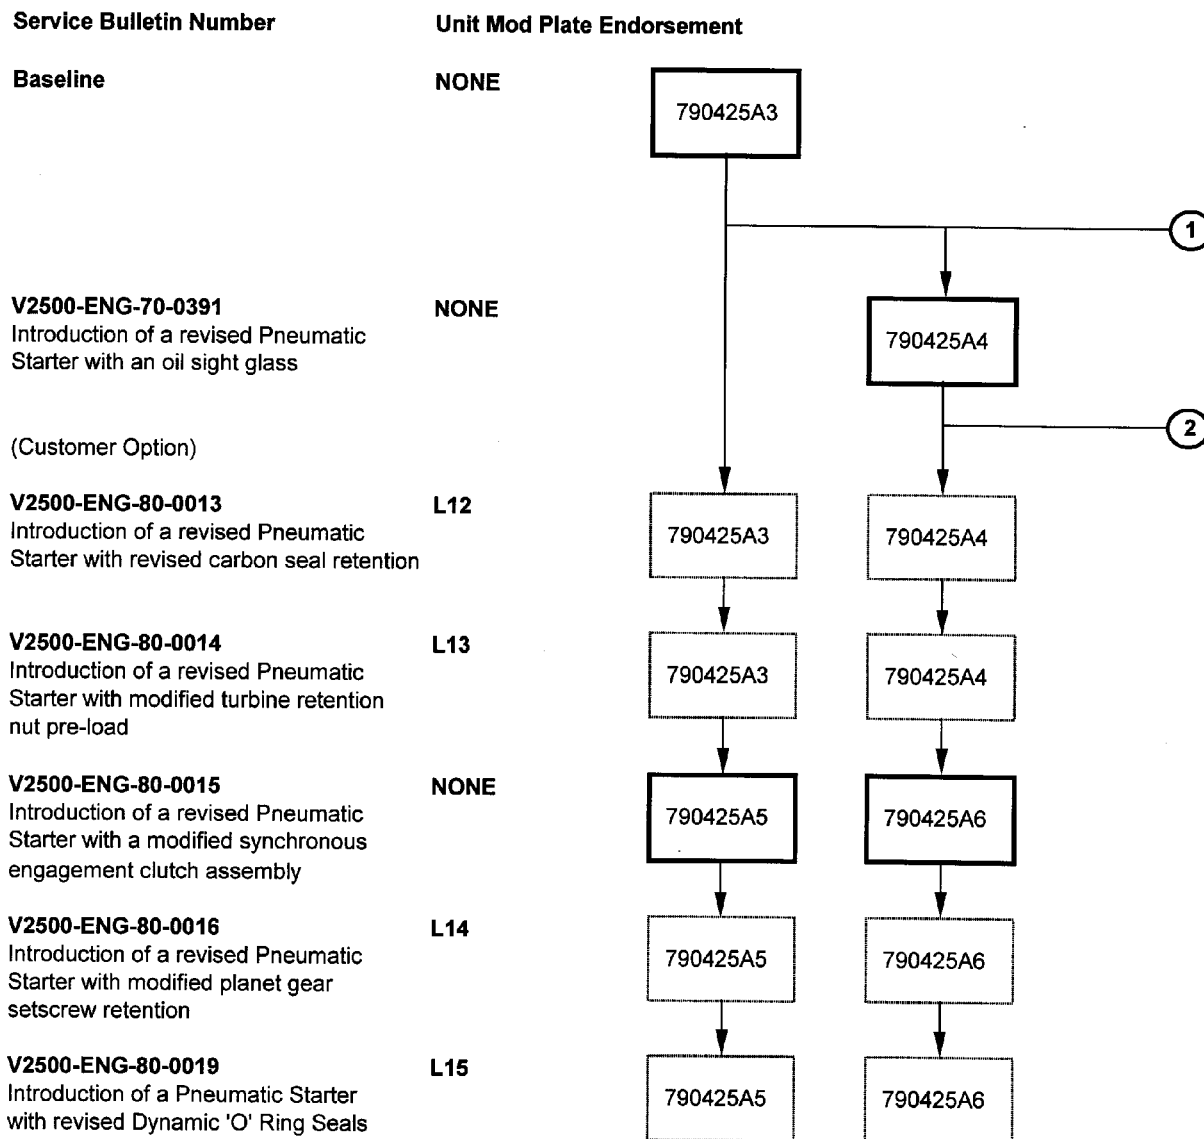
V2500-D5 Pneumatic Starter - Family Tree
Figure 4 (Sheet 1 of 2)

**V2500-D5 Pneumatic Starter Family Tree***

* This family tree is not intended to represent the combination of modifications fitted to units in service

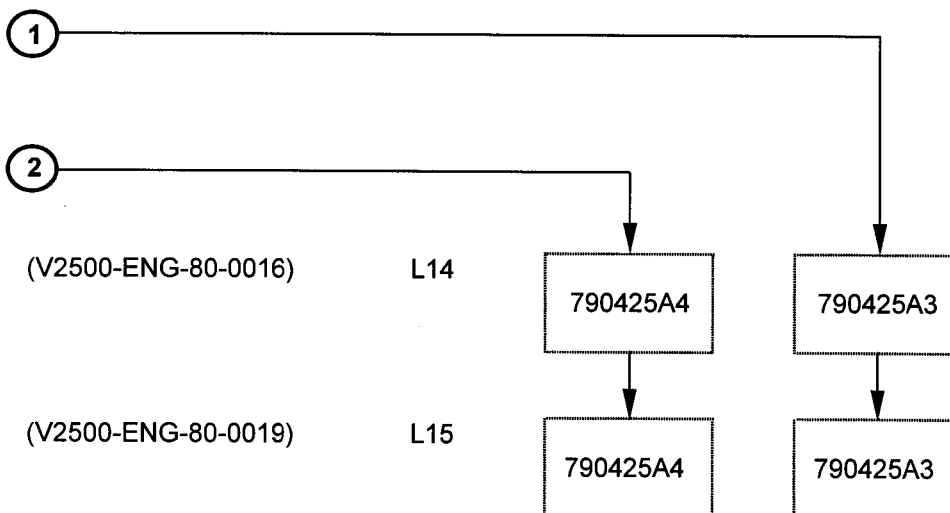
V2500-D5 Pneumatic Starter - Family Tree
Figure 4 (Sheet 2 of 2)

V2500-D5 Pneumatic Starter Family Tree* (cont.)
