## V2500-A1/A5/D5 SERIES PROPULSION SYSTEM NON-MODIFICATION SERVICE BULLETIN

NON-MODIFICATION SERVICE BULLETIN – AIR – REQUIREMENT TO FLUSH A VARIABLE STATOR VANE ACTUATOR (VSVA) 1685 UNIT FOLLOWING REPAIR OR RECONDITION AT AN APPROVED MAINTENANCE FACILITY

NON MODIFICATION SERVICE BULLETIN NUMBER VSVA 1685-75-010

PROCEDURE TO FLOW FLUSH A VSVA 1685 UNIT TO REMOVE ANY BUILT-IN  
CONTAMINATION AFTER REPAIR OR RECONDITION

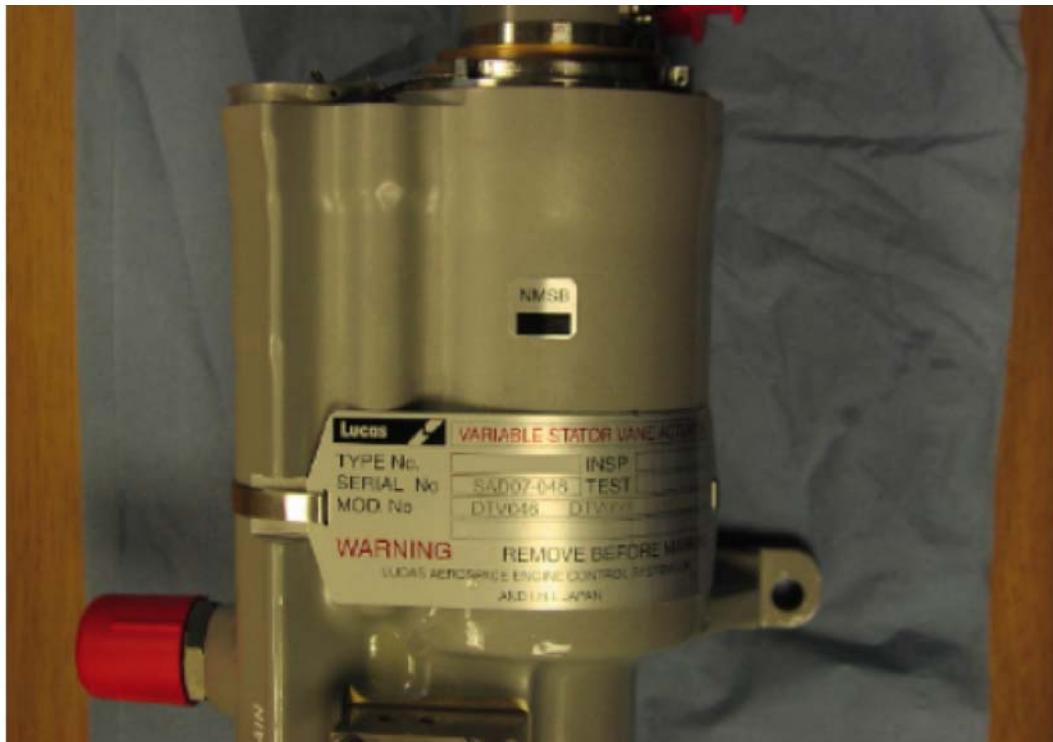
TP25626

Identification Label Position

- (b) Use a cloth that has no lint and Iso-propyl Alcohol to clean the surface where the identification label will be installed.
- (c) Install the identification label to the VSVA 1685 assembly body. Refer to Figure 1.
- (d) If an identification label has been installed before, it will be necessary to remove it. The installed identification label can be removed with the use of an applicable tool. If the surface of the VSVA is damaged during removal of the identification label, use process LP-5 to repair the damaged surface, ref. Goodrich Processes and Standard Practices Manual L-OP.
